# STUDY OF LOW-RISE RC BUILDINGS WITH RELATIVELY HIGH SEISMIC CAPACITY DAMAGED BY GREAT EAST JAPAN EARTHQUAKE 2011

## ABSTRACT

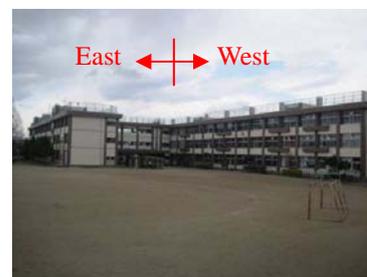
Fig.2 North view of H school building

Secondly, the study of 3 storied RC building of an elementary school in Sendai city constructed in 1974 is presented (Fig.2). The building is divided by expansion joint into west side and east side. Seismic evaluation was carried out to both sides. According to the seismic evaluation, the East side building needed to be retrofitted and the West side was evaluated to have enough seismic capacity and no retrofitting was needed. The East side building, which had already seismically retrofitted suffered only minor damage in its structural members. On the other hand, the West side building was heavily damaged.

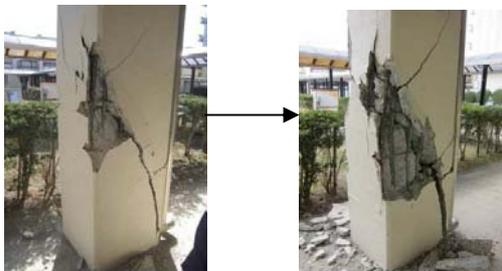
The N Lecture building had a severe shear failure in many of its columns in the 1<sup>st</sup> story in the longitudinal direction (see Fig.3). The damage to columns progressed much due to the 7<sup>th</sup> of April aftershock earthquake (see Fig.4). Less damage in the 2<sup>nd</sup> story but shear cracks were also noticed. Typical column size and its reinforcement is shown in Fig.5. First floor plan with damage classes in columns in the longitudinal direction are shown in Fig 6. Two columns were damaged by previous earthquake and strengthened by FRB sheets jacketing are marked as (? unknown) in Fig. 6. It is marked unknown because damage to concrete was invisible by the FRP jacket. The details of this repair were unavailable. However, the transverse direction was slightly damaged.

Fig.3 After 11<sup>th</sup> of March earthquake

Fig.4 After 7<sup>th</sup> of April aftershock

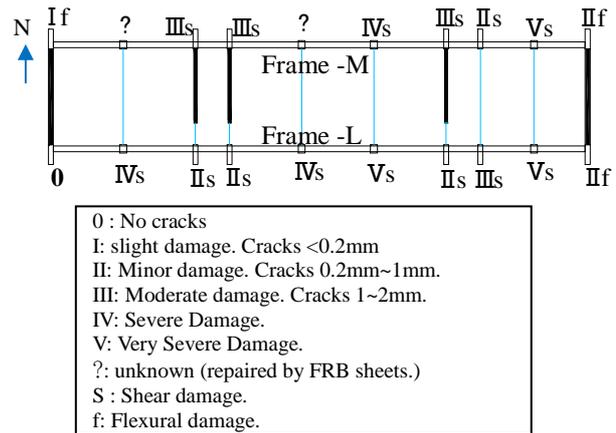
Fig6. 1<sup>st</sup> floor plan and damaged observed in longitudinal direction For N lecture building

The damage levels of each column are marked with Roman numbers based on the "Post-earthquake damage evaluation standards of Japan." [2].

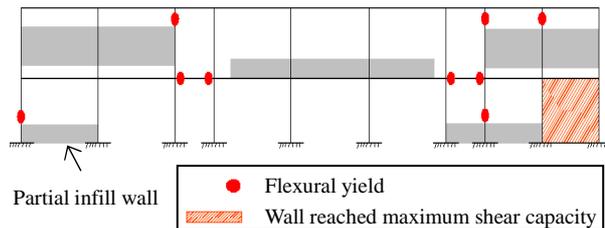
Fig.10 Damage predicted by pushover analysis for frame M of the S lecture at 1<sup>st</sup> story drift 0.5%

Fig. 10 shows yielded hinge locations in longitudinal direction of one frame of S lecture building at story drift of 1/200rad. The Shear wall has yielded and hinges are formed in two beams and two columns. However, as for the actual damage for S Lecture building, only shear cracks was noticed at the shear wall, no cracks was observed in other members. In the other hand, at the same story drift angle, three columns of the N Lecture building had failed in shear (Fig 11) and many columns were about to fail in shear.

Plastic hinges were expected in some beams as shown in the Fig. 10 and Fig. 11 which were not noticed in the actual damage investigation.

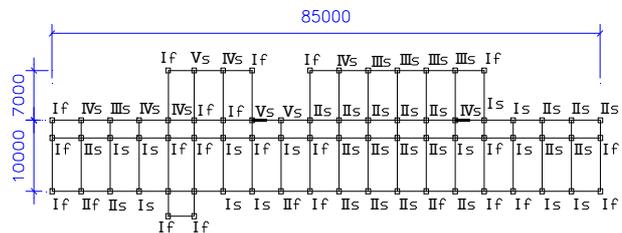
Fig17. 1<sup>st</sup> floor plan and damaged observed in longitudinal direction of building (W)

Typical story plan and its damage to the longitudinal direction of building (W) are shown in Fig. 17. Typical member's size and reinforcement are shown in Fig.18

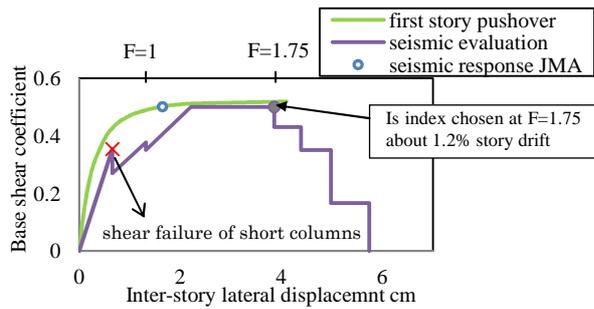
Fig23. Comparison between 1<sup>st</sup> story pushover and seismic evaluation results of building (W)

$I_s$  index for both buildings are chosen at a ductility greater than  $F=0.8$ , which means that the failure of extremely short columns was allowed in the seismic evaluation, since axial loads could be redistributed to other columns and the building will not collapse. However, short column failed only in building (W) and didn't in building (E). This is due to several reasons; The  $C_{TU} \cdot S_D$  for 1<sup>st</sup> story at ductility index  $F = 0.8$  for building (E) is about twice of building (W), as shown in Table 5. It is thought that building (E) had a story drift just less than  $F=0.8$ . This is shown using seismic response of JMA NW which is just before the shear failure of short columns (see Fig. 22). Therefore short columns didn't reach their maximum allowable ductility and escaped shear failure. In the other hand, The  $I_s$  value for building (W) depends on ductility ( $F=1.75$ ) to reach the criteria of  $I_s > 0.7$ . The anticipated seismic response using either JMA NW or MYG013NW spectrum are greater than  $F=1$  (see Fig.23). At this seismic response, all short and shear columns had shear failure.
