DAMAGE OF SIX-STORY RC BUILDING WITH COUPLING BEAMS HAVING ASPECT RATIOS LARGER THAN 2.0

Abstract: Several buildings in Tohoku University were severely damaged by the 2011 Great East Japan Earthquake. In this paper, the damages in one of these buildings are reported and the reason of this damage is discussed. The target of this investigation was a six-story reinforced concrete building. The building was constructed in 1968 and retrofitted in 1997. This building is assumed to have enough strength to resist earthquakes in Japanese seismic evaluation. The base shear coefficient of this building is estimated to be 0.6. Severe damage was observed in short beams with web openings in upper stories. On the other hand, the mainly observed damages in columns and shear walls are thin cracks less than 1mm wide. The observed failure is different from what was considered in the seismic evaluation. Therefore, the actual strength of the frame is estimated by using the limit analysis in which the observed failure mode is assumed. In the limit analysis model, the rotation angles of short beams are much higher than those of shear walls. Shear walls might be elastic when the beam failures occurred. T

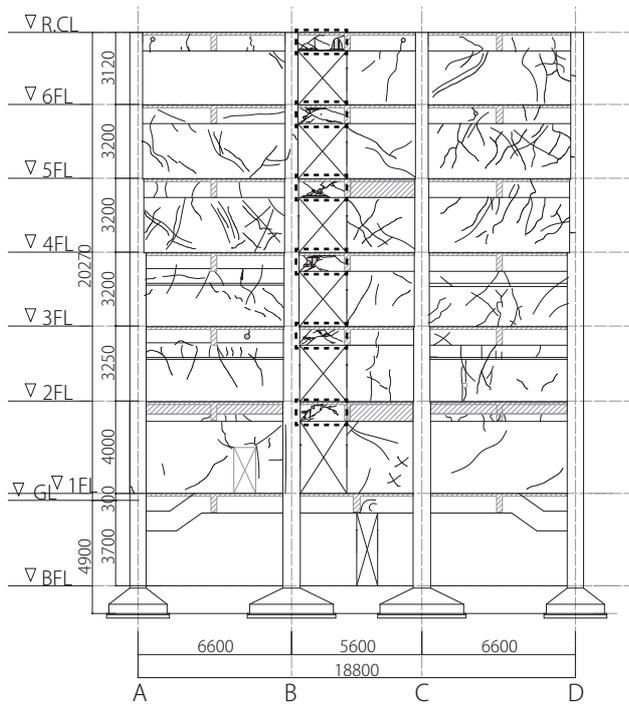
Figure 4 Observed cracks of transverse direction (axis 3)

Figures 3, 4, 6 and 7 show observed cracks in selected frames. Bold lines in the figures represent cracks of more than 1mm wide. Hatched areas represent the blocked areas. In longitudinal direction, severe damages concentrated on beams above openings (Fig. 3 and Photo 3). In transverse direction, severe damages concentrated on coupling beams with web openings (Figs. 4 and 7 and Photos 4 and 5). These observed damages indicate that the short beams failed in shear. Figure 5 shows cracks observed in short beams of transverse direction (axis 3) on each story (broken lines in Fig. 4 show these

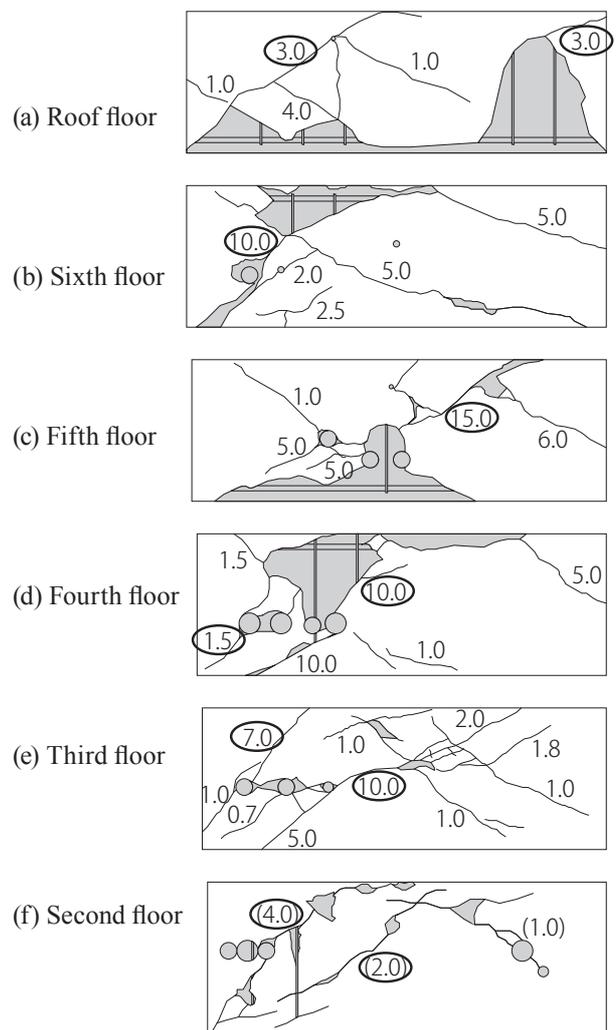
Figure 5 Observed cracks of the short beams (axis 3)

The circled numbers in Fig. 5 are residual shear crack widths assumed to be induced by the deformation shown in Fig. 11. The rotation angle of the beam attributed to shear deformation can be estimated roughly from these crack widths and clear spans of the beams on each story (Fig. 12). In Fig. 11, a shear wall between axis A and B is rotate around axis A due to a column on axis A. This is based on the assumption that the location of the neutral axis is near the centroid of the column. A shear wall between axis B' and D is rotate around axis C due to a column on axis C.

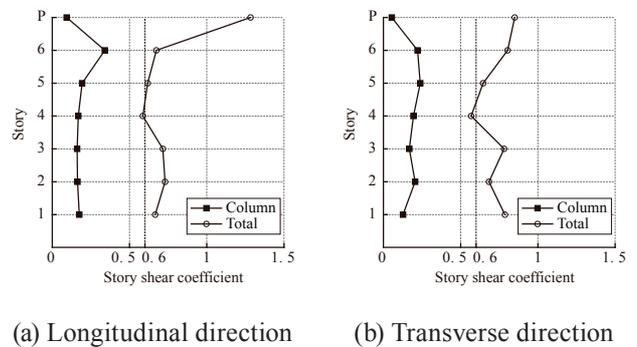
Figure 9 Story shear coefficients of each story

of crack widths was observed on fourth to fifth stories. The story shear coefficients are more than 0.57 in both directions. Therefore, the building was assumed having enough strength based on the evaluation. Nevertheless

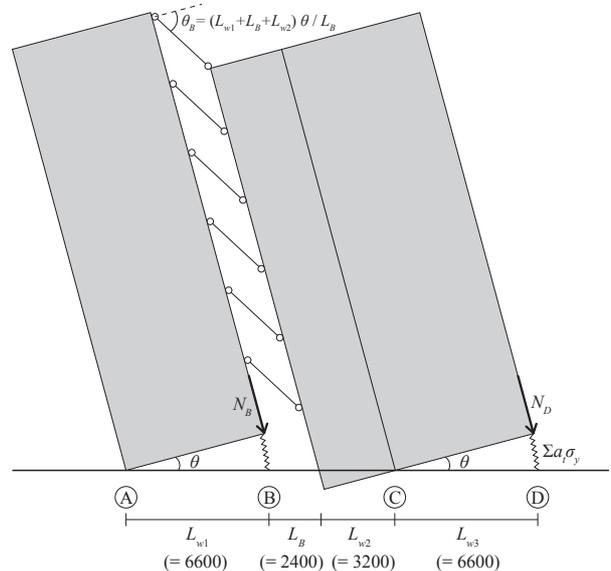
Figure 10 The assumed failure model

The coupled shear walls rotate as shown in Fig. 10 and vertical reinforcement bars are assumed to be yielding at the bottom of the first story, where a_i represents cross-section area of longitudinal reinforcement in boundary column and σ_y represents yield strength of the steel. N_1 and N_2 are the permanent loading axial forces on the boundary columns of the walls. The circles at beam-ends in this figure represent the plastic hinge.

In the analysis, two models have been proposed. In the first one, the short beams of the span L_B fail in shear: the beams are completely destroyed and capacity in hinges is negligible. In the second one, the beams yield in flexure at both ends.

of the cracks found in the walls of the building. As to the results of the analysis, the lateral capacity of the frame axis 3 is 10MN, in the case of considering the contribution of the short beams. In the case of neglecting those beams, the lateral capacity is 8MN. Thus, the actual value would exist between these two results and the beams make an important contribution to the capacity of the frame actually. According to the documents of the seismic evaluation, the lateral capacity of the frame axis 3 is 10MN. It is a coincidence that this value is almost equal to the analytical result with considering beam contributions, however, this indicates that the building is assumed to have enough strength.

The rotation angles of short beams, θ_B in Fig. 10, is

5.1 times larger than those of shear walls, θ in Fig. 10. It suggest that extremely large deformation will be induced to the short beams if the deformation of the building is relatively small.

large. The coupling beams should be reinforced to have larger shear strength than flexural strength and should not have openings.

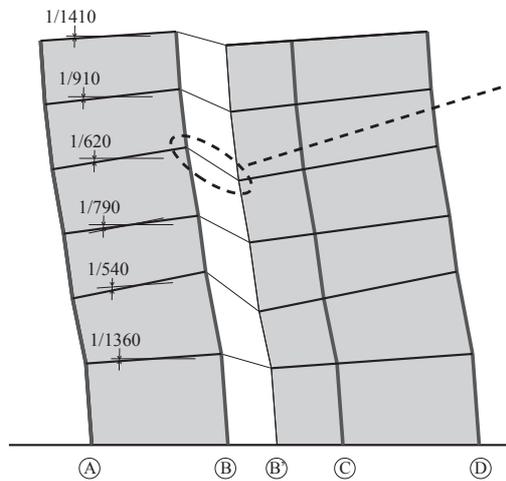
Figure 11 The assumed deformation model

Figure 11 shows assumed deformation model based on following assumptions.
