DAMAGE TO REINFORCED CONCRETE SCHOOL BUILDINGS IN MIYAGI AFTER THE 2011 GREAT EAST JAPAN EARTHQUAKE

ABSTRACT: Typical damage observed by author's field survey in Miyagi prefecture is described. Generally, reinforced concrete structures performed well and effect of seismic retrofit was found in mitigation of damage, although severe damage to some seismically retrofitted buildings was noticed. Some buildings are selected for detailed investigation. A good correlation was observed between calculated seismic capacity I_s -index and observed damage. However, major damage to non structural elements was commonly observed. The reasons for damage and lessons to seismic design are discussed.

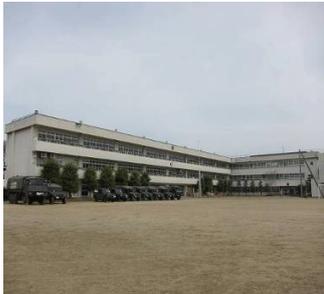
Fig. 9 shows 3 storied RC school building in Shitigahama town built in 1966. Seismic capacity I_s -index of the building was evaluated much lower than the criteria of 0.7. Seismic retrofit was planned for the buildings, however, it was not yet conducted before the earthquake. Many of columns and shear walls failed in shear as shown in figure 10 and figure 11.

Fig. 9 Overall view of damaged school building

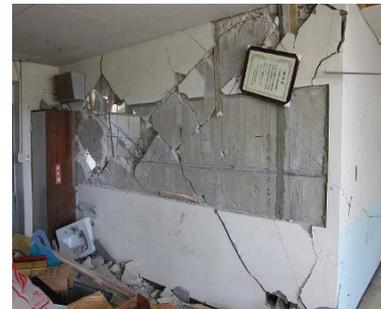
Fig. 11 Shear failure in shear wall

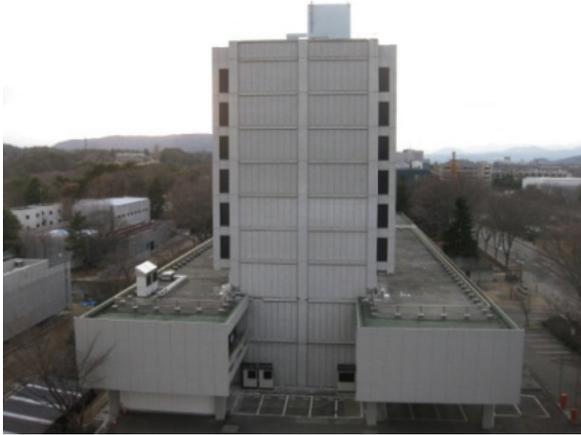
Figure 12 shows 9-story steel reinforced concrete (SRC) building of Civil Engineering and Architecture building in Tohoku University constructed in 1969, which suffered from minor damage due to the 1978 Miyagi Oki earthquake. Small shear cracks and flexural cracks were observed in exterior shear walls, adjacent beams and few columns in the 3rd and 4th floor as shown in figure 15(a)(Shiga 1980). Acceleration records were obtained by BRI both in 1st and 9th floor of the building.

Fig. 12 Civil Engineering Building in Tohoku Univ.

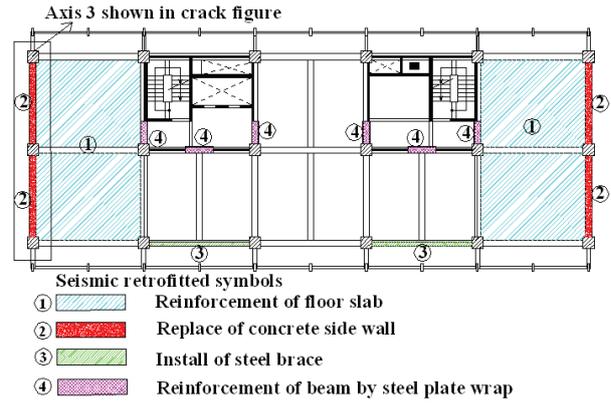
Fig. 13 Typical floor plan and outline of retrofit

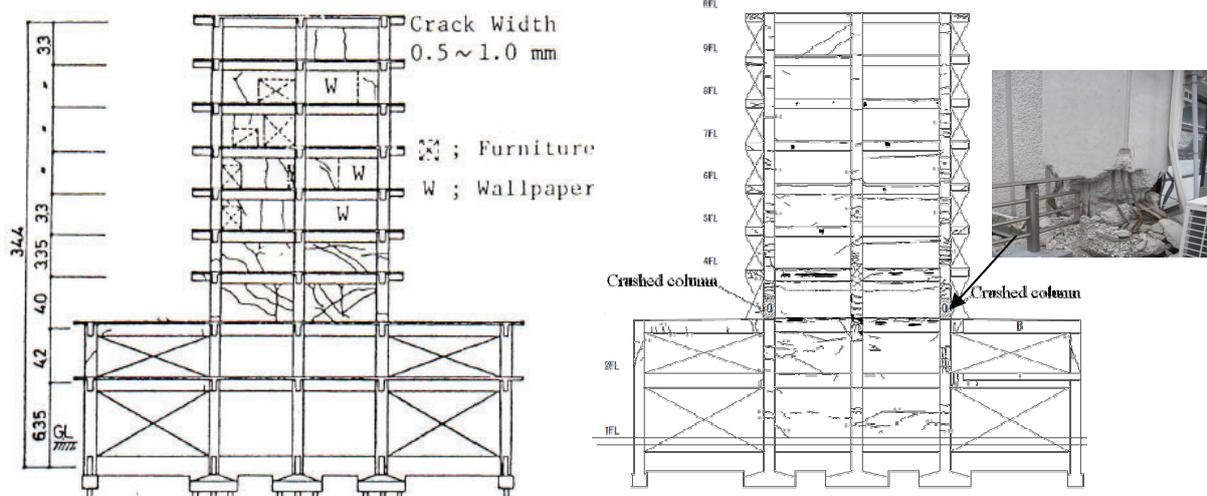
Even though it was retrofitted, it was severely damaged by the 2011 earthquake as shown in figure 14(b). There was strong ground motion at the site at periods close to 1 sec (see Fig.15), which is the fundamental vibration period measured for this building during the earthquake. Boundary columns failed in compression and the connection of walls to beam also failed indicating that the ductility of the shear walls was not increased as expected in the seismic retrofit. This may have been caused by poor connections between the wall webs (which were replaced during the retrofit) and the surrounding beams and columns.

(a) 1978 Miyagi Oki Earthquake

(b) 2011 East Japan Earthquake

Fig.14 Crack pattern of building in Tohoku University

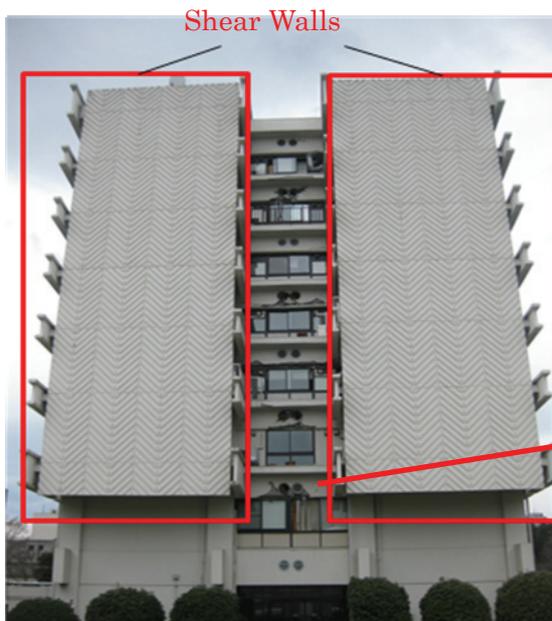
(a) Coupled shear wall and link beam

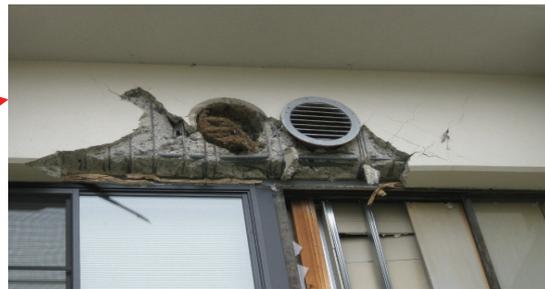
(b) Close up of shear failed coupling beam

Fig 16 Electrical building in Tohoku University

Fig. 16 shows another building severely damaged in Tohoku University. This building is 8-story reinforced concrete building of electrical engineering building constructed in 1969. Electrical building in Tohoku Univ. was also retrofitted 1997. A base shear-displacement curve produced by a seismic evaluation indicated that response of this building was expected to be linear (see Fig.15). Note that the beams were assumed not to be vulnerable to shear failure and base shear was dominated by the resistance of the shear walls. Collapse was successfully prevented and no one was injured. Although

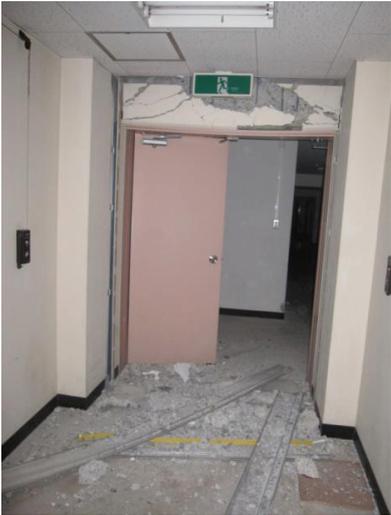
damage to structural walls and columns was light, damage to beams was severe (see fig.17). Penthouse was also severely damage (see Fig.18) Demolition was decided because of high repair cost.

Fig 17. Shear failure in short beams

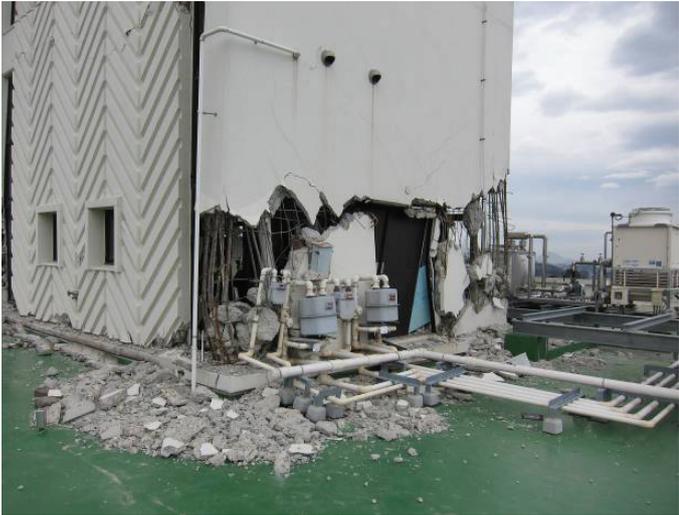
Fig. 18 Collapse of penthouse

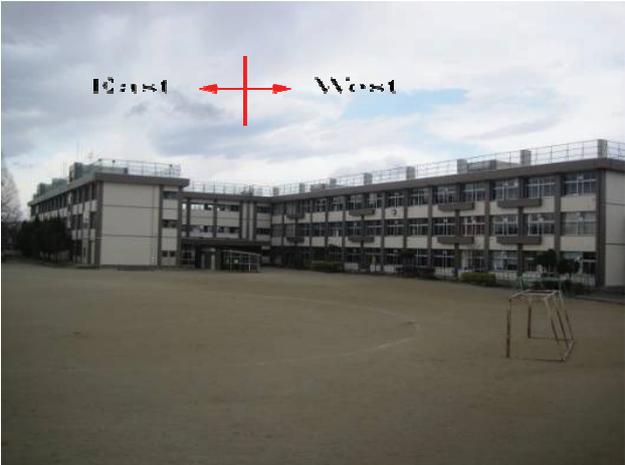
Figure 19 shows 3 storied RC building of an elementary school in Sendai city constructed in 1974. The building is divided by expansion joint into west side and east side. Seismic evaluation was carried out to both sides. According to the seismic evaluation, the East side building needed to be retrofitted (see fig. 22) and the West side was evaluated to have enough seismic capacity and no retrofiting was needed. The Is-index for West side building depends on ductility ($F=1.75$) to reach the of $I_s > 0.7$ which is the criteria in Japan (see Fig. 21). The East side building was retrofitted by adding framed steel braces and shear walls. By this earthquake, the retrofitted building had only minor damage. On the other hand, the West side building had shear failure in its short columns as shown in figure 20. Shear failure of those short columns was allowed in the seismic evaluation because axial loads could be redistributed to other columns and the building didn't collapse. This building wasn't retrofitted since it's judged that there is no threat to life safety. However, the school could not use this building after the earthquake and repairing expenses would be relatively high if compared to the retrofiting expenses for a better performance. This issue of functionality is one of important issues that require more attention. The response spectrum of this area is mentioned above in figure 3 as 2011 East Japan MYG013 NS.

Fig.19 North view of school building

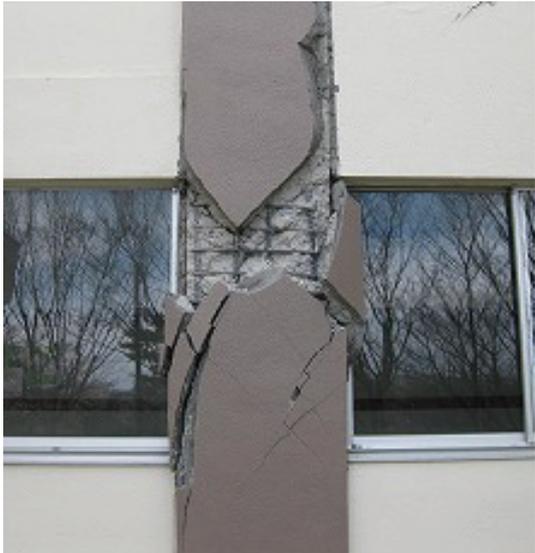
Fig.20 Shear failure in column

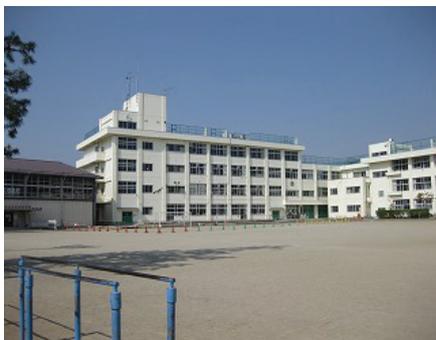
All the school facilities in Sendai city were either designed with the current seismic code or have been already seismically evaluated and retrofitted if necessary. Severely damaged buildings which may be a threat to life safety were not observed in this survey. However, Moderate damage to some buildings designed according to the early versions (early 1980s) of the current seismic design code was observed. Figure 23 shows a typical example of a four storied elementary school building constructed in 1985. This building had a shear failure in one of its walls as shown in figure 24. Beams with shear failure were also noticed as shown in figure 25.

Fig. 23. North view of building

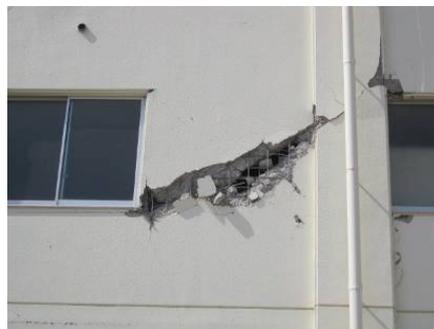
Fig. 24 Shear failure in wing wall

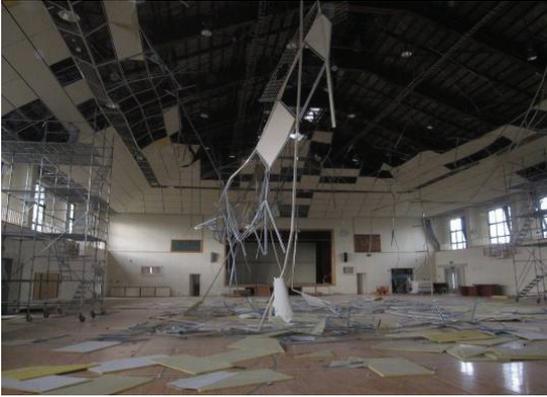
In figure 26, large parts of ceiling fell in a gym of a junior high school in Kurihara city fell down. Figure 27 shows a damaged masonry wall of which some concrete blocks fell down. Such damage could be a life threat.

Fig. 26 Large parts of the false ceiling fell down

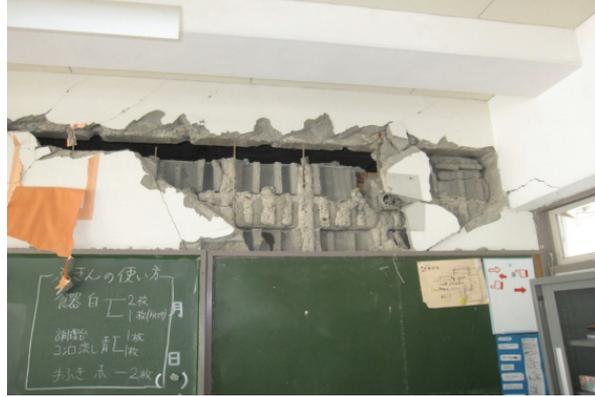
Fig. 27 Partial collapse of concrete blocks partition wall

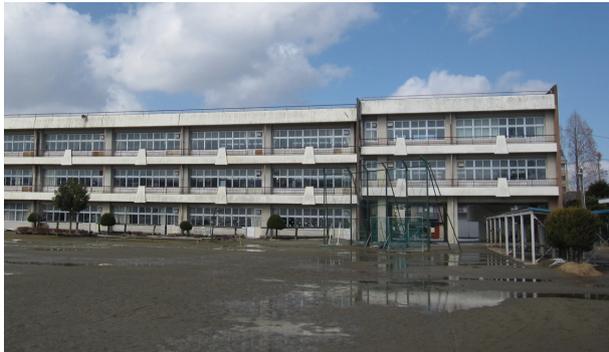
Settlement and tilting of buildings as a result of liquefaction had occurred in some regions of Miyagi prefecture. Figure 28 shows a junior high school building in Osaki city. The right side of the building was constructed in 1978. The left side was added in 1991. This school rests on a soft ground with pile foundation of 20m in depth. Evidence of liquefaction was seen around the school as shown in Fig. 29. The right side part had a settlement of about 60 cm, the south part was inclined by angle of 1/25 rad. The newly added part had a settlement of about 10 cm and slightly inclined. The response spectrum of this area is mentioned above in figure 3 as 2011 East Japan 4B9 NS.

Fig. 28 Settlement of school building in Osaki City

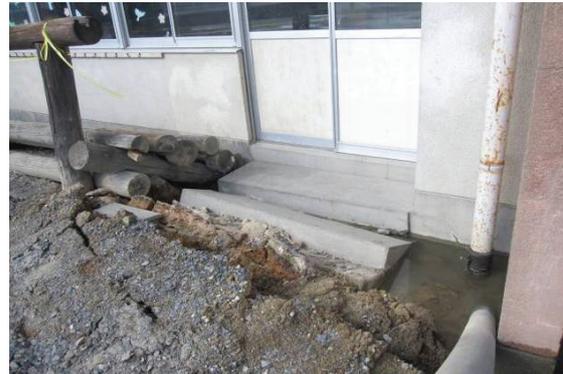
Fig. 29 Liquefaction evidence located 3 stair steps from the ground surface.

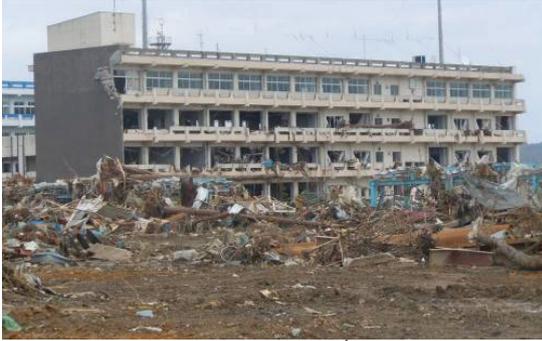
Figure 30 shows a high school building in Kesenuma city. The flooding reached 3rd floor. Windows, doors ceiling were washed away and classrooms were full of debris.

Fig. 30 Flood reached 3rd floor

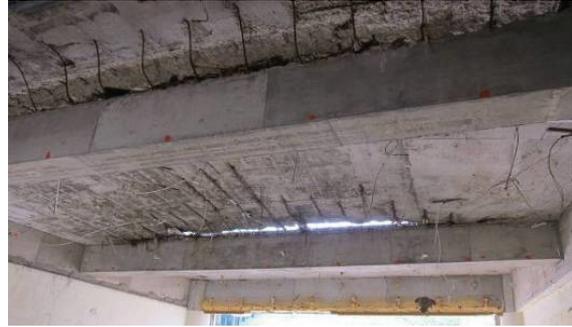
Figure 31 shows a floor slab that was lifted up and damaged at connections with beams in Ishinomaki city.

Fig. 31 Slab uplifted and dismantled from beam
