DAMAGE OF RC BUILDING WITH COUPLED SHEAR WALLS CAUSED BY THE 2011 GREAT EAST JAPAN EARTHQUAKE

Abstract: An eight-story reinforced concrete building retrofitted according to 1990 Japanese Standard was severely damaged during the 2011 Great East Japan Earthquake. The building was constructed in 1966 at Tohoku University. In 1996 the building was retrofitted using structural walls and carbon fiber. Dramatic damages were observed in coupling beams, a penthouse and a structural wall. Coupling beams failed in shear and bond. Columns and walls in the penthouse collapsed by torsion. The structural wall failed in compression at its end. Some of structural members were different from original drawings. Therefore, their strengths are re-calculated considering these differences by using 2010 Japanese Standard. Based on these calculated strengths, a pushover analysis is conducted. The failure mode in the analysis agrees with observed failure. Furthermore, it is confirmed that perpendicular walls cause large deformation of coupling beams.

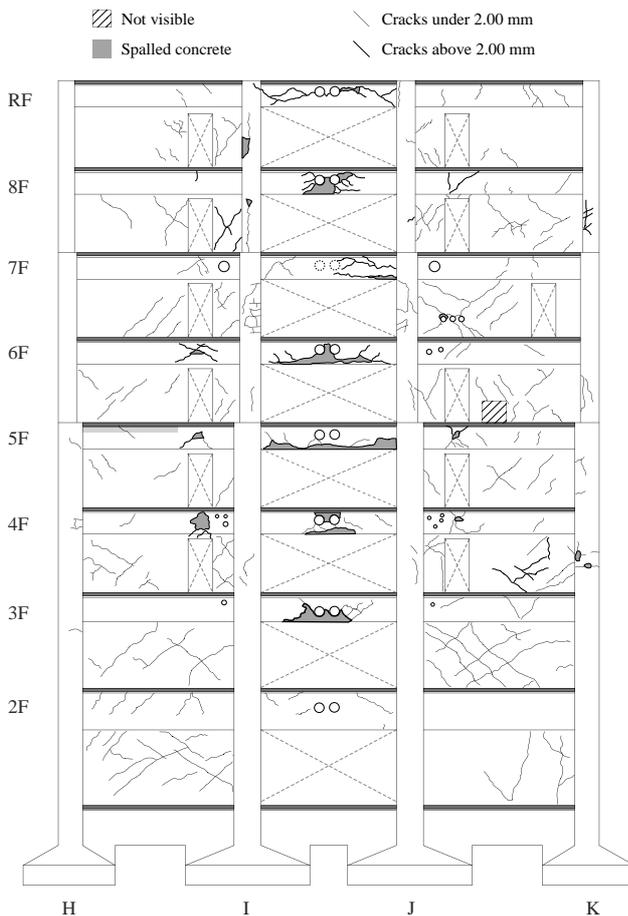
Figure 6 Frame 14 cracks schedule

Figure 6 illustrates that severe damages were detected in these coupling beams of the frame number 14. They have two openings near their midspans. They failed in shear at the center of beam at 3rd, 4th, 6th and 8th stories, and bond failure at the 5th, 6th, 7th stories. About bond failure they have two patterns. 5th and 6th stories failed from end to end of the beams and, 7th stories failed not center but ends.

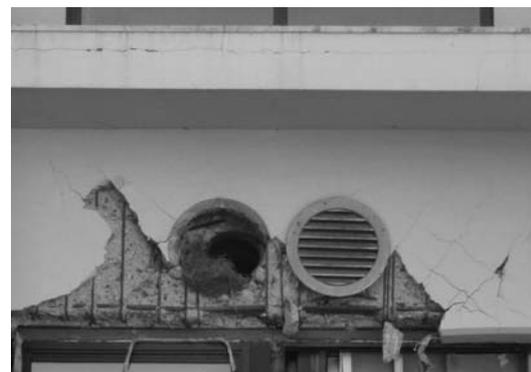
Photo 3 Beam of the 3rd Floor

Photo 3 and Figure 10 show the beam of the third floor. From these investigations, the section of this beam with openings can be estimated as Figure 11. The diameter was not constant along the beam depth and it was larger in outside part of the beam. In addition, the distance between of these openings was 600mm which was estimated from photo. There were no stirrups under

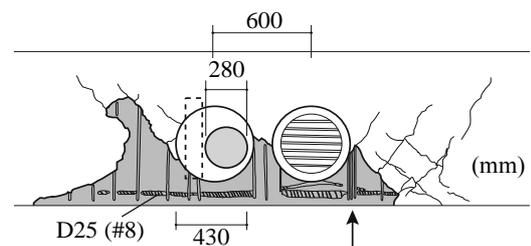
Figure 10 Detail of beam of the 3rd Floor

openings. The arrow in Figure 10 illustrates three stirrups were gathered beside the opening. In the broken area in this figure, there were no stirrups because they were cut for the opening.

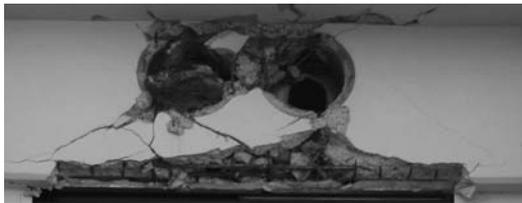
Photo 4 Beam of the 4th Floor

Photo 4 and Figure 12 describe the beam in the fourth floor. It was different from third floor where some stirrups were gathered beside the opening. Stirrups were cut above the opening as shown in the broken area. In addition, straight anchorage of diagonal reinforcement was different from drawing which adopted bent bars. Diameter of this opening was constant along the beam width. (Figure 11)

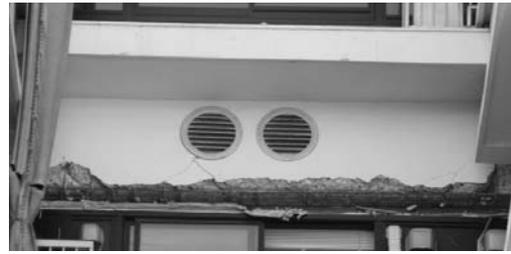
Photo 5 Beam of the 5th Floor

The beam of fifth floor is provided in Photo 5. This failed in bond from end to end. Figure 13 shows the beam bottom surface viewed from below. The upper part of the figure is outside and the lower part is a window frame. Deformed bars are the longitudinal reinforcements in the beam. It shows that window frame was attached to the longitudinal reinforcement, and stirrups were cut as shown in the circle. These stirrups were cut to get the window frame into position. It was estimated that the beam got little covering depth of concrete for window frame.

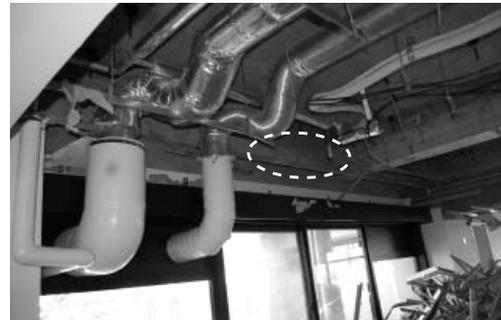
Photo 6 Beam of the 7th Floor from inside

The beam of 7th floor failed bond at both sides, and not shear around openings. Photo 6 was taken from inside of the building. It was detected that the beam had no opening at the 7th floor whereas the ducts in the openings were found in 6th floor as shown in Photo 7.

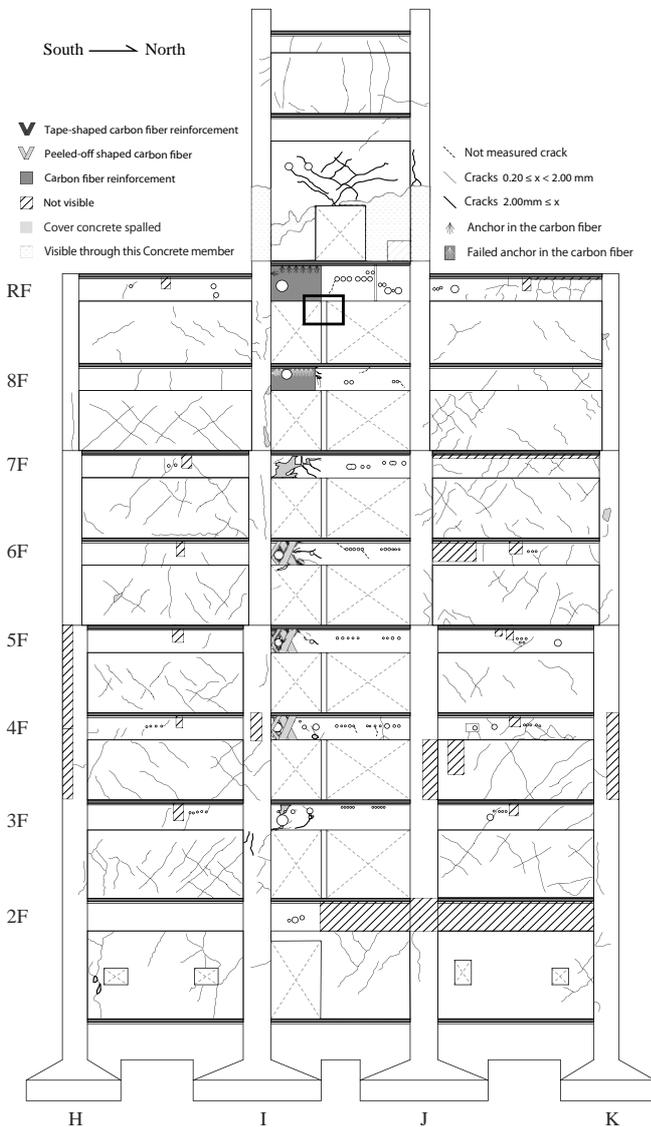
Figure 14 Frame 11 cracks schedule

The frames 11 were constituted of shear walls and coupling beams between these walls. Figure 14 illustrates that coupling beams of second floor and roof floor had less damage. But those of other floors suffered heavy damage as shown Fig. 15. They had perpendicular walls under coupling beams. On the South side of this perpendicular wall, the coupling beam failed in shear whereas the other side had less damage. It indicates that the coupling beam was restrained by the perpendicular wall.

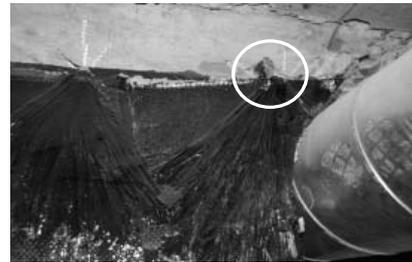
Photo 8 Failed anchorage at coupling beam floor 8

Some beams were reinforced by carbon fiber around openings. The carbon fiber used to prevent shear failure. But it did not work appropriately because the anchorage length of continuous carbon reinforcements was not enough. (Photo 8) They usually need 100mm anchorage length, but actual anchorage length was 40mm. The tape-shaped fiber of the short beams were unstuck and peeled off.

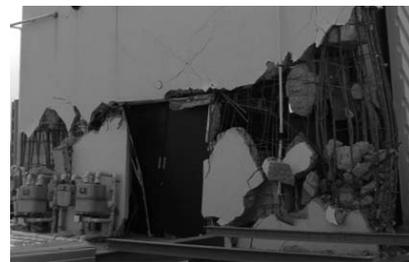
The penthouse of the building was severely damaged that required emergency strengthening just after the earthquake in order to prevent collapse. Both columns and walls were completely destroyed at the first story of the penthouse, while the second story was in a similar condition to the rest of the building. In investigation, thickness of walls was 120mm, but drawing illustrates that was 180mm. (Figure 16) Damage in the first story of the penthouse was more remarkable on transverse directions than on longitudinal one. Figure 17 shows penthouse cracks schedule of each frame. Frame 8 was less damaged. Frame 11 damaged heavily. (Photo 9) Damage in east area became increasingly hard. Capacity of walls in the first story of the penthouse was calculated in each frame as shown in the work by Villanova et al. (2012). The frame 8 had approximately twice the capacity of 9, 10 and 11 frames. Therefore, Penthouse might have torsional response. This might have caused such severe damage.

Photo 9 Wall at the first story of the penthouse

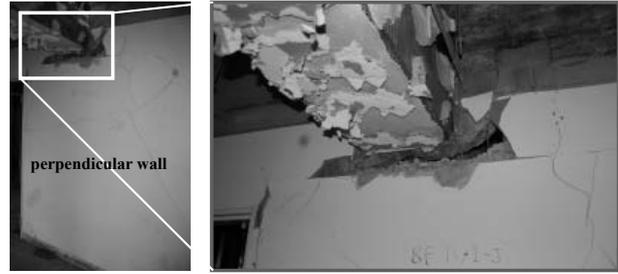
Figure 19 Bar pullout at top of the perpendicular wall in 8th floor

The pullout of bars were observed at the top of the perpendicular wall in 8th floor which is shown in Figure 19 and the square in the Figure 14. Perpendicular wall might constrain vettical displacement of the coupling beam at the mid span, and, as a result, clear span of the beam was shortened and failed in shear. Pullout of bars is a evidence of the behavior

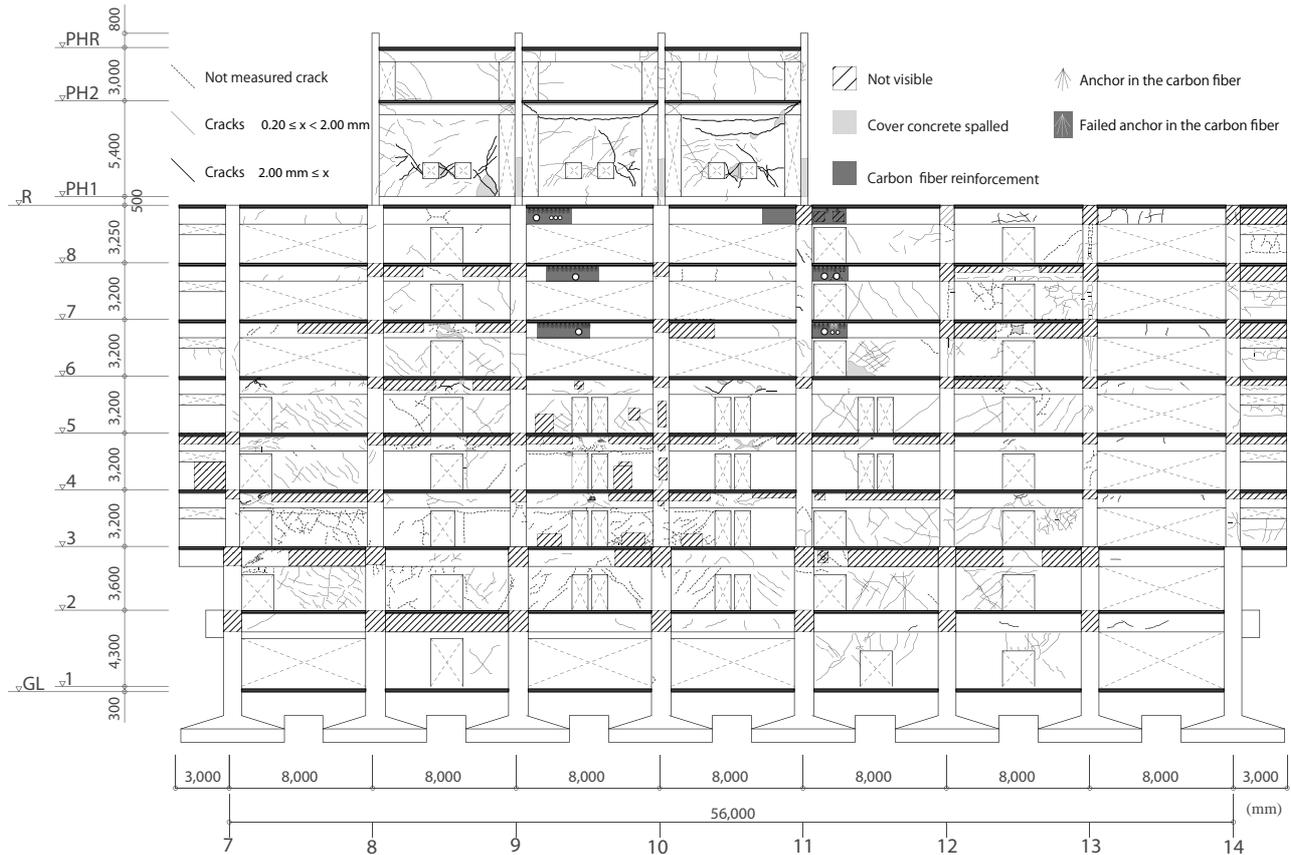
Figure 18 Frame I cracks schedule

Figure 18 illustrates frame I cracks schedule in longitudinal direction. There were few cracks in the 1st story on both X and Y directions. In the 2nd and upper stories, cracks were prominent. However, they were smaller than those of beams. Most of them were narrower than 1mm.
