PERFORMANCE OF THE BUILDING OF THE FACULTY OF ENGINEERING AT TOHOKU UNIVERSITY DURING THE GREAT EAST JAPAN EARTHQUAKE OF 2011

Abstract: This paper presents a study of a retrofitted SRC building which was damaged by 2011 Great East Japan Earthquake. The building was severely damaged in 2011 Great East Japan earthquake. However, this building also suffered from minor damage due to the 1978 Miyagi Oki earthquake. In 2001, This building was seismically evaluated using Japanese seismic evaluation standard (JBDPA) and it was retrofitted based on this seismic evaluation. It was retrofitted by installing framed steel braces, replacement of shear walls and jacketing of adjacent beams with steel plates. Characteristics and crack Figures of the structural damage is presented. The actual damage observed was different from estimated damage of the seismic evaluation. Plausible explanation of such damage and its mechanism is presented, compared and discussed with the seismic evaluation results, virtual work method and capacity spectrum method .

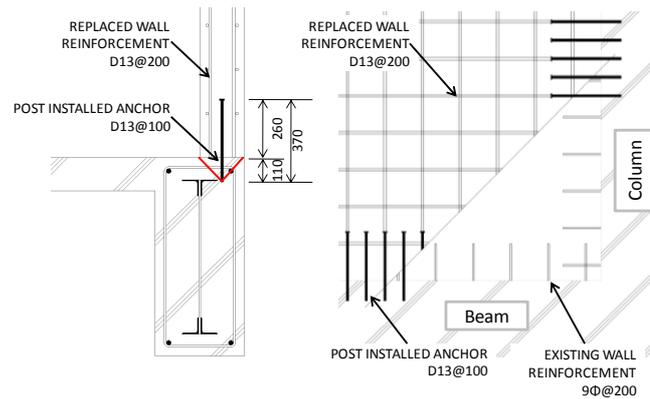
Figure8 Detail of replaced wall

It is important to emphasize that development length of post installed anchors were 110mm according design document for seismic retrofit design. The length of anchor met the guidelines for seismic Retrofit of Existing Reinforced Concrete Building (JBDPA 2001). However, the tensile strength of anchor is conditioned on cone shaped fracture, as can be seen in Figure 8.

The reinforcing details of the panels replaced in walls X3 and X8 are shown in Table 2 and Figure 8. These wall panels were replaced as follows:

- 1) the original concrete was removed with jack hammers,
- 2) 310-mm long adhesive anchors (D13 bars) with an embedment length of 110 mm were installed in beams and columns,
- 3) existing reinforcing bars (round 9-mm plain bars) were cut 200 mm away from beam and column faces,
- 4) new reinforcing bars (deformed 13-mm bars) were spliced with the adhesive anchors in both the longitudinal and horizontal directions.
- 5) concrete was cast in the wall panel.

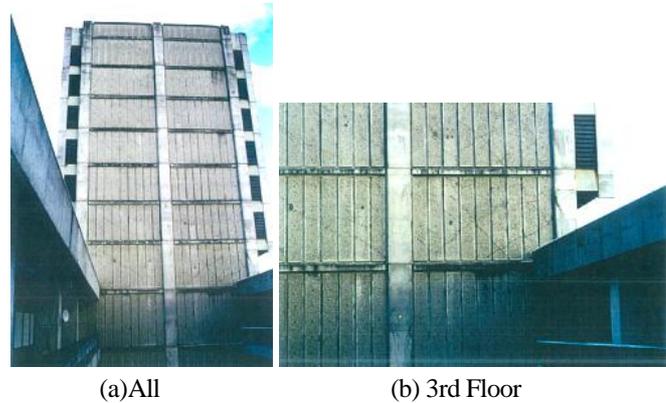
Detail damage survey was conducted after the 1978 Miyagi Oki earthquake by professors Shiga and Shibata, Tohoku University (Shiga et al. 1981). According to their report, small shear cracks and flexural cracks were observed in exterior shear walls (see Figure 13), adjacent beams and a few columns on the third and fourth floor. Typical wall and short beams crack patterns are shown in Figure 14 and 15. The maximum width of shear cracks in shear walls and that of flexural cracks in columns and beams are reported about as 1.0mm. The width of shear cracks in the adjacent beams with openings was reported about as 1.5mm. Therefore, the structural damage of the building by the 1978 June earthquake, was considered to be fairly minor. As can be seen in Figure 15, exterior shear wall successfully sustained lateral force and contributed as shear resisting elements, because shear cracks were relatively uniformly distributed in the wall panels.

Figure 13 Damaged wall in 1978 Miyagi Oki

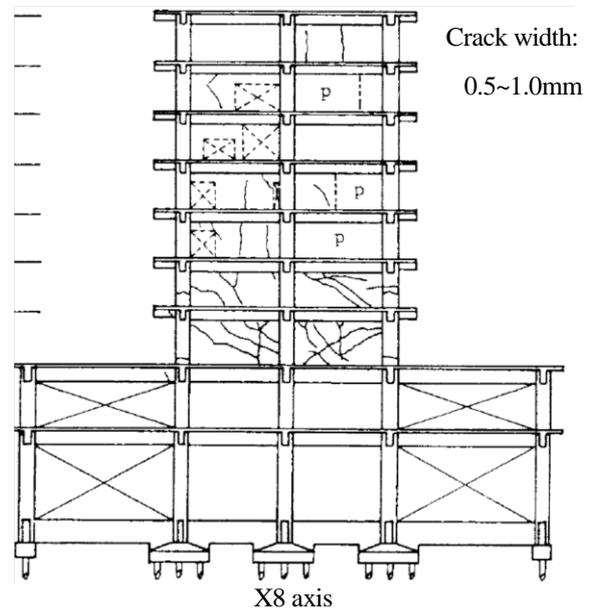
Figure 14 1978Miyagi Oki earthquake crack map (Shiga et al 1981)

caused to these walls by the Earthquakes of 2011 (Figure 18) and 1978 (Figure 14) suggests that there was a radical change in the mechanism through which these walls resisted lateral loads. It seems that in 1978 the exterior walls acted as units (composed of webs and columns connected to integrally), while in 2011 the webs did not seem to contribute much to lateral resistance. This inference and the followings facts:

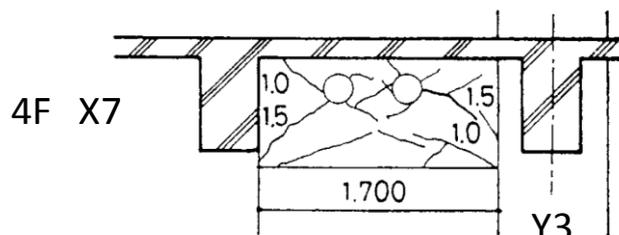
Figure 15 Damaged short beams

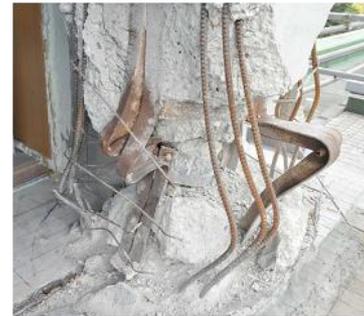
fractured as shown in Figures 16 and 18a). A close-up of the disintegrated near their bases, and the steel angles and reinforcing bars embedded in them either buckled or base of column X8-Y2 is shown in Figure 17.

Figure17 X8-Y2 column after remove the crush concrete

It is believed that it was the buckling of the steel what triggered the disintegration of the concrete at column bases because even the exterior columns along axis Y3 exhibited bar buckling and spalling of concrete despite the fact they resisted no compression at peak displacements. Sliding could have damaged these columns too but no clear signs of sliding at wall bases were observed. If compression had been the trigger, we would have expected severe spalling and crushing (similar to what was observed at columns in axes X3 and X8) in the stems of the C-shaped walls that formed

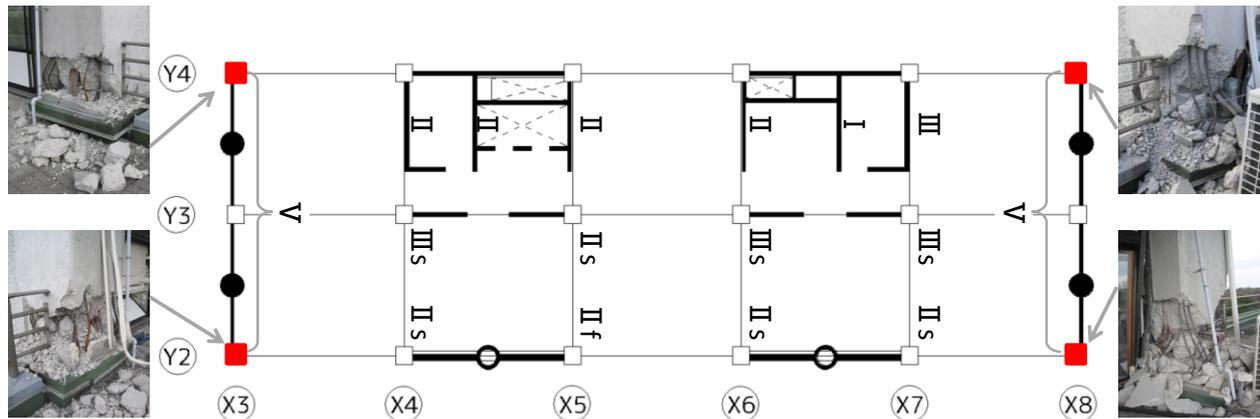
The authors carried out detailed damage surveys of the building after the 2011 earthquake. The most severe damage took place in the 3rd story. Four corner boundary columns in exterior walls X3 and X8 (which were intervened in 2001)

Figure16 Damage situation of 3F-Y direction

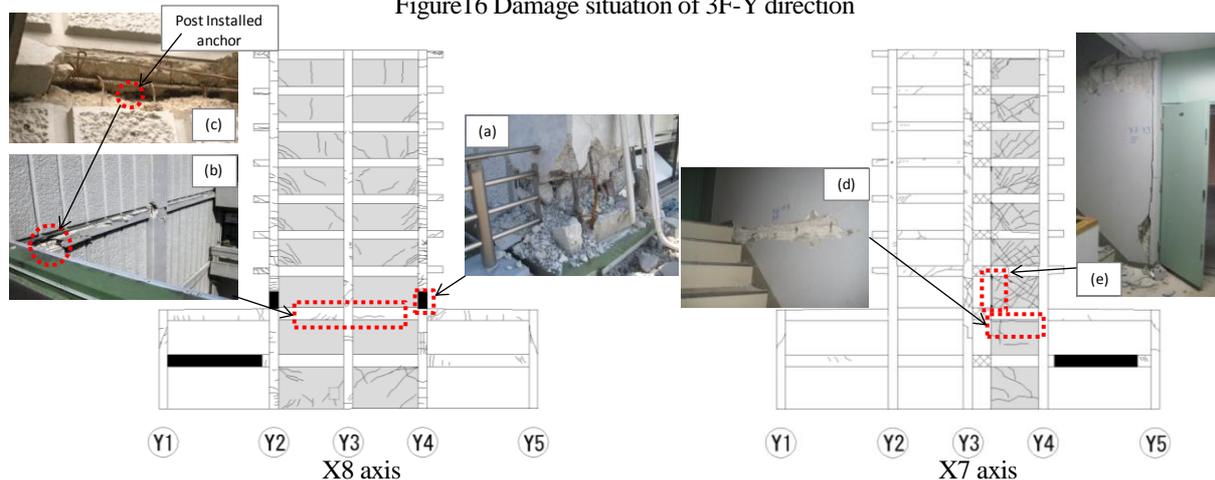
Figure 18 shows cracks observed on the exterior walls in the transverse direction. A horizontal separation formed at the base of the third story, between the post-installed structural wall panels (shown in Figure 18b)) and the beam supporting them. The post-installed anchors that were supposed to prevent this separation appeared to have pulled out of the beam as shown in the close-up in Figure 18c) and Figure 19.

Figure 18 2011 Great East Japan earthquake crack map (transverse)

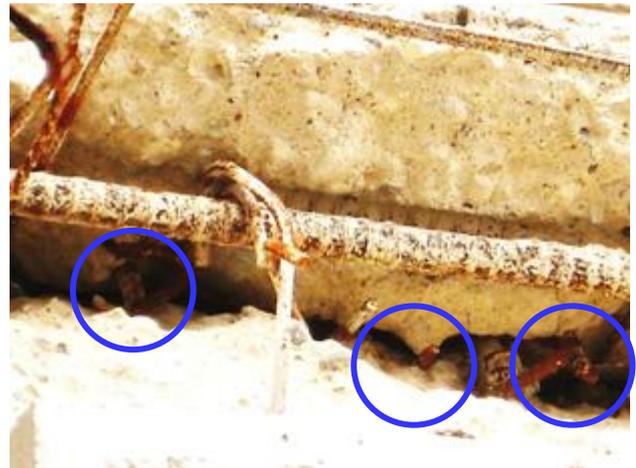
- 4) The result of 1), 2) and 3) was that, at the tops of the slabs and at every floor, the vertical web reinforcement was essentially discontinuous.
- 5) The discontinuity in the web reinforcement caused rotations to concentrate at the top of the third-floor slab causing the steel angles and reinforcing bars in the boundary elements to reach large tensile strains.(see Figure 19) These strains led to either fracture or buckling during load reversals.

Figure 19 Zoom viewing of wall anchor

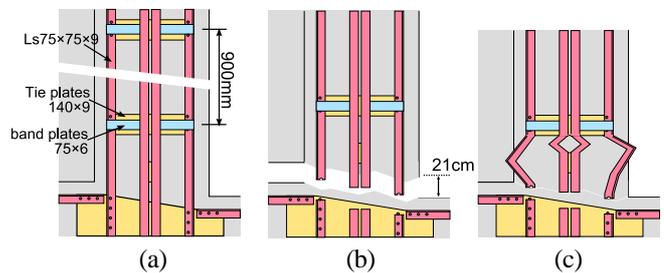
Figure 21 illustrates a plausible explanation for what occurred:

- 1) The anchor bolts installed in the retrofit had an extremely short embedment length
- 2) The existing reinforcement was smooth, and was cut too close to the beam face to develop its strength through bond (gained mainly through adhesion to the concrete cast in 2001)

- 3) If one draws lines from the bottom of the anchor bolt in Fig. 8 to the points where the wall outer and inner faces meet the cold joint at the top of the slab, one obtains a “surface” that is not crossed by any reinforcement working in tension and adequately anchored.

Figure 21 Mechanism of Column crushed

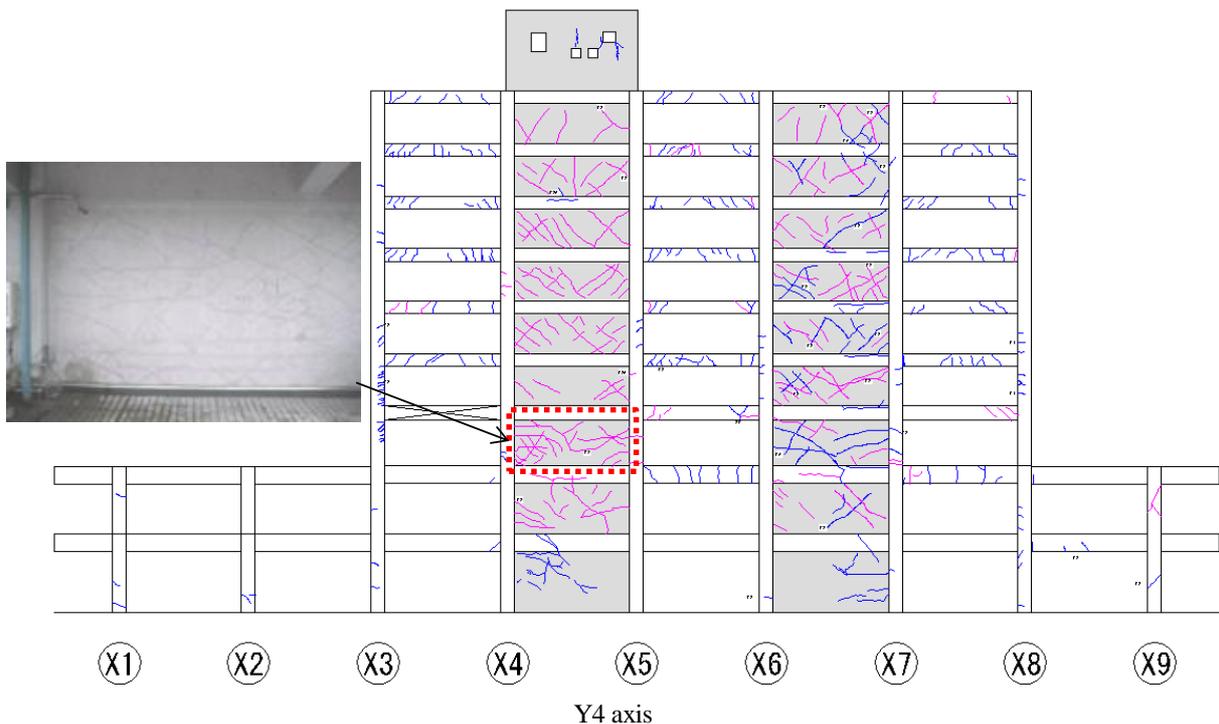
In the longitudinal direction, the damage concentrated on the walls, which had cracks of 0.2~0.5mm in width as shown in Figure 20. These walls also remained integral and were effective in resisting lateral loads. Additionally, there were horizontal cracks at the 3rd story.

Figure 20 2011 Great East Japan Earthquake crack map(longitudinal)
