Damage of RC Building Structures due to 2011 East Japan Earthquake

This paper presented the investigation of reinforced concrete building structures by 2011 East Japan Earthquake. Generally, reinforced concrete structures in Miyagi region performed very well during the earthquake and effect of seismic retrofit was found in mitigation of damage, although severe damage to some seismically retrofitted buildings was noticed. A good correlation was observed between calculated seismic capacity I_s -index and observed damage. Moreover, buildings designed according to the current seismic design code had minor damage in its structural members. However, major damage to non structural elements was commonly observed. Some typical damage observed by author's field survey in Miyagi pref. which is conducted mainly as an activity of the AIJ committee is described. Damage to structural members was not found in most of RC buildings which suffered tsunami, although damage to non structural elements was generally severe. However, severe structural damage induced by devastating tsunami was observed in some buildings.

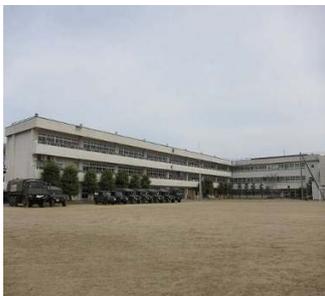
Figure 10 shows 3 storied RC school building in Shitigahama town built in 1966. Seismic capacity I_s -index of the building was evaluated much lower than the criteria of 0.7, however, it was not retrofitted before the earthquake. Many of its columns and shear walls failed in shear as shown in figure 11 and figure 12.

Figure 10. North view of school building

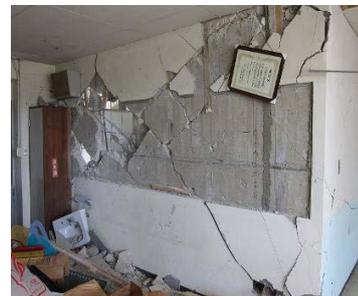
Figure 12. Shear failure in shear wall

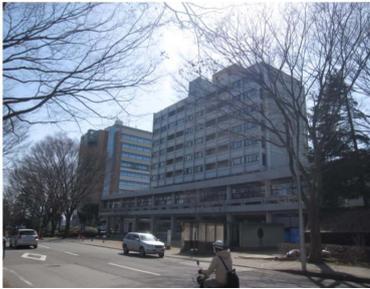
Figure 13 shows 9-story steel reinforced concrete (SRC) building of Civil Engineering and Architecture building in Tohoku University constructed in 1969,

which suffered from minor damage due to the 1978 Miyagi Oki earthquake. Small shear cracks and flexure cracks were observed in main shear walls, adjacent beams and few columns in the 3rd and 4th floor as shown in figure 15(a)(Shiga 1980). Acceleration records were obtained both in 1st and 9th floor.

Figure 13. North view of building in Tohoku Univ.

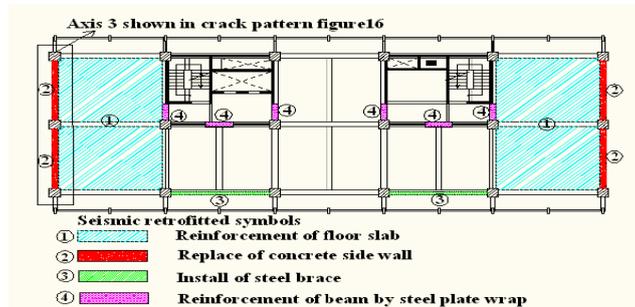
Figure 14. Typical floor plan

In 2001, it was seismically retrofitted by installing framed steel braces to the longitudinal direction, replacement of shear walls in transverse direction and jacketing of adjacent beams with steel plates (see Figure 14). Even though it was retrofitted, it was severely damaged by the 2011 earthquake as shown in figure 15(b). The damage was concentrated in the 3rd story. Boundary columns of shear wall in transverse direction were crushed with fracture and buckling of steel (see Figure 16). Damage to connection between installed shear wall and frame was observed (see Figure 17). One of the reasons for such a severe damage to a retrofitted building would be poor connection between new installed elements and existing structure. Another reason may be strong ground motion at the site especially for period of 1 sec. which is fundamental vibration period of this building as mentioned above in figure 4 as 2011 East Japan THU NS.

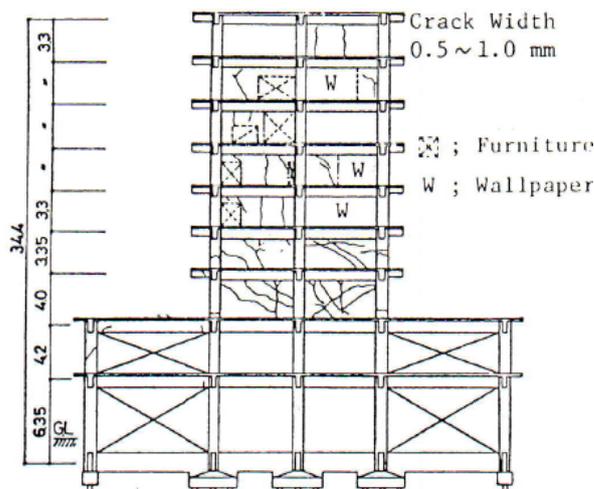
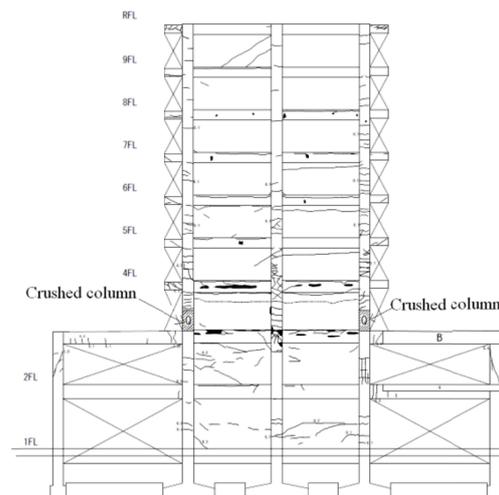
Figure 15. Crack pattern of building in Tohoku University

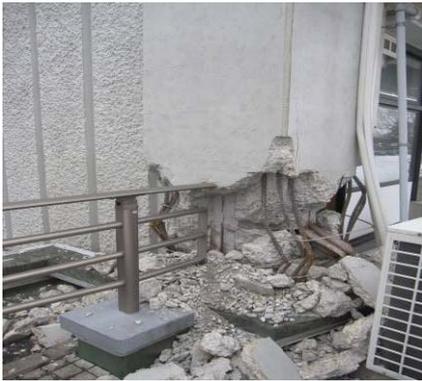
Figure 16. Boundary column of shear wall at 3rd story

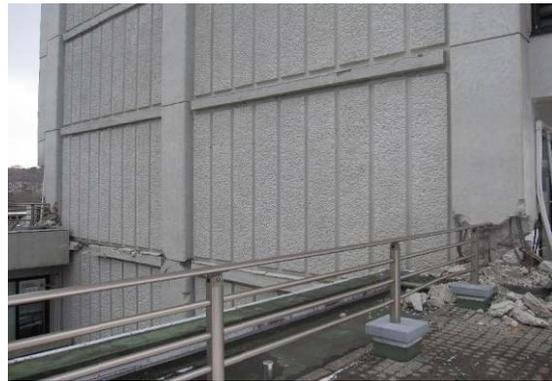
Figure 17. Damage to bottom of shear wall in the 3rd story

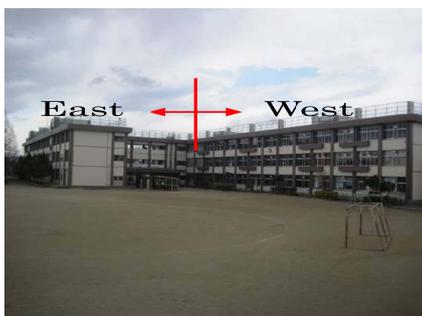
Figure 18 shows 3 storied RC building of an elementary school in Sendai city constructed in 1974. The building is divided by expansion joint into west side and east side. Seismic evaluation was carried out to both sides. According to the seismic evaluation, the East side building needed to be retrofitted and the West side was evaluated to have enough seismic capacity and no retrofitting was needed. The East side building was retrofitted by adding framed steel braces and shear walls. By this earthquake, the retrofitted building had only minor damage. On the other hand, the East side building had shear failure in its short columns as shown in figure 19. Shear failure of those short columns was allowed in the seismic evaluation because axial loads could be redistributed to other columns and the building didn't collapse. However, the school couldn't continue using the east side of the building. This issue of functionality is one of important problems. The response spectrum of this area is mentioned above in figure 4 as 2011 East Japan MYG013 NS.

Figure 18. North view of school building in Sendai city

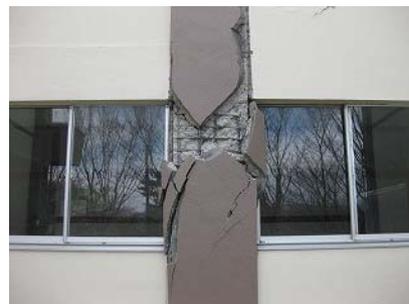
Figure 19. Shear Failure in short columns of East side building

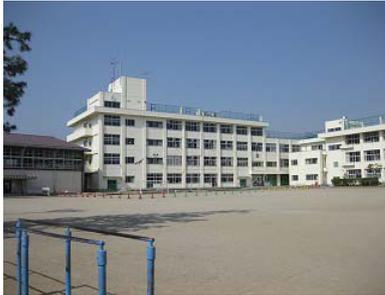
Severely damaged buildings which may be a threat to life safety were not observed in this survey. However, Moderate damage to some buildings designed according to the early versions (early 1980s) of the current seismic design code was observed. This damage caused the building to be non-functional after the earthquake. Figure 20 shows a typical example of a four storied elementary school building constructed in 1985. This building had a shear failure in one of its walls as shown in figure 21. Beams with shear failure were also noticed as shown in figure 22.

Figure 20. North view.

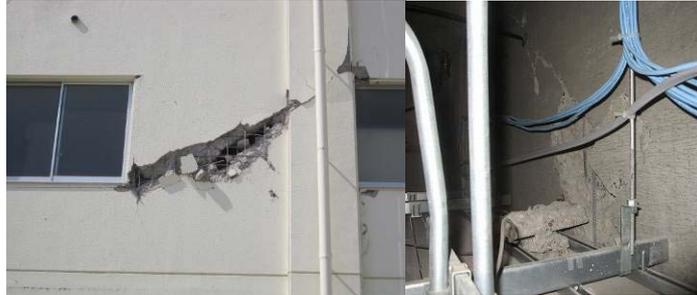
Figure 21. Large shear cracks in wing wall.

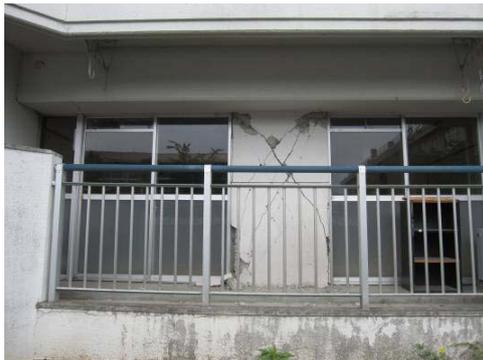
Figure 23 shows an eleven storied SRC apartment building in Sendai city. It had a minor damage in its structural members. However, many of its non structural partition RC walls around doors and windows were severely damaged as shown in Figure 23. Most of the residents of this building were concerned about safety and had to leave. Therefore, this building became unusable due to such damage. In figure 28, large parts of ceiling fell in a gym of a junior high school in Kurihara city fell down.

Figure 23. Damage to non structural wall

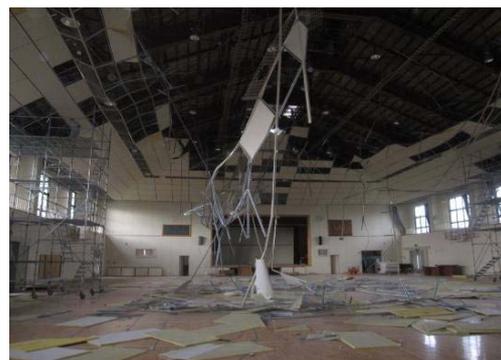
Figure 24. Large parts of the false ceiling fell down

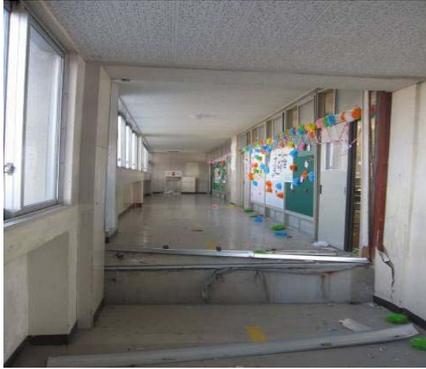
Settlement and tilting of buildings as a result of liquefaction had occurred in some regions of Miyagi prefecture. Figure 25 shows a junior high school building in Osaki city. The right side of the building was constructed in 1978. The left side was

added in 1991. This school rests on a soft ground with pile foundation of 20m in depth. Evidence of liquefaction was seen around the school as shown in figure 26. The right side part had a settlement of about 60 cm, the south part was inclined by angle of $1/25$ rad. The newly added part had a settlement of about 10 cm and slightly inclined. The response spectrum of this area is mentioned above in figure 4 as 2011 East Japan 4B9 NS.

Figure 25. Difference in level of Expansion joint

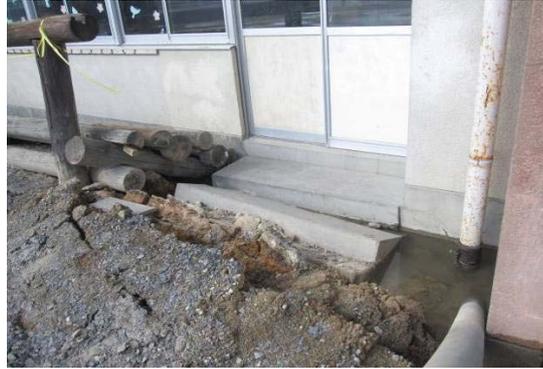
Figure 26. Liquefaction evidence located 3 stair steps from the ground surface.

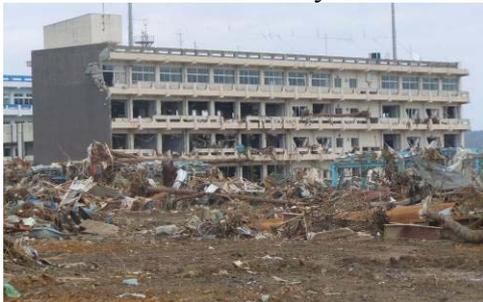
The Northeast coastal areas have been heavily damaged by Tsunami. However, as for reinforced concrete structures, most of the damage due to tsunami were in its non structural elements such as false ceilings, window and doors. Figure 27 shows a high school building in Kesenuma city. The flooding reached 3rd floor. Windows, doors ceiling were washed away and classrooms were full of debris. Figure 28 shows a floor slab that was lifted up and damaged at connections with beams in Ishonomaki city.

Figure 27. Flood reached 3rd floor

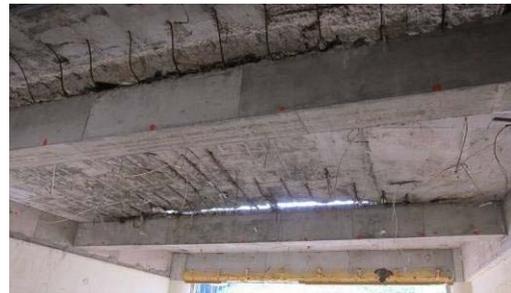
Figure 28. Slab uplifted and dismantled from beam

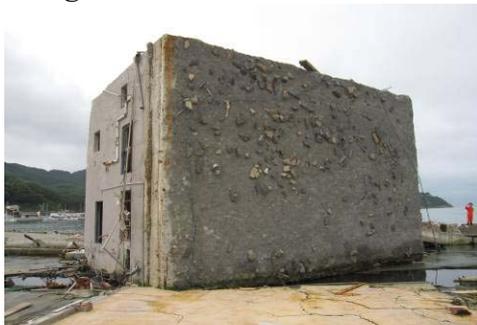
Figure 29. Building overturned by tsunami

In addition, Onagawa town suffered a devastating tsunami, some RC building were overturned from its base as shown in figure 29. Piles were pulled out and buildings overturned as shown in figure 30. Design structures to resist such force were not considered since it the first time to experience such forces and behavior. Such phenomena needs further study.

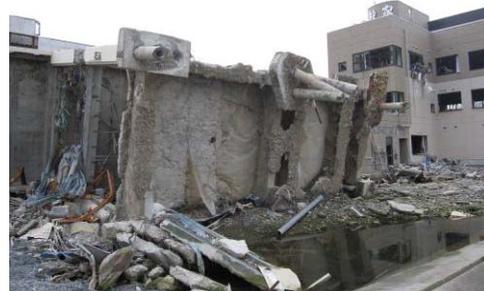
Figure 30. piles were pulled out and fractured
