Damage Survey on Reinforced Concrete School Buildings in Miyagi after the 2011 East Japan Earthquake

Keywords: Great East Japan earthquake, RC school buildings, damage survey, seismic evaluation

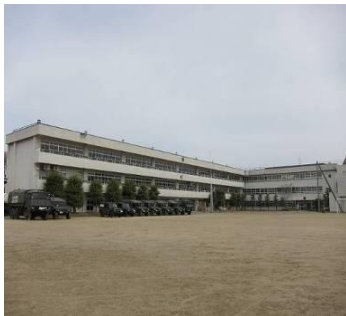
Figure 9 shows 3 storied RC school building in Shitigahama town built in 1966. Seismic capacity Is-index of the building was evaluated much lower than the criteria of 0.7. Seismic retrofit was planned for the buildings, however, it was not yet conducted before the earthquake. Many of columns and shear walls failed in shear as shown in Figure 10 and Figure 11.

Figure 9. Overall view of damaged school building

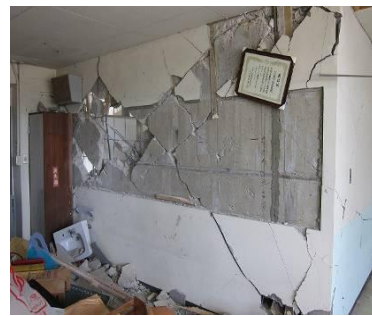
Figure 11. Shear failure in shear wall

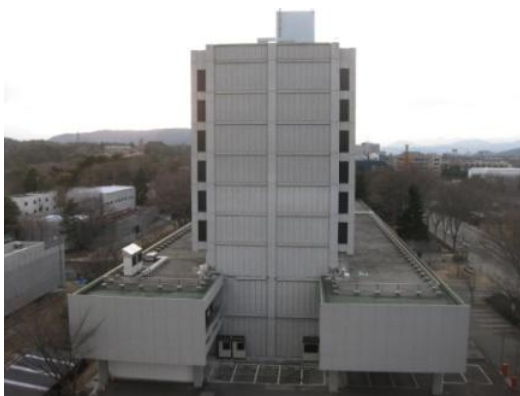
Figure 12 shows 9-story steel reinforced concrete (SRC) building of Civil Engineering and Architecture building in Tohoku University constructed in 1969, which suffered from minor damage due to the 1978 Miyagi Oki earthquake. Small shear cracks and flexural cracks were observed in exterior shear walls, adjacent beams and few columns in the 3rd and 4th floor as shown in Figure 15(a)(Shiga 1980). Acceleration records were obtained by BRI both in 1st and 9th floor of the building. The response acceleration of 1st floor in the NS direction is shown in figure 3 and marked as 2011 East Japan THU. Response acceleration of 1st floor in the NS direction of 1978 Miyagi Oki earthquake is also shown in figure 3.

Figure 12. Civil Engineering Building in Tohoku Univ.

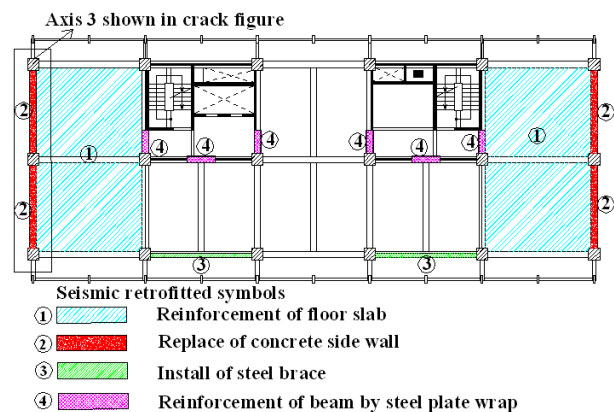
Figure 13. Typical floor plan and outline of retrofit

Originally, seismic capacities I_s -indices were insufficient for the criteria of $I_s = 0.7$ as shown in Table 2. Table 2 shows I_s -indices in transverse direction (Y-direction) in lower stories. There exist many residual cracks induced by previous earthquakes such as 1978 Miyagi Oki earthquake so that quite low age factor $T=0.85$ was employed in the evaluation. As can be shown in Table 2, C -index, which is lateral strength of the building in terms of story shear coefficient, is relatively low but large ductility was estimated. In 2001, the building was seismically retrofitted by installing framed steel braces in the longitudinal direction, replacement of RC shear walls in transverse direction and jacketing of adjacent beams with steel plates (see Figure 13). The main scheme of the seismic retrofit was mainly to increase lateral strength and ductility of the structure. The building was estimated as a relatively ductile structure, so that ductile members were selected for new installing elements in seismic retrofit. Although seismic capacities I_s -indices after retrofit exceeded the criteria of $I_s = 0.7$, as shown in Table 3, C -indices for most ductile member group were about 0.3, which is minimum requirement of base shear coefficient for RC ductile moment frame structures.

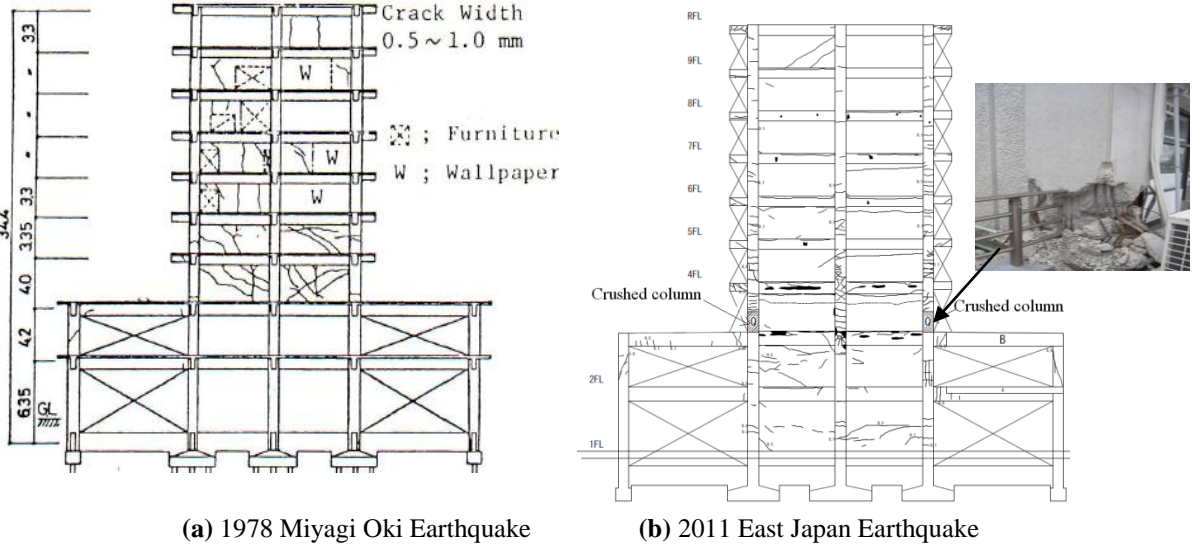
Even though it was retrofitted, it was severely damaged by the 2011 earthquake as shown in Figure 14(b). There was strong ground motion at the site at periods close to 1 sec, which is the fundamental vibration period measured for this building during the earthquake. Boundary columns failed in compression and the connection of walls to beam also failed indicating that the ductility of the shear walls was not increased as expected in the seismic retrofit. This may have been caused by poor connections between the wall webs (which were replaced during the retrofit) and the surrounding beams and columns.

Figure 14. Crack pattern of building in Tohoku University

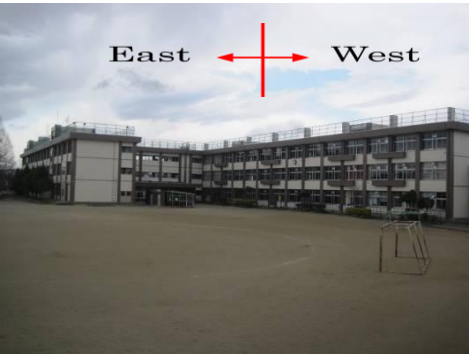
Figure 15 shows 3 storied RC building of an elementary school in Sendai city constructed in 1974. The building is divided by expansion joint into west side and east side. Seismic evaluation was carried out to both sides. According to the seismic evaluation, the East side building needed to be retrofitted (see Figure 18) and the West side was evaluated to have enough seismic capacity and no retrofitting was needed. The Is-index for West side building depends on ductility ($F=1.75$) to reach the of $I_s > 0.7$ which is the criteria in Japan (see Figure. 17). The East side building was retrofitted by adding framed steel braces and shear walls. By this earthquake, the retrofitted building had only minor damage. On the other hand, the West side building had shear failure in its short columns as shown in Figure 16. Shear failure of those short columns was allowed in the seismic evaluation because axial loads could be redistributed to other columns and the building didn't collapse. This building wasn't retrofitted since it's judged that there is no threat to life safety. However, the school could not use this building after the earthquake and repairing expenses would be relatively high if compared to the retrofitting expenses for a better performance. This issue of functionality is one of important issues that require more attention. The response spectrum of this area is mentioned above in Figure 3 as 2011 East Japan MYG013 NS.

Figure 15. North view of school building

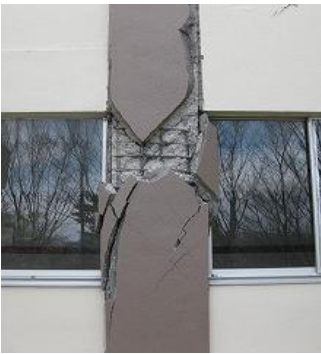
Figure 16. Shear failure in column

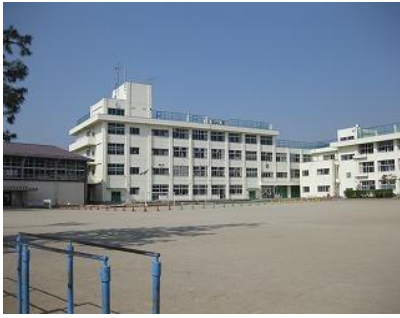
All the school facilities in Sendai city were either designed with the current seismic code or have been already seismically evaluated and retrofitted if necessary. Severely damaged buildings which may be a threat to life safety were not observed in this survey. However, Moderate damage to some buildings designed according to the early versions (early 1980s) of the current seismic design code was observed. Figure 19 shows a typical example of a four storied elementary school building constructed in 1985. This building had a shear failure in one of its walls as shown in Figure 20. Beams with shear failure were also noticed as shown in Figure 21.

Figure 19. North view of building

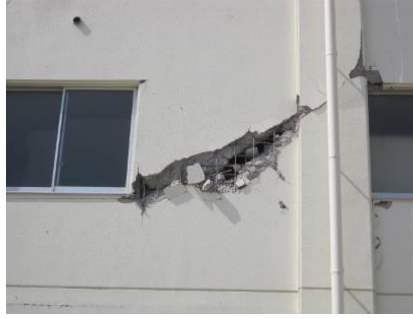
Figure 20. Shear failure in wing wall

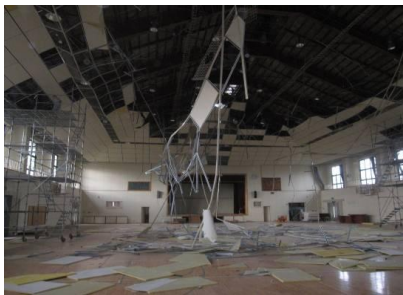
In Figure 22, large parts of ceiling fell in a gym of a junior high school in Kurihara city fell down. Figure 23 shows a damaged masonry wall of which some concrete blocks fell down. Such damage could be a life threat.

Figure 22. False ceiling fell down

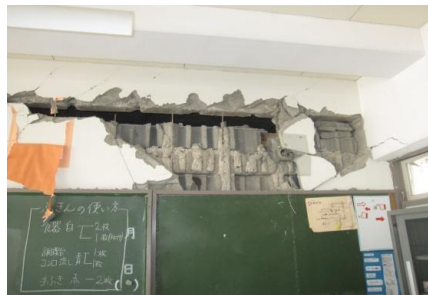
Figure 23. Partial collapse of concrete blocks partition wall

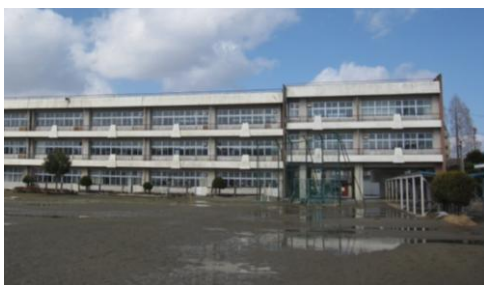
Settlement and tilting of buildings as a result of liquefaction had occurred in some regions of Miyagi prefecture. Figure 24 shows a junior high school building in Osaki city. The right side of the building was constructed in 1978. The left side was added in 1991. This school rests on a soft ground with pile foundation of 20m in depth. Evidence of liquefaction was seen around the school as shown in Figure. 25. The right side part had a settlement of about 60 cm, the south part was inclined by angle of $1/25$ rad. The newly added part had a settlement of about 10 cm and slightly inclined. The response spectrum of this area is mentioned above in Figure 3 as 2011 East Japan 4B9 NS.

Figure 24. Settlement of school building in Osaki City

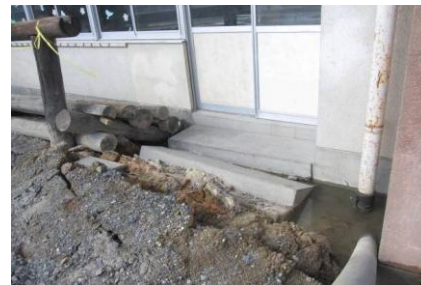
Figure 25. Liquefaction evidence located 3 stair steps from the ground surface.

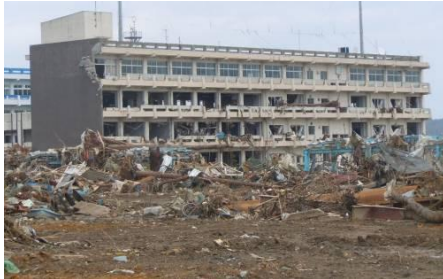
The Northeast coastal areas have been heavily damaged by Tsunami. However, as for reinforced concrete structures, most of the damage due to tsunami was in non structural elements such as false ceilings, window and doors. Figure 26 shows a high school building in Kesenuma city. The flooding reached 3rd floor. Windows, doors ceiling were washed away and classrooms were full of debris. Figure 27 shows a floor slab that was lifted up and disconnected from beams in Ishonamaki city.

Figure 26. Flood reached 3rd floor

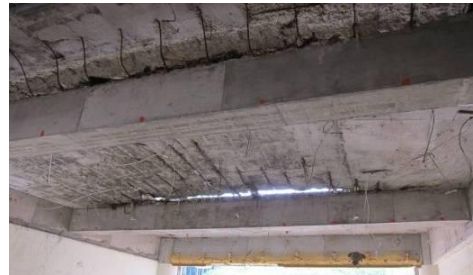
Figure 27. Slab uplifted and dismantled from beam
