## Revision of Guideline for Post-Earthquake Damage Evaluation of Reinforced Concrete Buildings in Japan

In Japan, the Guideline for Post-Earthquake Damage Evaluation and Rehabilitation, originally developed in 1991 and revised in 2001, was revised in 2015 based on the lessons from damaging earthquakes such as the 2011 East Japan Earthquake. The authors have developed a method to evaluate residual seismic capacity of reinforced concrete structures based on *R*-index, which was employed in the Damage Evaluation Guideline. The *R*-index is defined as the ratio of residual seismic capacity to the original capacity, and is calculated from residual seismic capacity in structural members. In this paper, firstly, the general concept of the Guideline for reinforced concrete buildings is presented. Secondly, the main points in the revision in 2015 are introduced.

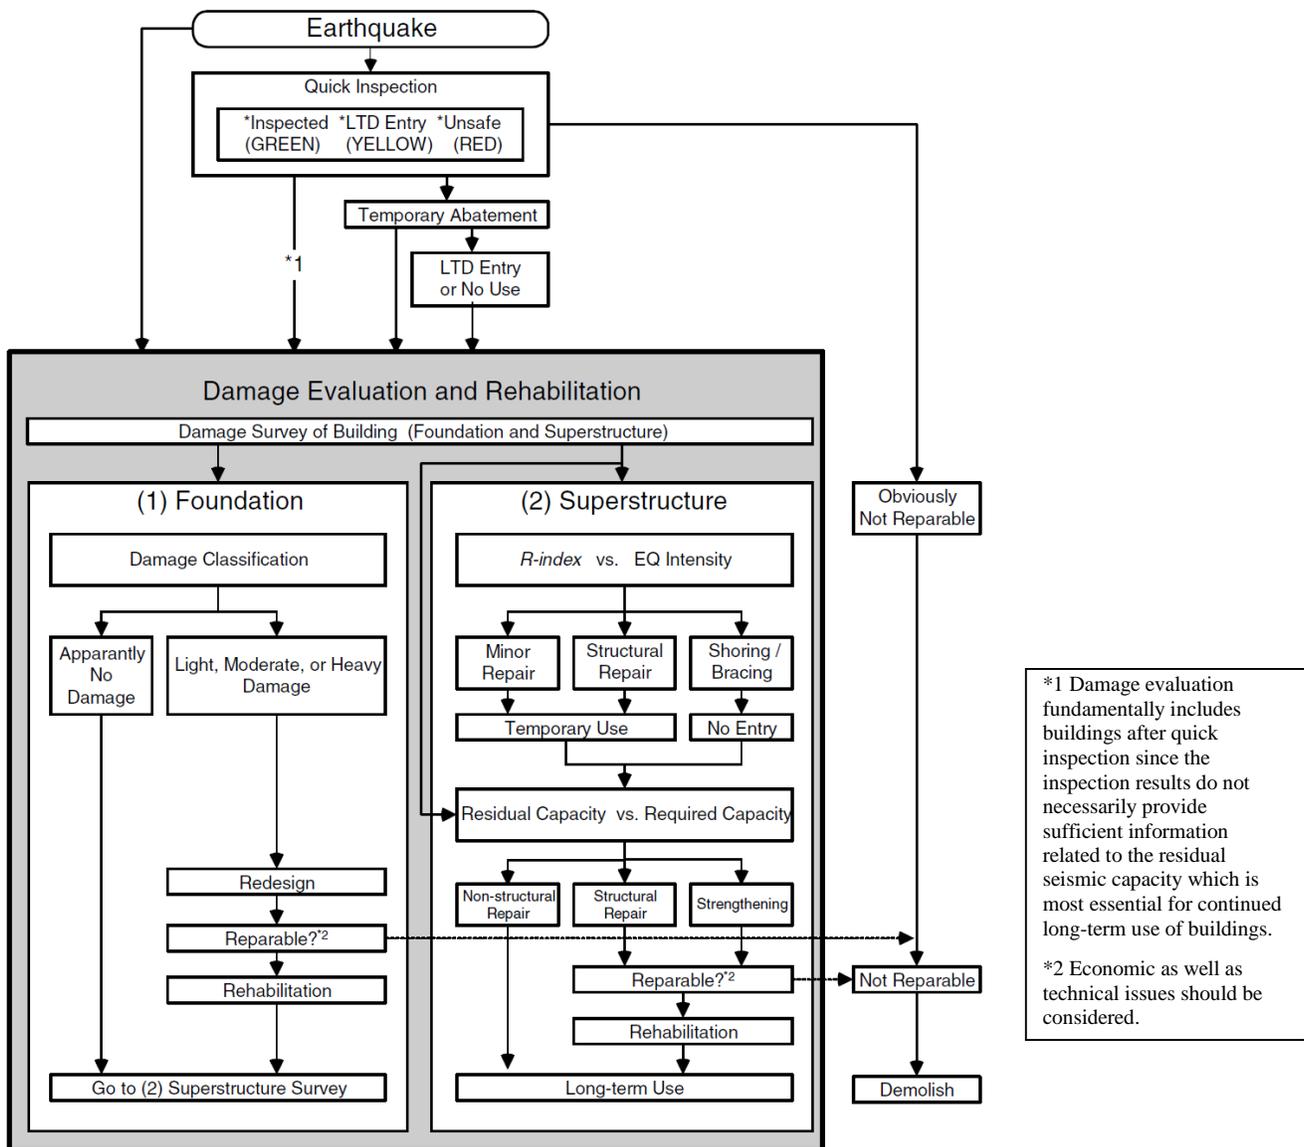
Fig.1 – General Flow of Damage Evaluation and Rehabilitation in the Guideline [3]

Damage evaluation of a building is performed on the foundation system and superstructure system, respectively, and the damage rating of each building is made in a combination form for each system such as “no damage in foundation and moderate damage in superstructure”. Rehabilitation actions necessary for the building are then determined considering identified damage. Fig. 1 shows the general flow of damage evaluation and subsequent rehabilitation.

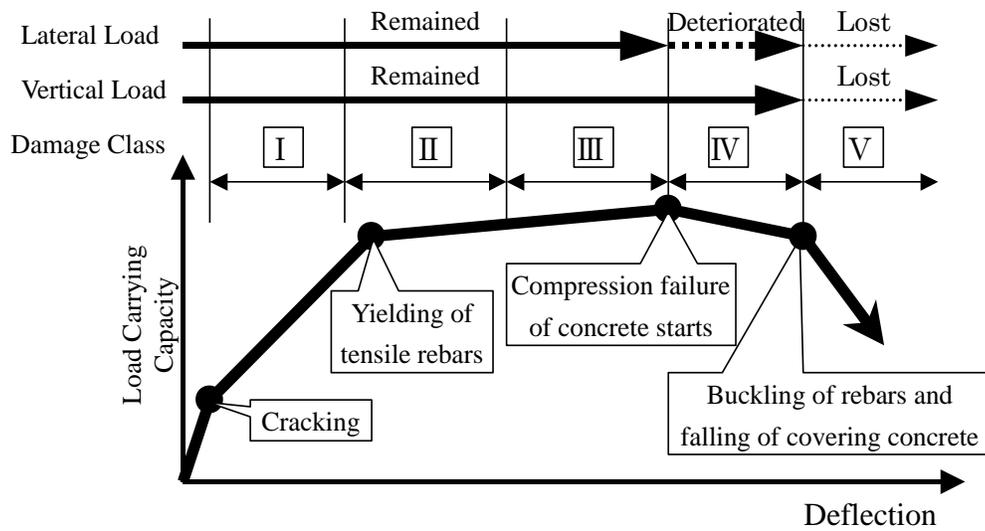
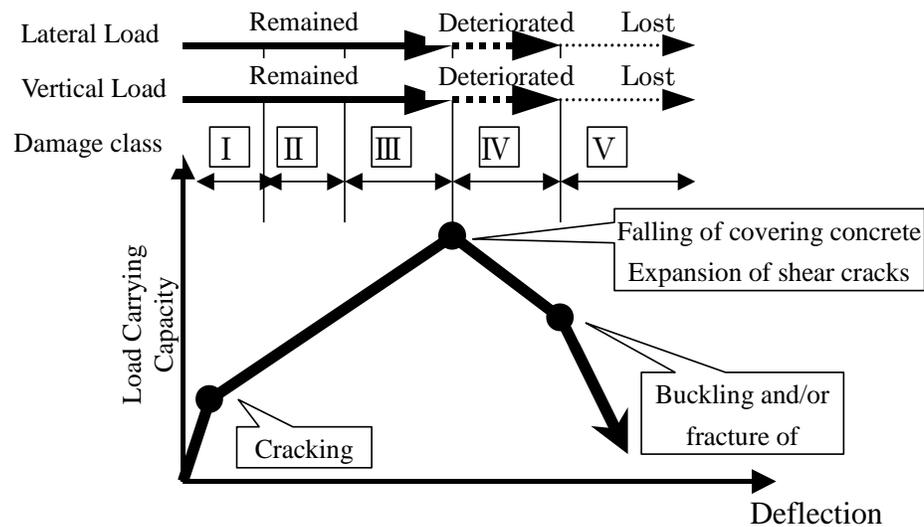
(a) Ductile member

(b) Brittle member

Fig. 2 – Idealized lateral force-displacement relationships and damage class [2]

In the Damage Evaluation Guideline [1], the state of damage of each structural member is first classified into one of the five classes listed in Table 1. The relationship between each damage class given in Table 1 and the lateral force-displacement curve is approximated as shown in Fig. 2. Examples of damage class for columns and walls are shown in Photo 1.

In Fig. 2(a), a ductile member deforms up to a maximum lateral strength level after yielding. Furthermore, after reaching the maximum strength, the reduction of strength is relatively small. If the maximum deformation during an earthquake does not reach deformation at yielding point, extensive damage would not occur. This state corresponds to damage class I, between the cracking and yield points. If the maximum deformation does not exceed the maximum strength, damage to cover concrete is limited and most of the lateral and vertical strengths remains in the flexural member. This state corresponds to damage class II and damage class III. If the maximum response exceeds the maximum lateral strength point, deterioration in lateral strengths with spalling of cover concrete would be observed. The vertical strength may remain if the buckling and/or fracture of reinforcing bars and crush of core concrete, etc., do not occur. This state corresponds to damage class IV. If buckling and/or fracture of reinforcing bars and crush of core concrete occur, both the lateral and vertical load carrying capacities will be lost (damage class V).

The degree of damage in a brittle member, as shown in Fig. 2(b), is similar to that of a ductile member up to the maximum strength, although diagonal or X-shape cracks may also be visible (damage classes I, II and III). After the maximum strength is reached, a significant reduction in both lateral and vertical strength may occur (damage class IV). Finally, X-shape shear cracks widen and both lateral and vertical load carrying capacity will be lost suddenly (damage class V).

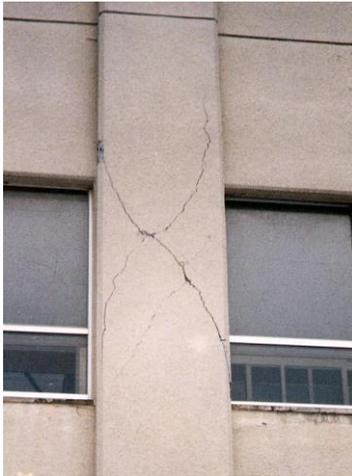
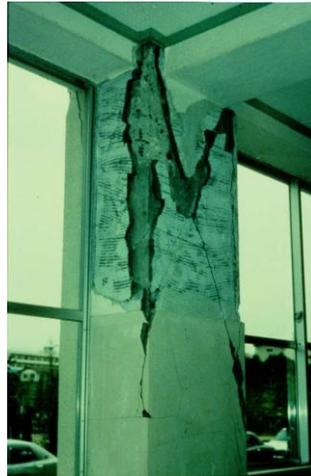
Damage class III: (left) Cracks with a width of about 2mm on structural concrete  
(right) Spalling concrete cover and slightly exposed rebars

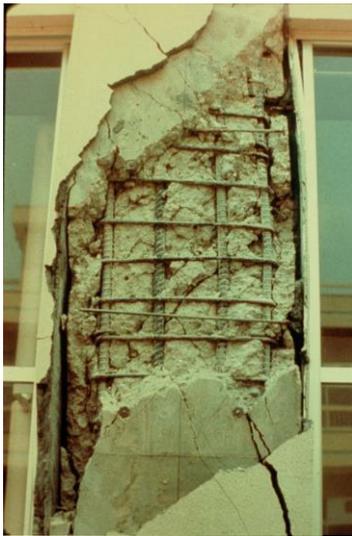
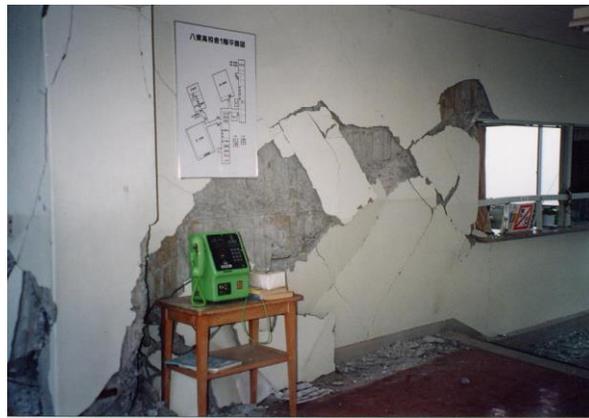
Damage class IV: Exposed rebars without buckling or fracture

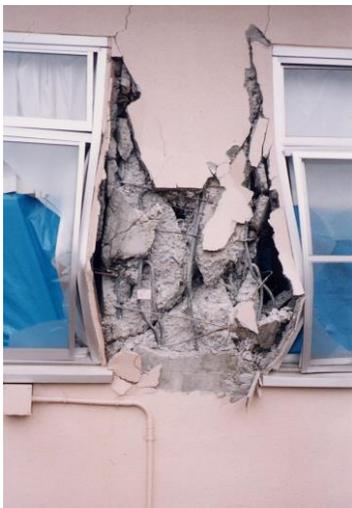
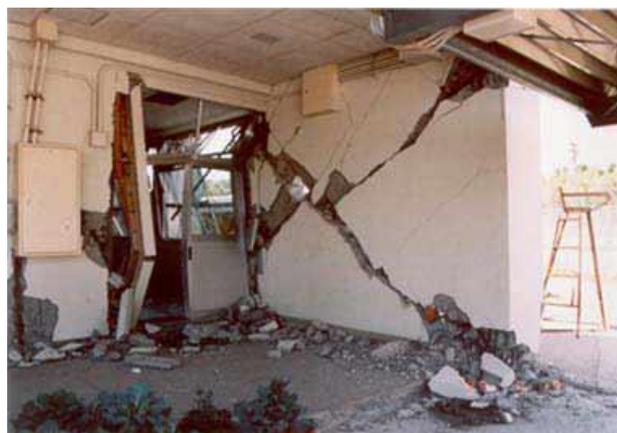
Damage class V:

Photo 1 – Damage class examples

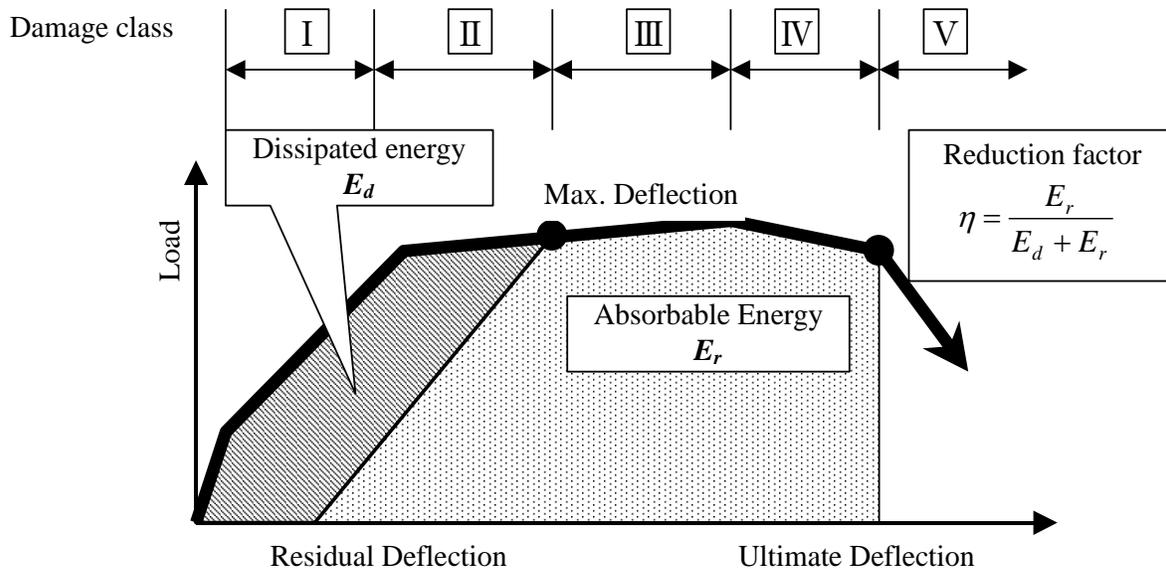
Fig. 3 – Seismic capacity reduction factor  $\eta$

The seismic capacity reduction factors, *i.e.*,  $\eta$  factors for structural members corresponding to the damage classes, are listed in Table 2. The values for  $\eta$  factors are determined from the residual crack width and the overall damage state of RC columns observed in the first author's laboratory experiments [4] and analytical studies [5], [6]. The post-earthquake seismic capacity,  $D I_s$  index, of the overall building after earthquake damage can be calculated based on the  $E_0$  index reduced by the  $\eta$  factor corresponding to the observed damage class of each structural member.

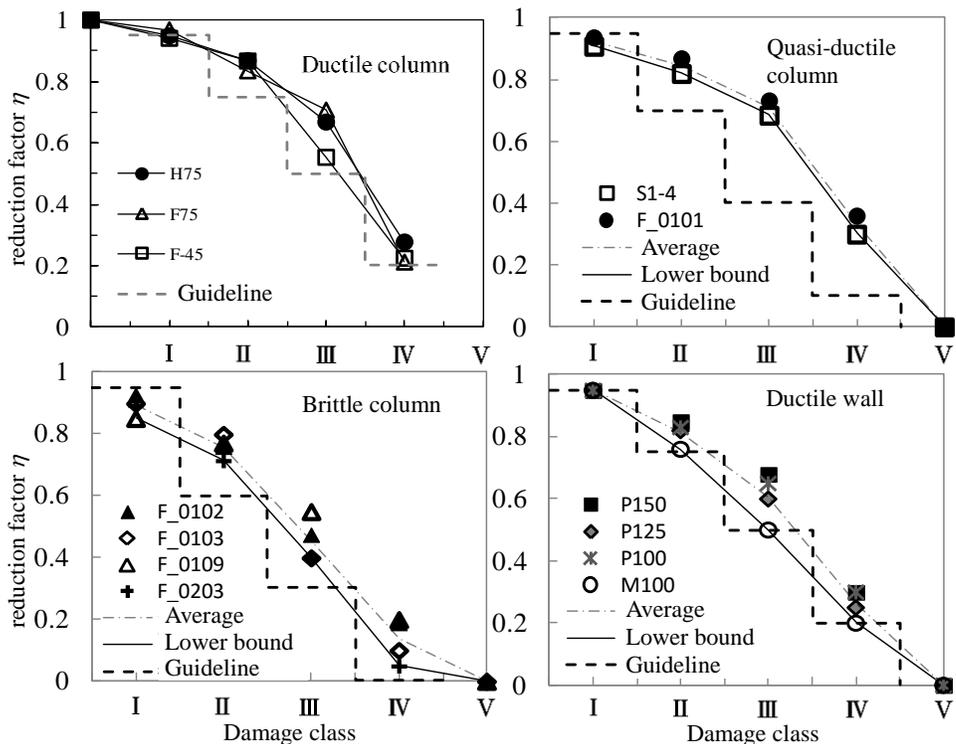
Fig. 4 – Experimental data of Seismic capacity reduction factor  $\eta$

The values of  $\eta$  factors for brittle columns were applied to shear walls in the previous Guideline [1], and no recommendation for beams as shown in Table 2, because experimental data focused on residual seismic capacity was quite limited at the 2001 revision. In the 2015 revision, the values of  $\eta$  factors were enhanced through examination of experimental data [7,8]. A new category of “Quasi-ductile columns” was introduced in addition to ductile and brittle columns in the previous Guideline. The values of  $\eta$  factors were re-evaluated based on conservative estimation of experimental data are shown in Fig. 4. Moreover,  $\eta$  factors for beams and walls were given independently as shown in Table 3.

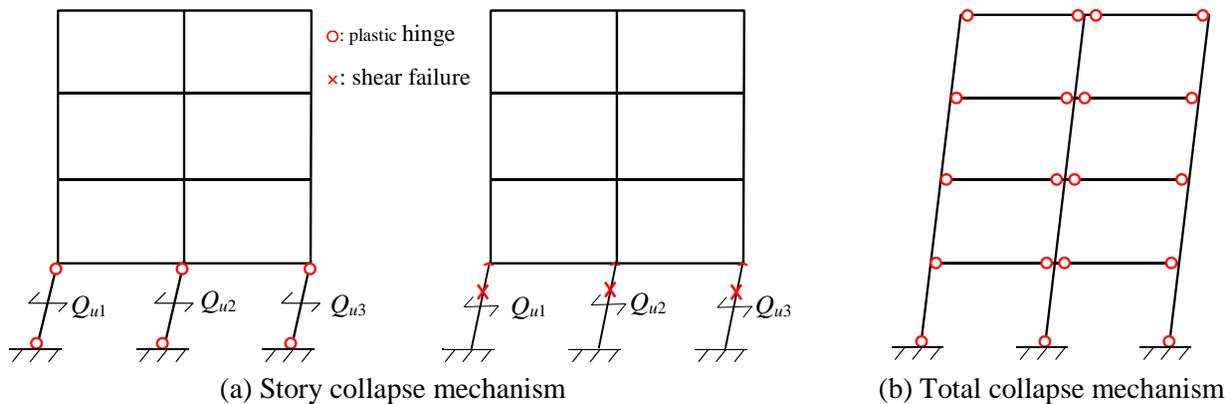
Fig. 5 – typical collapse mechanism of frame structures

Fig. 5 shows typical collapse mechanism of frame structures. As was revealed in past damaging earthquakes in Japan, typical life-threatening damage is generally found in vertical members, and story collapse mechanism, as shown in Fig. 5(a) and Photo 2, is formed. Therefore, the current Guideline is essentially designed to identify and classify damage in columns and walls rather than in beams, and residual seismic capacity,  $R$ -index, can be evaluated based on story shear by Eq. (3) assuming ductility index ( $F$  index) is uniform in all the vertical elements in the story. When damage is found in beams, the damage classification needs to be performed considering their deficiency in vertical load carrying capacity as well as lateral resisting of columns adjacent to damaged beams.

Although story collapse is the most popular failure mechanism, other relatively ductile failure patterns, total collapse mechanism, were observed in reinforced concrete buildings damage by recent earthquakes such as the 2011 East Japan Earthquake. Beam yielding total collapse mechanism (Fig. 5(b)), which is recommended in the current seismic code and guidelines, was found in some relatively new middle or high rise buildings designed according to current seismic codes. Therefore, the evaluation method for total collapse mechanism, proposed by the first author et al. [9], is introduced into the Guideline and the scope of application was widened.  $R$ -index for total collapse mechanism is evaluated by Eq. (4). Eq. (4) gives a ratio of internal work at all the plastic hinges in virtual work method before and after an earthquake.

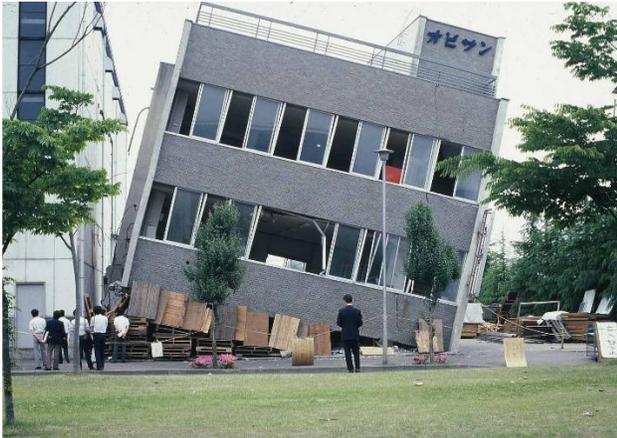
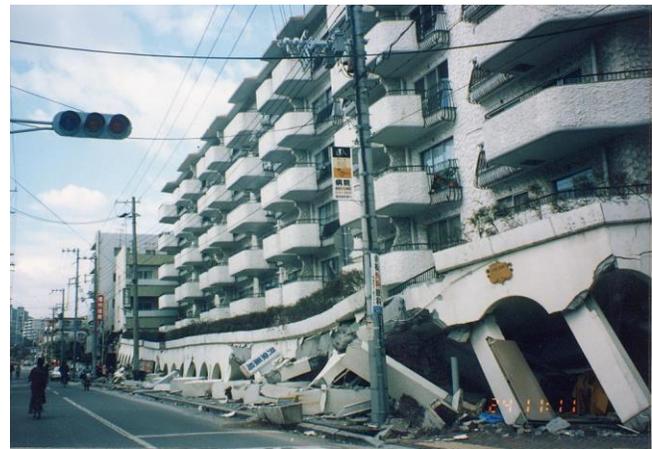
(a) 1978 Miyagi-ken-oki Earthquake

(b) 1995 Kobe Earthquake

Photo 2 – Story collapse of reinforced concrete buildings due to past earthquakes

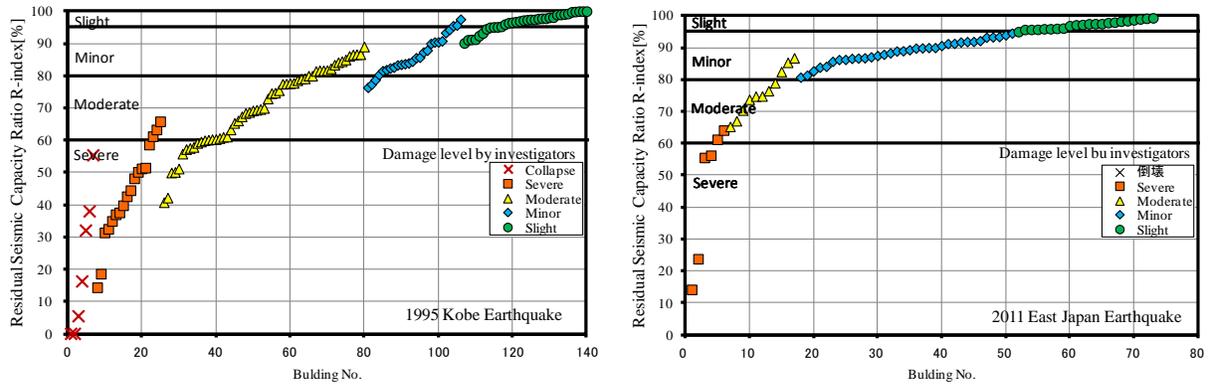
Fig. 6 – Residual seismic capacity index  $R$  and observed damage levels due to the 1995 Kobe Earthquake and 2011 East Japan Earthquake

The proposed damage evaluation method was applied to reinforced concrete buildings damaged due to the 1995 Hyogo-Ken-Nambu (Kobe) Earthquake and the 2011 East Japan Earthquake. The residual seismic capacity ratio,  $R$  index, of about 140 reinforced concrete buildings damaged due to the Kobe Earthquake and about 70 buildings due to the East Japan Earthquake are shown in Fig. 6 together with the observed damage levels from field surveys by experts such as professors. The horizontal lines in Fig. 6 are the boundaries between damage levels employed in the Damage Evaluation Guideline in 2001.

The boundary lines between damage levels were examined in the 2001 Guideline revision for the buildings in Fig. 6(a), of which failure mechanism is story collapse. The boundary line between slight and minor damage was set to  $R = 95\%$  to harmonize “slight damage” to the serviceability limit state in which the building is functional without repair. Almost all severely damaged buildings and approximately 1/3 of moderately damaged buildings were demolished and rebuilt after the earthquake according to a report of the Hyogo Prefectural Government (1998). If the boundary between moderate and severe damage was set to  $R = 60\%$ , “moderate damage” may correspond to the reparability limit state.

As shown in Fig. 6(b), the damage levels based on the  $R$  index generally agree with those classified by investigators for the buildings suffered from the 2011 East Japan Earthquake, which include buildings with total collapse mechanism. Photo 3 shows overall view and damages to a residential buildings suffered from the 2011 East Japan Earthquake. The building was a 11-storied steel reinforced concrete structure constructed in 1979. Structural drawing of an outside frame was shown in Fig.7 together with crack maps. Damage to non-structural walls are severe, in particular, in lower stories and shear failure was found as shown in photo 4(b) and (c). On the other hand, damage to structural frame was limited. The frame formed total collapse mechanism with plastic hinges at beam ends by flexural yielding (Photo 4 (d)). Major damage class of beams were III for lower stories and I or II for middle and higher stories. Assuming story collapse mechanism,  $R$ -index is evaluated story by story ranging from 69% in the 2<sup>nd</sup> story to 95% in 8<sup>th</sup> story and as a result damage level is classified as “moderate”. However, calculation method for total collapse mechanism gives one  $R$ -index of 87% in the sense of an average of whole

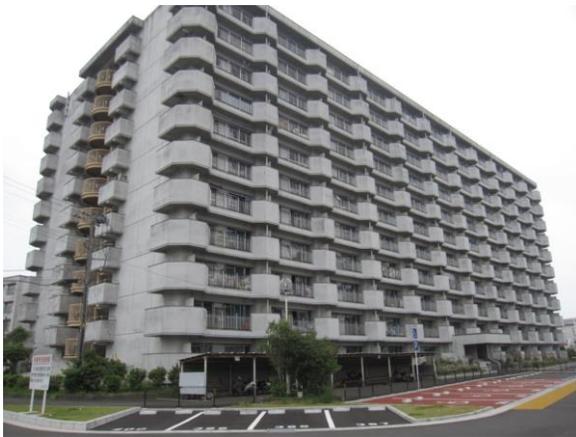
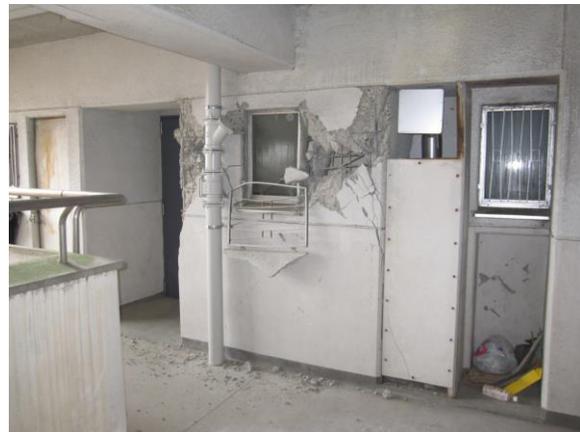
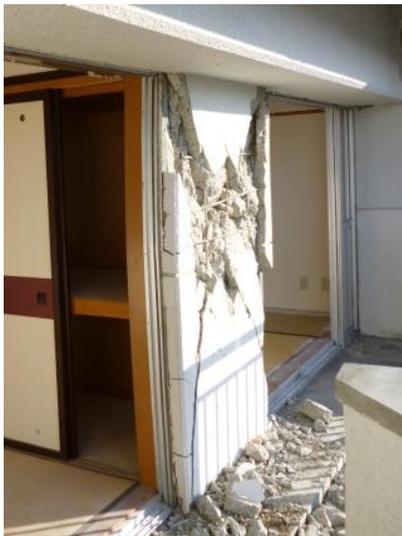
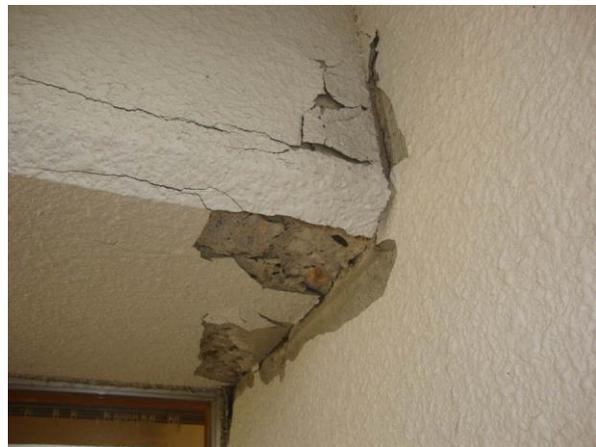
(a) Overall view

(b) Shear failure of non-structural wall

(c) Shear failure of non-structural wall

(d) Crush of concrete at plastic hinge region of a beam end

Photo 3 – Damage to a residential building with total collapse mechanism of beam yielding type

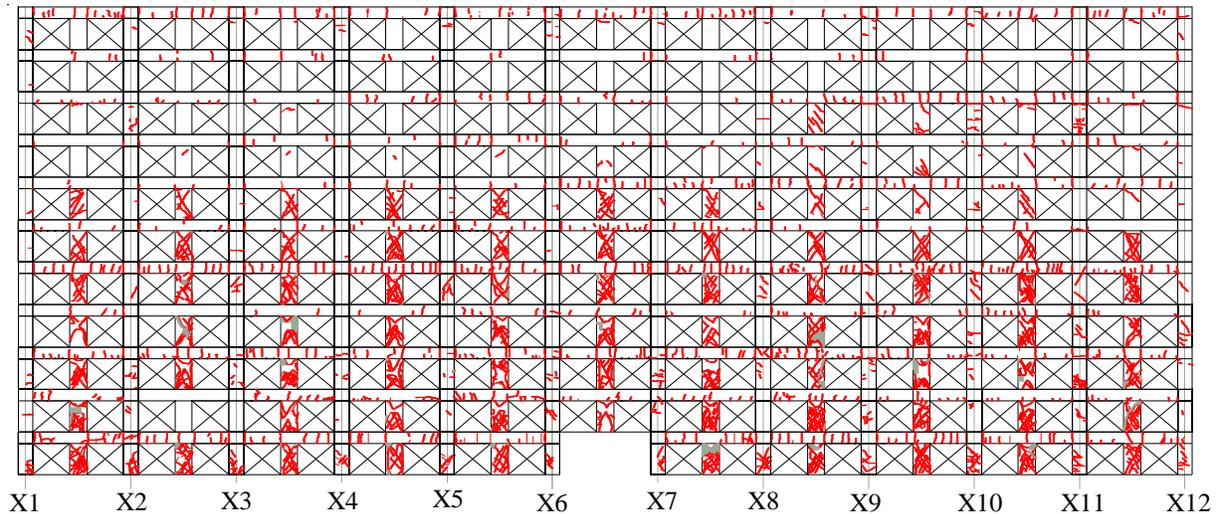
Fig. 7 – Elevation of a frame with crack map of a residential building damaged due to the 2011 East Japan Earthquake
