# STUDY OF LOW-RISE RC BUILDINGS WITH RELATIVELY HIGH SEISMIC CAPACITY DAMAGED BY GREAT EAST JAPAN EARTHQUAKE 2011

## ABSTRACT

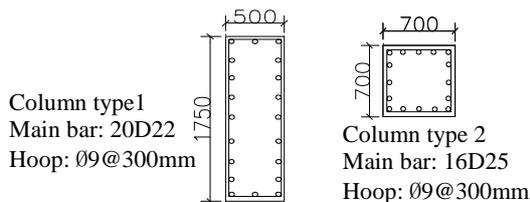
Fig.5 Typical column size and reinforcement

As shown in Table.1 the  $I_s$  index and  $C_{TU.SD}$  index for both of the buildings are almost the same, but the N lecture building had a greater damage than expected in the seismic evaluation. This is thought to be of the poor construction of columns. The cover around the hoops is so thin in some cases 0.5 cm (see Fig.12). Moreover, the ends of bars should be hooked by bending of at least of 135°, but in this case it was bent by angle of 90° as shown in Fig.13. Therefore, the bond between the concrete and hoops is weak and the hoops didn't reach its maximum yielding point and slipped. The hoops are not really helping shear strength. The N Lecture building depends in its seismic capacity mainly on shear columns. In the other hand, the S Lecture building depends mainly on the wall for its seismic capacity. The shear capacity for the columns didn't reach its maximum strength since most of the seismic load was carried first by the wall which was not affected by the poor detailing of the hoops.

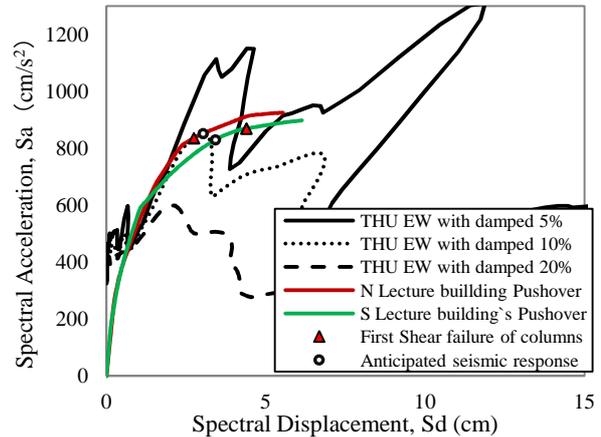
Fig.9 THU EW response spectrum

The response spectra curve of THU EW has low values and sharp peaks at short periods as shown in

Fig.9 and intersects the capacity curve of both buildings at low  $S_a$  values. If the capacity method is used, the seismic response for both buildings was expected in the elastic region and that contradicts the actual damage observed in the buildings. Therefore anticipated seismic response was chosen at the point where the actual damage observed relatively matched the damage calculated by pushover analysis which was at relative story drift angle of about 1/200rad in the 1<sup>st</sup> story for both buildings.

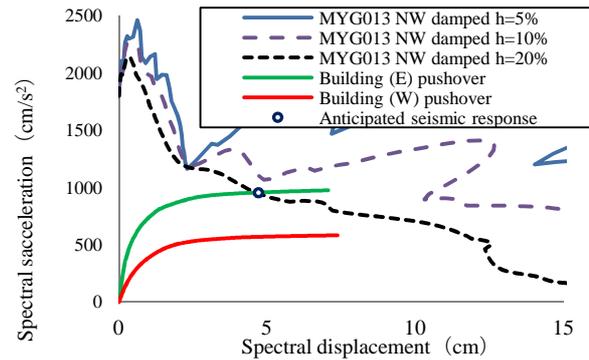
Fig.20 MYG013 NW response spectrum and pushover curves

Two Response spectra, MYG013 KNET and JMA Sendai, are used for analysis. Using MYG013 response spectra, Fig. 20, it is demonstrated that more significant structural damage would occur in building (E) and a higher probability of collapse for building (W). In the other hand, the damage expected using JMA Sendai Spectra, Fig. 21, relatively matches the actual damage.

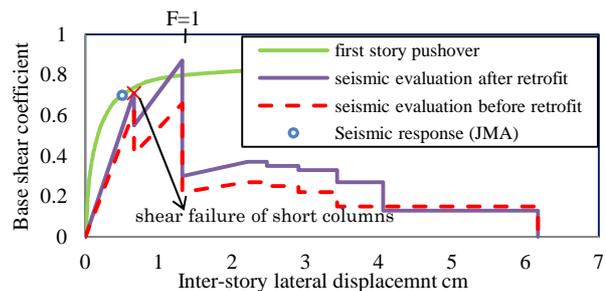
Fig22. Comparison between 1<sup>st</sup> story pushover and seismic evaluation results of building (E)

$I_s$  index for both buildings are chosen at a ductility greater than  $F=0.8$ , which means that the failure of extremely short columns was allowed in the seismic evaluation, since axial loads could be redistributed to other columns and the building will not collapse. However, short column failed only in building (W) and didn't in building (E). This is due to several reasons; The  $C_{TU} \cdot S_D$  for 1<sup>st</sup> story at ductility index  $F = 0.8$  for building (E) is about twice of building (W), as shown in Table 5. It is thought that building (E) had a story drift just less than  $F=0.8$ . This is shown using seismic response of JMA NW which is just before the shear failure of short columns (see Fig. 22). Therefore short columns didn't reach their maximum allowable ductility and escaped shear failure. In the other hand, The  $I_s$  value for building (W) depends on ductility ( $F=1.75$ ) to reach the criteria of  $I_s > 0.7$ . The anticipated seismic response using either JMA NW or MYG013NW spectrum are greater than  $F=1$  (see Fig.23). At this seismic response, all short and shear columns had shear failure.
