DAMAGE TO REINFORCED CONCRETE SCHOOL BUILDINGS IN MIYAGI AFTER THE 2011 GREAT EAST JAPAN EARTHQUAKE

ABSTRACT: Typical damage observed by author's field survey in Miyagi prefecture is described. Generally, reinforced concrete structures performed well and effect of seismic retrofit was found in mitigation of damage, although severe damage to some seismically retrofitted buildings was noticed. Some buildings are selected for detailed investigation. A good correlation was observed between calculated seismic capacity I_s -index and observed damage. However, major damage to non structural elements was commonly observed. The reasons for damage and lessons to seismic design are discussed.

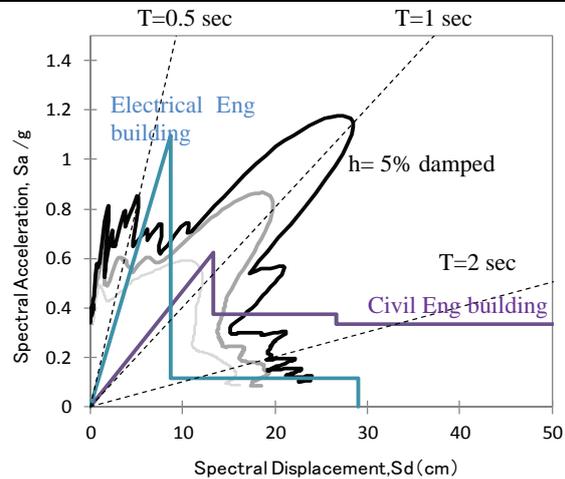
Fig.15 Response spectra of Tohoku university NS

Even though it was retrofitted, it was severely damaged by the 2011 earthquake as shown in figure 14(b). There was strong ground motion at the site at periods close to 1 sec (see Fig.15), which is the fundamental vibration period measured for this building during the earthquake. Boundary columns failed in compression and the connection of walls to beam also failed indicating that the ductility of the shear walls was not increased as expected in the seismic retrofit. This may have been caused by poor connections between the wall webs (which were replaced during the retrofit) and the surrounding beams and columns.

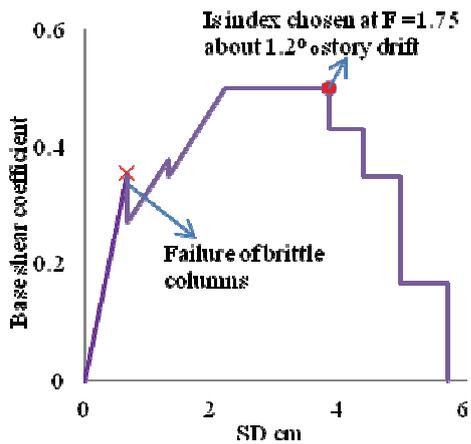
Fig. 21. 1st story seismic evaluation results of West side Building

Figure 19 shows 3 storied RC building of an elementary school in Sendai city constructed in 1974. The building is divided by expansion joint into west side and east side. Seismic evaluation was carried out to both sides. According to the seismic evaluation, the East side building needed to be retrofitted (see fig. 22) and the West side was evaluated to have enough seismic capacity and no retrofiting was needed. The Is-index for West side building depends on ductility ($F=1.75$) to reach the of $I_s > 0.7$ which is the criteria in Japan (see Fig. 21). The East side building was retrofitted by adding framed steel braces and shear walls. By this earthquake, the retrofitted building had only minor damage. On the other hand, the West side building had shear failure in its short columns as shown in figure 20. Shear failure of those short columns was allowed in the seismic evaluation because axial loads could be redistributed to other columns and the building didn't collapse. This building wasn't retrofitted since it's judged that there is no threat to life safety. However, the school could not use this building after the earthquake and repairing expenses would be relatively high if compared to the retrofiting expenses for a better performance. This issue of functionality is one of important issues that require more attention. The response spectrum of this area is mentioned above in figure 3 as 2011 East Japan MYG013 NS.
