DAMAGE OF RC BUILDING WITH COUPLED SHEAR WALLS CAUSED BY THE 2011 GREAT EAST JAPAN EARTHQUAKE

Abstract: An eight-story reinforced concrete building retrofitted according to 1990 Japanese Standard was severely damaged during the 2011 Great East Japan Earthquake. The building was constructed in 1966 at Tohoku University. In 1996 the building was retrofitted using structural walls and carbon fiber. Dramatic damages were observed in coupling beams, a penthouse and a structural wall. Coupling beams failed in shear and bond. Columns and walls in the penthouse collapsed by torsion. The structural wall failed in compression at its end. Some of structural members were different from original drawings. Therefore, their strengths are re-calculated considering these differences by using 2010 Japanese Standard. Based on these calculated strengths, a pushover analysis is conducted. The failure mode in the analysis agrees with observed failure. Furthermore, it is confirmed that perpendicular walls cause large deformation of coupling beams.

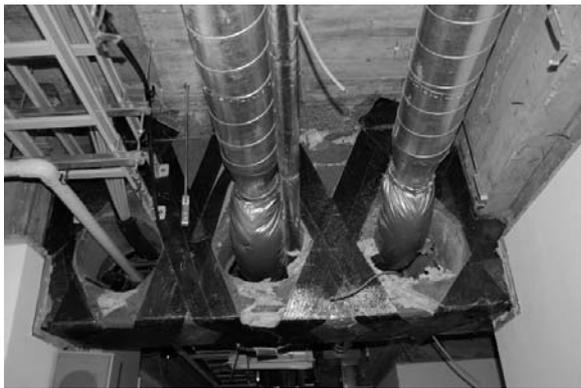
Photo 1 Tape-shaped fiber

The building was retrofitted in 1996 referred to the 1990 Japanese standard (building Research Institute 2001). The main changes during the retrofit were addition of new walls, replace RC walls for new and thicker ones and reinforcing some of the beams with carbon fiber. Addition and replacement of RC walls were described in the seismic retrofit document, but reinforcement using carbon fiber was not. The wall changes were concentrated in lower stories, from first to fifth stories, the carbon fiber reinforcement had been located mostly in the upper ones. About the location of the carbon fiber reinforcement, since there was no documentation, a deep field investigation was needed. The carbon fiber reinforcements were applied around openings in the beams. There were two kinds of fiber reinforcement: the first one is tape-shaped, the second one was a continuous fiber wrapping all beams with anchorages inside the concrete. (Photos 1 and 2) Regarding to the penthouse, no retrofit was done.

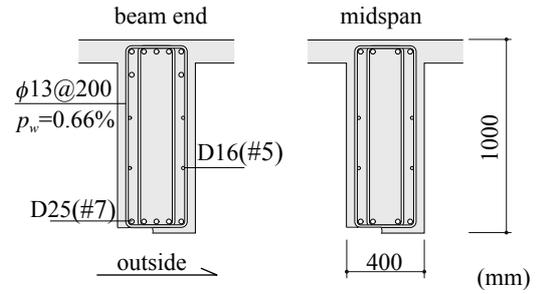
Figure 7 Section of the beam of the floor 4,5

Bar arrangements of the beams were visible because concrete had spalled. They were different from the drawing. In the drawing, the longitudinal reinforcements were D25(#8) or D22(#7) bars, diagonal reinforcements were D16(#5) bars and stirrups were $\phi 13$ or $\phi 9$ bars (Figures 7 and 8). Lack of cover concrete for window frame was expressed in the figures. Figure 9 illustrates the drawing of reinforcements around the openings of 300mm in diameter. The distance between two openings was 800mm.

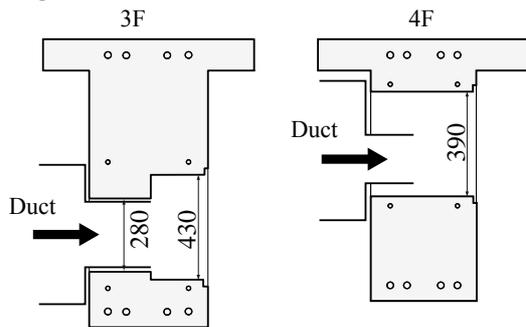
Figure 11 Image of the beam section across the opening

Photo 3 and Figure 10 show the beam of the third floor. From these investigations, the section of this beam with openings can be estimated as Figure 11. The diameter was not constant along the beam depth and it was larger in outside part of the beam. In addition, the distance between of these openings was 600mm which was estimated from photo. There were no stirrups under

Photo 4 and Figure 12 describe the beam in the fourth floor. It was different from third floor where some stirrups were gathered beside the opening. Stirrups were cut above the opening as shown in the broken area. In addition, straight anchorage of diagonal reinforcement was different from drawing which adopted bent bars. Diameter of this opening was constant along the beam width. (Figure 11)

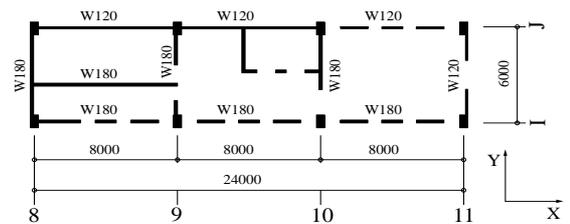
Figure 16 Penthouse 1st story (mm)

The penthouse of the building was severely damaged that required emergency strengthening just after the earthquake in order to prevent collapse. Both columns and walls were completely destroyed at the first story of the penthouse, while the second story was in a similar condition to the rest of the building. In investigation, thickness of walls was 120mm, but drawing illustrates that was 180mm. (Figure 16) Damage in the first story of the penthouse was more remarkable on transverse directions than on longitudinal one. Figure 17 shows penthouse cracks schedule of each frame. Frame 8 was less damaged. Frame 11 damaged heavily. (Photo 9) Damage in east area became increasingly hard. Capacity of walls in the first story of the penthouse was calculated in each frame as shown in the work by Villanova et al. (2012). The frame 8 had approximately twice the capacity of 9, 10 and 11 frames. Therefore, Penthouse might have torsional response. This might have caused such severe damage.

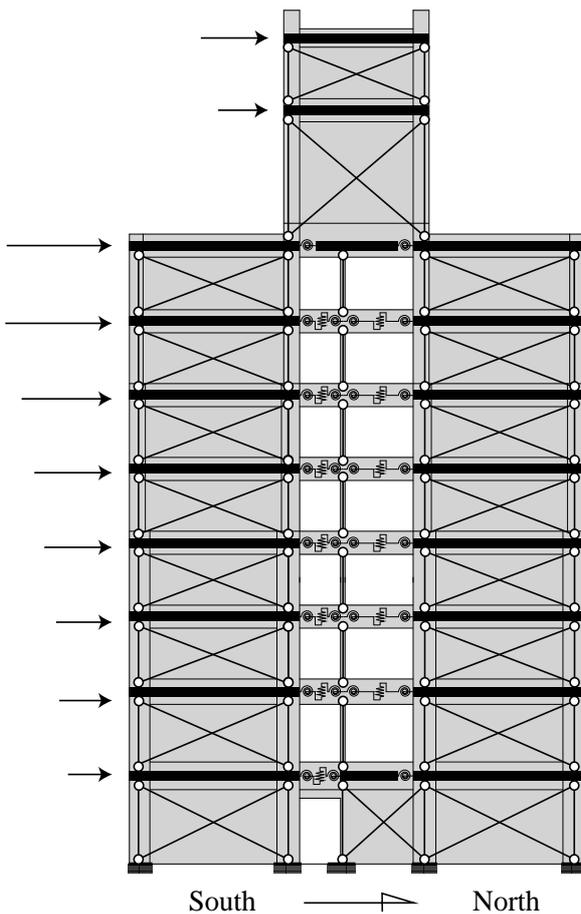
Figure 20 Analysis model

The analytical model of the frame on 11 axis is shown in Figure 20. Coupling beams are idealized by two nonlinear rotational spring at their end and nonlinear shear spring. Coupling beams of 3rd to 8th floors are idealized

with two separated beams to consider the effect of the perpendicular walls. The backbone curves of rotational springs and shear springs are represented by a tri-linear relation. The first break point in the relation represents cracked state, the second represents ultimate limit state.

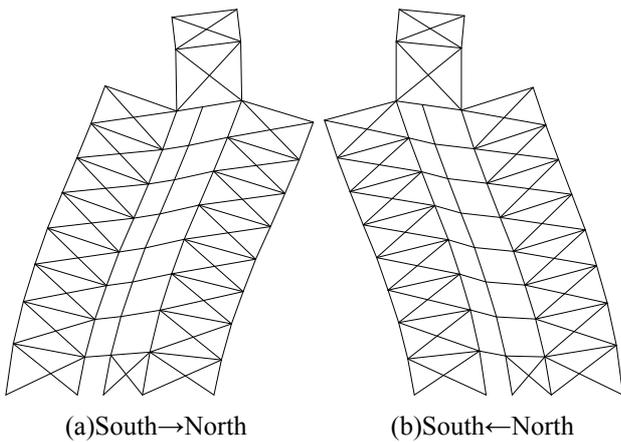
Figure 22 The deformation of the building at $0.48 Q_{max}$

base shear coefficient of this building is estimated as 0.48. Figures 22 shows the deformation of the building in the case that story shear forces are applied $0.48 Q_{max}$. These displacements are illustrated by 50 magnifications. Drifts of short beams seems almost the same as long beam in Fig. 22(a). On the other hand, drifts of short beams seems larger than long beams in Fig. 22(b). Therefore, it is considered that short beam is damaged by the loading from North to South.

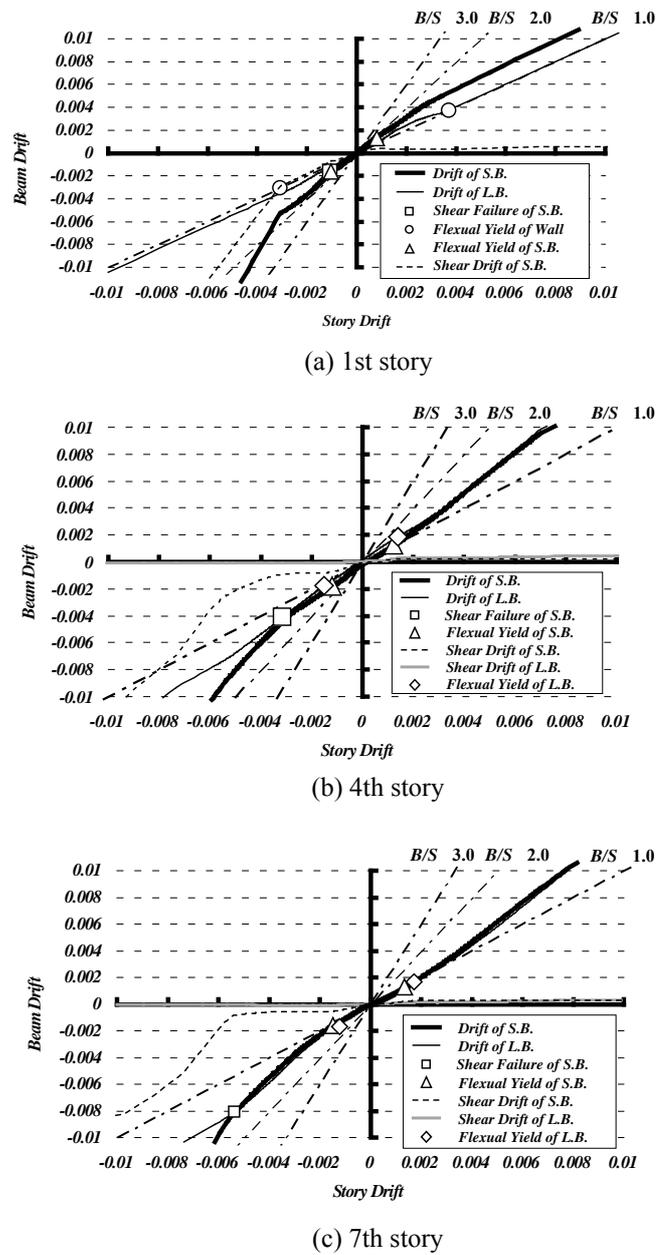
Figure 23 The relation between beam drift and story drift

Figure 23 shows the relation between beam drift and story drift on the lower floor (1F), middle floor (4F) and upper floor (7F). Beam drift means the summation of shear drift and flexural drift. These figures show drifts in the case of both analyses. The drift of rotational spring nearby structure walls is considered larger than that nearby perpendicular walls. Therefore, flexural drift is estimated by using the rotational spring nearby structure walls. According to these relation in the area of loading direction from north to south, when walls in 1st floor failed, the drift of short beams is 1.5 to 2.0 times as large as story drift. The higher floor up, the lower the drift of short beams. On the other hand, the drift of long beam is almost the same as story drift. Figures also show the shear drift of short and long beams. It represents that the shear drift of short beams is larger than long beams. In the loading direction from south to north, the drift of short beams is almost the same as the drift of long beam. Therefore, the larger shear force acts to short beams compare to long beams in the case of loading direction south to north.

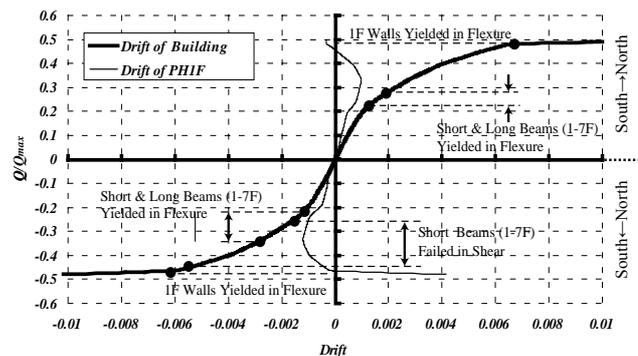
Figure 24 The relation between Q/Q_{max} and drifts

Figure 24 shows the relation between Q/Q_{max} and drifts. Q factor indicates the story shear force in each steps. Bold line indicates the drift of the building, the other indicates the drift of the penthouse first floor. The drift of the building in this graph mean the horizontal displacement at roof floor divided by the height between first and roof floor. Positive area of Q/Q_{max} in this graph represents the analysis of loading direction from south to north, opposite area represents the analysis of opposite direction. When walls in 1st floor failed, the drift of the building is about 0.65%, and the drift of the penthouse 1st floor is nearly zero in both loading directions. Even

maximum drift of penthouse before walls in 1st floor failed is about 0.1%. Furthermore, in the loading direction from North to South all short beams except roof floor beam failed in flexural and shear before wall failed.

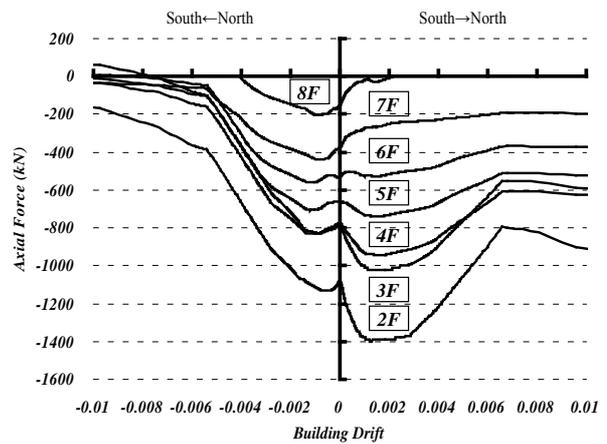
Figure 25 The relation between building drift and axial force of perpendicular walls

Figure 25 shows the relation between building drift and axial force of perpendicular walls. The figure represents that the perpendicular wall in 8th floor failed in bond slippage when the building drift reaches about 0.002 in south to north direction, and 0.004 in opposite direction.

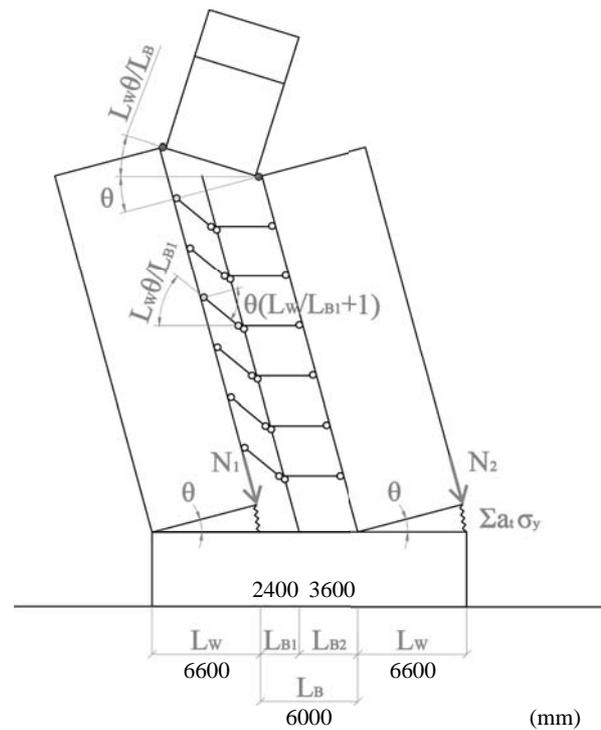
Figure 26 Model of calculation for the frame number 11

Collapse model of this building in 11 axis is assumed as shown in Figure 26 and the ultimate lateral strength was calculated two patterns. The one pattern considers the work of short beam, the other one does not consider it. The strength was evaluated by using virtual work method. In this calculation, there are four assumption. First, structure walls in 2nd floor are failed in flexure. Second, the first story is considered as rigid, because it does not have significant damages. Third, top of the perpendicular wall in 8th floor is failed in bond slippage. Fourth, joints between columns in 8th floor and coupling beams in roof floor failed as shown in Fig. 27. In the result of this calculation, the ultimate lateral strength is 6.5MN without considering the effects of the beams, and 8.7MN in the other case. Furthermore, short span coupling beams are deformed 3.75 times as large as the drift of the building. According to the documents of the seismic evaluation, the ultimate lateral strength at 2nd floor is 10.7MN, and base shear coefficient is 0.8. Therefore, base shear coefficient of this calculation is estimated 0.49 and 0.65.

According to the result of pushover analysis, several behaviors of the analysis correspond with the suggested model. Regarding to ultimate lateral strength, the result of analysis is almost same as the suggested model's, but is smaller than the value of seismic evaluation. However, there are more walls in 1st than upper stories on other axes shown in Figure 28. Therefore, larger base shear coefficient than 0.48 can be expected in this building. Though drifts of short beams of the analysis are smaller than the model in Fig. 26, they are larger than story drifts as indicated in Fig. 26. Perpendicular wall in 8th floor failed in bond slippage in the pushover analysis and
