PERFORMANCE OF THE BUILDING OF THE FACULTY OF ENGINEERING AT TOHOKU UNIVERSITY DURING THE GREAT EAST JAPAN EARTHQUAKE OF 2011

Abstract: This paper presents a study of a retrofitted SRC building which was damaged by 2011 Great East Japan Earthquake. The building was severely damaged in 2011 Great East Japan earthquake. However, this building also suffered from minor damage due to the 1978 Miyagi Oki earthquake. In 2001, This building was seismically evaluated using Japanese seismic evaluation standard (JBDPA) and it was retrofitted based on this seismic evaluation. It was retrofitted by installing framed steel braces, replacement of shear walls and jacketing of adjacent beams with steel plates. Characteristics and crack Figures of the structural damage is presented. The actual damage observed was different from estimated damage of the seismic evaluation. Plausible explanation of such damage and its mechanism is presented, compared and discussed with the seismic evaluation results, virtual work method and capacity spectrum method .

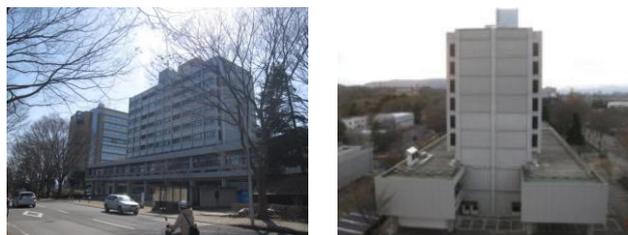
Figure 2 General view of this building

Figures 2a and 2b show the North and East elevations of the CE building. The building was a 9-story steel/concrete composite building. The first two stories were larger in plan than the upper stories (Figure 2b), Figure 3). The typical floor plan for the 3rd to 9th floors is shown in Figure 3a), and the floor plan of the 1st and 2nd floors is shown in Figure 3 b). The locations of the accelerometers are indicated by the stars in Figure 3.

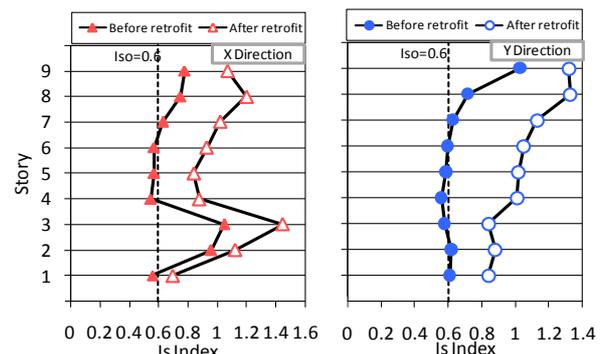
Figure 4 I_s index of each story

Figure 4 shows the I_s -index of all stories for both before and after retrofit. This building was retrofitted because I_s -index was less than 0.6 for most stories.

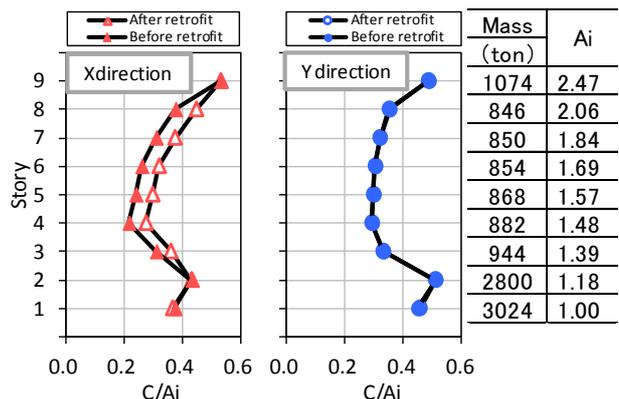
Figure 5 C index and A_i of each story

Figure 5 shows the C -index / A_i . 1st and 2nd stories have higher lateral strength ($C/A_i=0.4\sim 0.5$) than upper stories in both directions. In the Y direction, 3rd-8th story have approximately the same C/A_i value (=about 0.3). $C/A_i = 0.3$ is the minimum requirement for RC buildings in the current seismic code in Japan

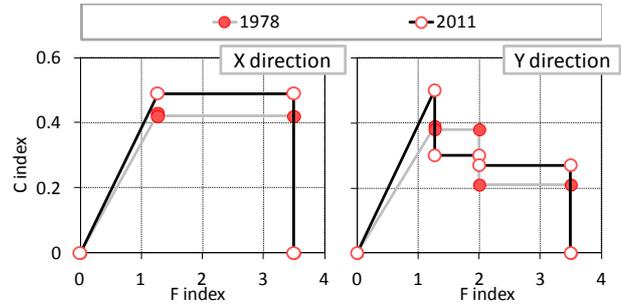
Figure 6 3F C-F curve

Figure 6 shows the C - F curve of 3rd story. Both directions have $F=3.5$, and the building was stronger in X direction than in Y direction. In Y direction, the strength index is as low as 0.29.

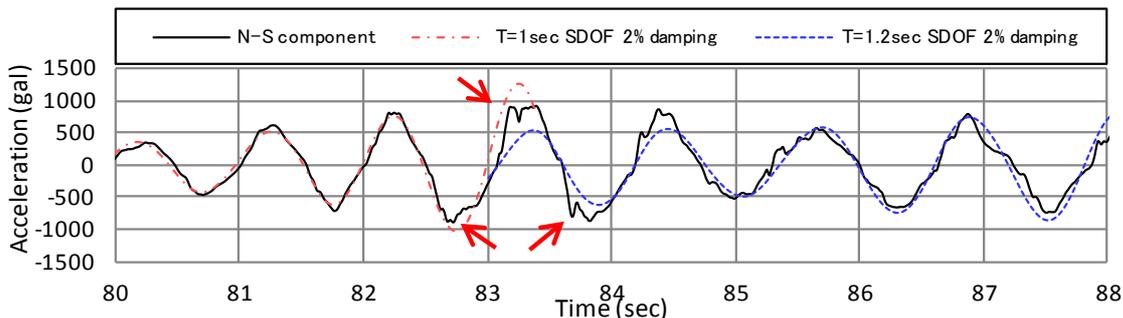
Figure 11 Zoom viewing of Acceleration time history

2) there were sudden drops in acceleration (marked with red arrows) at $t=82.7, 83.3,$ and 83.8 sec.

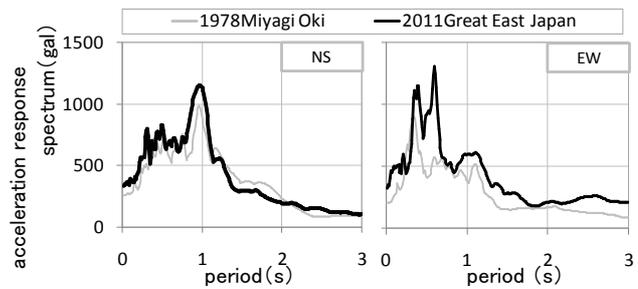
Figure 12 5% damping acceleration response spectrum

Figure 12 shows acceleration response spectra computed for both records (1978 and 2011) using a damping coefficient of 5%. In the NS direction, the two spectra are strikingly similar. The same is true for displacement spectra. It is reasonable to conclude that these two earthquakes produced comparable demands on the building in the N-S direction. This conclusion is supported by two observations:

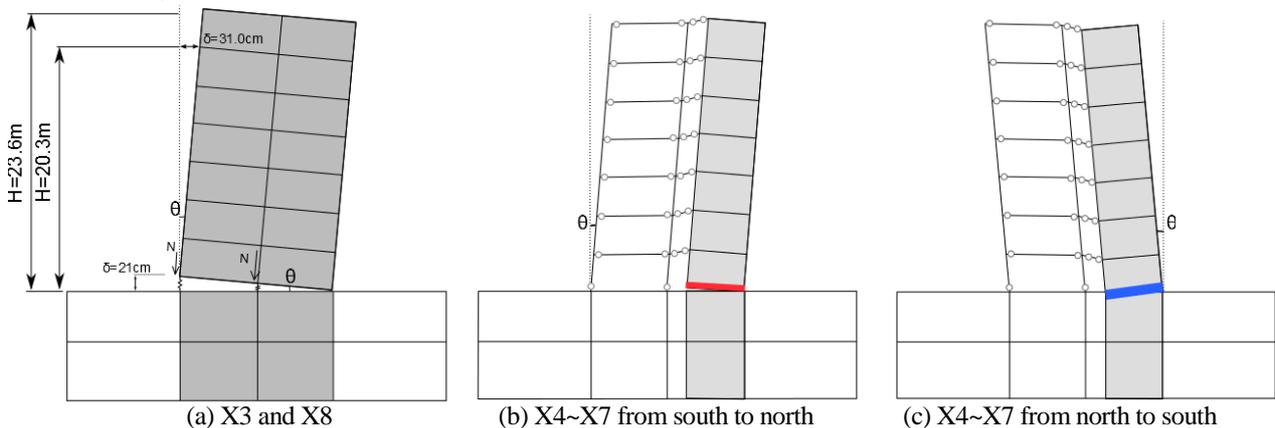
Figure 22 Estimated building collapse mechanism

- The wall will break and rotate at the base of 3rd floor (see Figure 22a)).
- The strength of the wall reinforcement are assigned in the center of wall.

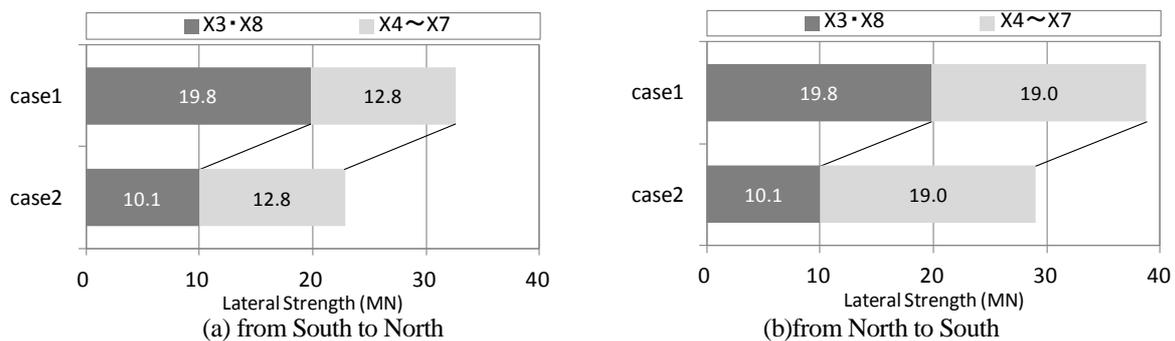
Figure 23 Lateral strength at 3rd floor

As it shown in the Figure 23. The difference between the two cases is more than 30% of the total strength. This building depends mainly on these exterior installed walls. Any poor detailing of the installed walls shall led to dramatic damage.

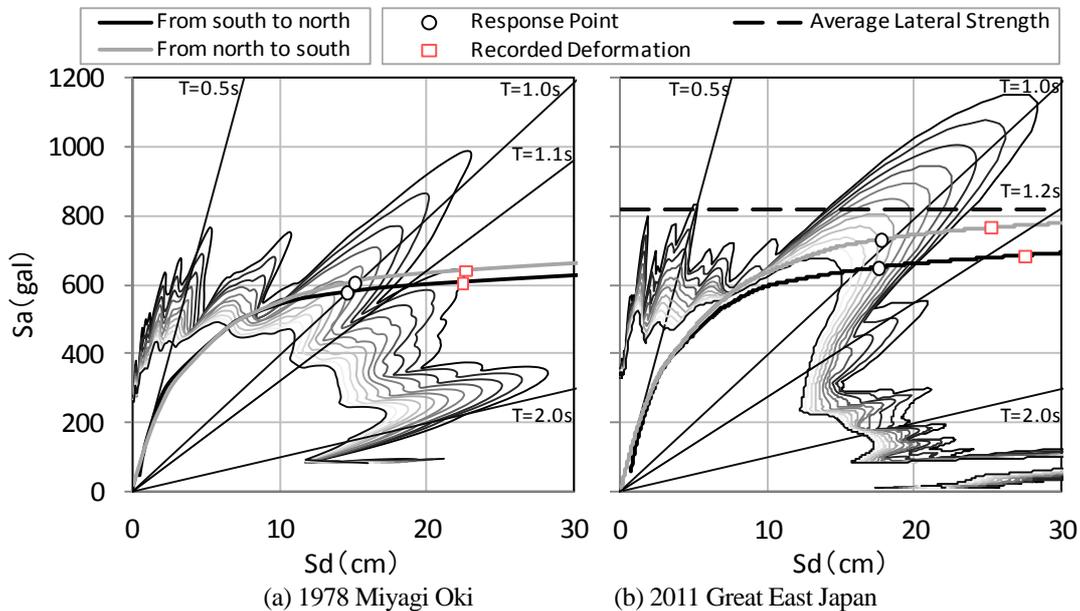
Figure 25 Result of the pushover analysis

The capacity spectra (Sa-Sd) of building are plotted with response spectra of the 1978 earthquake and 2011 earthquake with 5%~20% damping. (see Figure 25).

The dotted horizontal line in Figures 25b) shows the lateral strength capacity that was previously calculated using the virtual work method for case 1 stated previously. The ultimate strength of pushover and the lateral strength by virtual work method of case 1 showed good agreement

Using capacity spectrum method, in the case of 1978 earthquake, the estimated response drift was about 15 cm and the calculated displacement was about 23 cm, in the case of 2011 earthquake, the estimated response drift was about 18 cm and the calculated displacement was about 29 cm, each model have big difference between estimate and recorded deformation. The difference between the two values might be caused due to the rocking at the base and unique failure mechanism of this building.
