Damage Survey on Reinforced Concrete School Buildings in Miyagi after the 2011 East Japan Earthquake

Keywords: Great East Japan earthquake, RC school buildings, damage survey, seismic evaluation

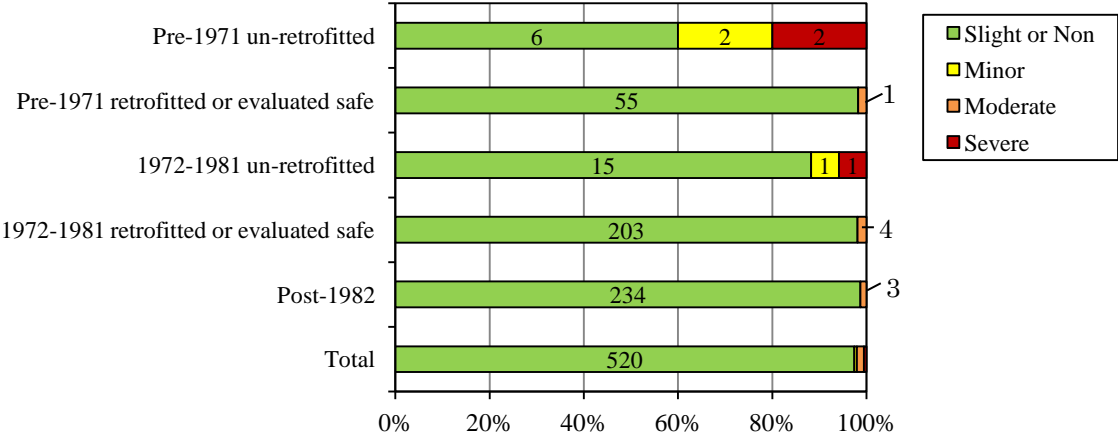
Figure 6. Damage ratio of RC school buildings of main cities of Miyagi Pref. 2011

hand, most new buildings designed according to the current seismic codes enforced in 1981 showed fairly good performance and prevented severe structural damage. Figure.6 shows the damage ratio of 538 RC school buildings in main cities of Miyagi Prefecture suffered from the 2011 East Japan Earthquake. The buildings suffered from tsunami and damage of the foundation were excluded in the Figure. There were no collapses. Although there are few buildings suffered from over moderate damage, the effect of seismic retrofit can be obviously found in comparing with seismically retrofitted and un-retrofitted buildings. In addition, the ratio of serious damage for post-1981 or retrofitted is much smaller than that in 1995 Kobe Earthquake, it suggest that ground motion in 2011 East Japan Earthquake was not severe as 1995 Kobe Earthquake.

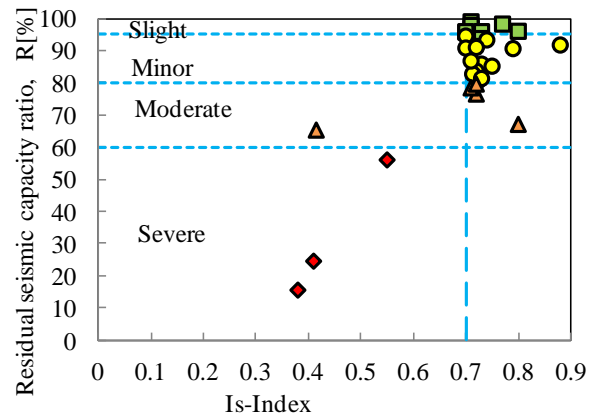
Figure 8. I_s -Indices and damage indices

The Seismic Evaluation Standard recommends as the demand criterion that I_s -Index higher than 0.6 should be provided to prevent major structural damage or collapse. This criterion is based on the correlation study from the past earthquake damage and the calculated indices for the damaged buildings(Okada 1998). Past experiences of damaging earthquakes reported that buildings with I_s -Indices higher than 0.6 escaped severe damage or collapse. I_s -Index of school buildings is demanded higher value (0.7) than normal buildings. It is because that school buildings require not only the security of safety but also the security of function to use buildings without repairing structural damage after big earthquake. Figures 7 and 8 show all the buildings with I_s -index lower than the criteria suffered from severe damage. As mentioned earlier, over 90% of RC school buildings have been already seismically retrofitted, I_s -Indices for most of the buildings were more than 0.7 and prevented severe structural damage even if they were old buildings. Figure.8 shows the relationship between I_s -Index and damage level indices R -Index proposed in “Standard for Post-earthquake Damage Level Classification of Reinforced Concrete Building” (JBDPA 2001a). A good correlation was observed between calculated I_s -index and observed damage. Most buildings with I_s -values lower than 0.6 were vulnerable to moderate and severe damage. Most of the buildings with I_s -values higher than 0.7 avoided severe damage and had minor or slight damage (residual seismic capacity ratio $R > 80$). I_s -Index of 0.7 is generally regarded as an effective demand criterion for screening seismically vulnerable buildings.

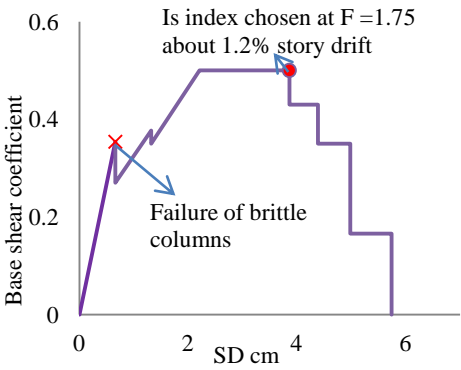
Figure 17. 1st story seismic evaluation results of West side Building

Figure 15 shows 3 storied RC building of an elementary school in Sendai city constructed in 1974. The building is divided by expansion joint into west side and east side. Seismic evaluation was carried out to both sides. According to the seismic evaluation, the East side building needed to be retrofitted (see Figure 18) and the West side was evaluated to have enough seismic capacity and no retrofitting was needed. The Is-index for West side building depends on ductility ($F=1.75$) to reach the of $I_s > 0.7$ which is the criteria in Japan (see Figure. 17). The East side building was retrofitted by adding framed steel braces and shear walls. By this earthquake, the retrofitted building had only minor damage. On the other hand, the West side building had shear failure in its short columns as shown in Figure 16. Shear failure of those short columns was allowed in the seismic evaluation because axial loads could be redistributed to other columns and the building didn't collapse. This building wasn't retrofitted since it's judged that there is no threat to life safety. However, the school could not use this building after the earthquake and repairing expenses would be relatively high if compared to the retrofitting expenses for a better performance. This issue of functionality is one of important issues that require more attention. The response spectrum of this area is mentioned above in Figure 3 as 2011 East Japan MYG013 NS.
