## GUIDELINE FOR POST-EARTHQUAKE DAMAGE EVALUATION OF RC BUILDINGS IN JAPAN

### ABSTRACT

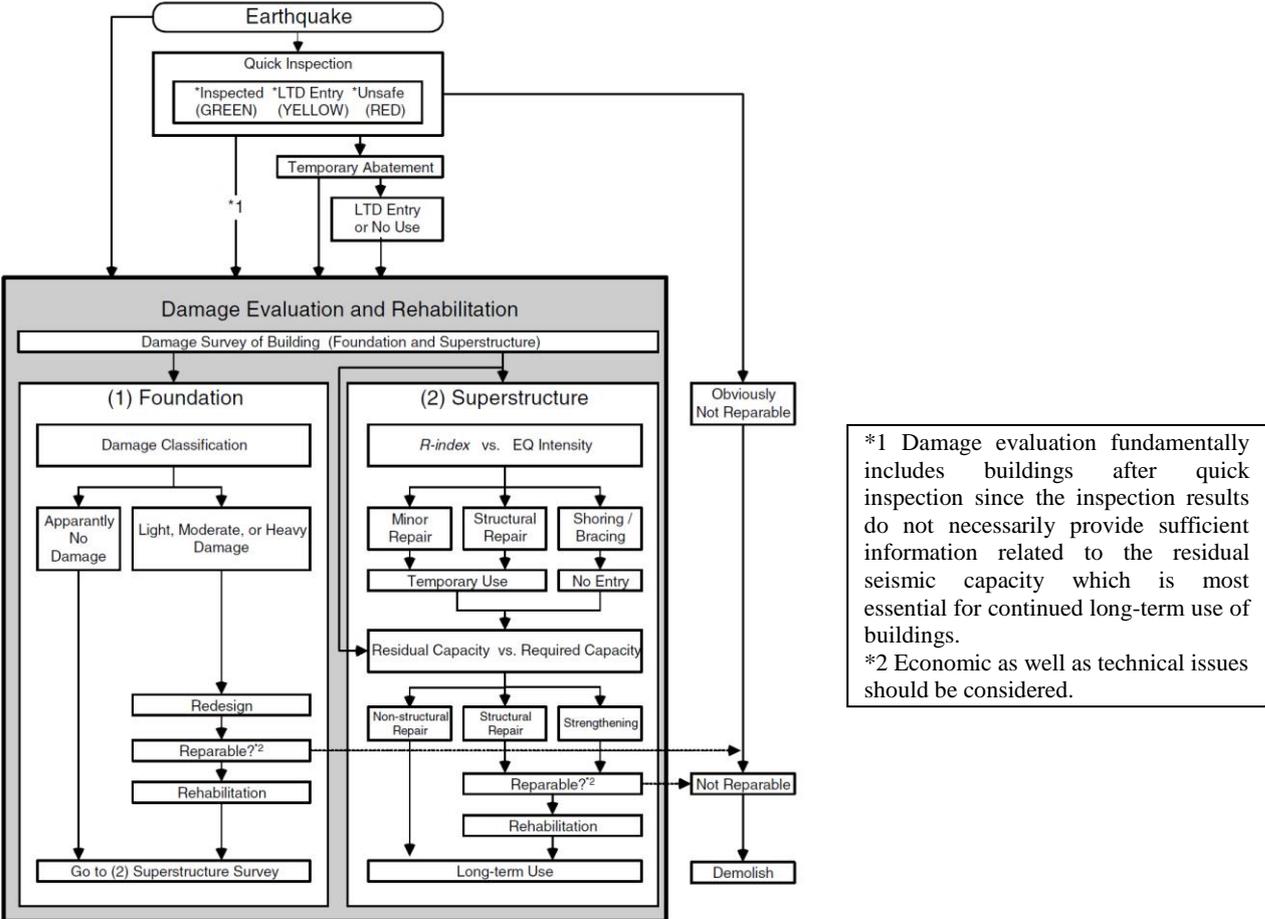
Figure 1. General Flow of Damage Evaluation and Rehabilitation in the Guideline (Nakano et al. 2004)

Damage evaluation of a building is performed on the foundation system and superstructure system, respectively, and the damage rating of each building is made in a combination form for each system such as “no damage in foundation and moderate damage in superstructure”. Rehabilitation actions necessary for the building are then determined considering identified damage. Fig. 1 shows the general flow of damage evaluation and subsequent rehabilitation.

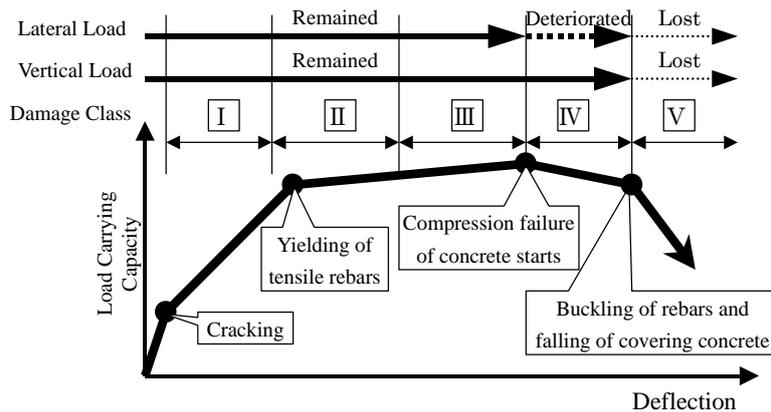
In Fig. 2(a), a ductile member deforms up to a maximum lateral strength level after yielding. Furthermore, after reaching the maximum strength, the reduction of strength is relatively small. If the maximum deformation during an earthquake does not reach deformation at yielding point, extensive damage would not occur. This state corresponds to damage class I, between the cracking and yield points. If the maximum deformation does not exceed the maximum strength, damage to cover concrete is limited and most of the lateral and vertical strengths remains in the flexural member. This state corresponds to damage class II and damage class III. If the maximum response exceeds the maximum lateral strength point, deterioration in lateral strengths with spalling of cover concrete would be observed. The vertical strength may remain if the buckling and/or fracture of reinforcing bars and crush of core concrete, etc., do not occur. This state corresponds to damage class IV. If buckling and/or fracture of reinforcing bars and crush of core concrete occur, both the lateral and vertical load carrying capacities will be lost (damage class V).

(a) Ductile member

Figure 2. Idealized lateral force-displacement relationships and damage class (JBDPA 2001a)

In the Damage Evaluation Guideline (JBDPA 2001a), the state of damage of each structural member is first classified into one of the five classes listed in Table 1. The relationship between each damage class given in Table 1 and the lateral force-displacement curve is approximated as shown in Fig. 2. Examples of damage class for columns and walls are shown in Photo 1.

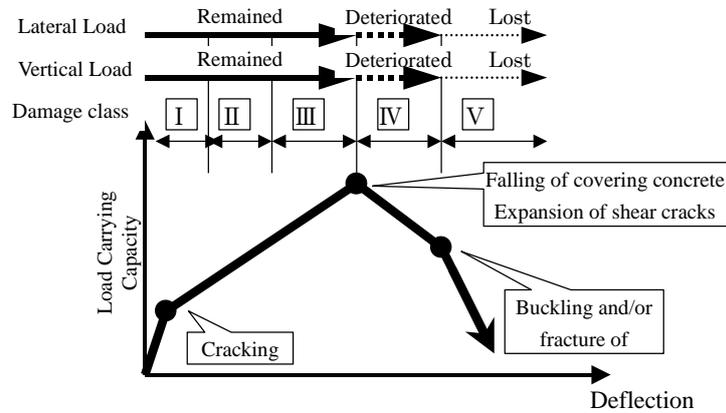
The degree of damage in a brittle member, as shown in Fig. 2(b), is similar to that of a ductile member up to the maximum strength, although diagonal or X-shape cracks may also be visible (damage classes I, II and III). After the maximum strength is reached, a significant reduction in both lateral and vertical strength may occur (damage class IV). Finally, X-shape shear cracks widen and both lateral and vertical load carrying capacity will be lost suddenly (damage class V).

(b) Brittle member

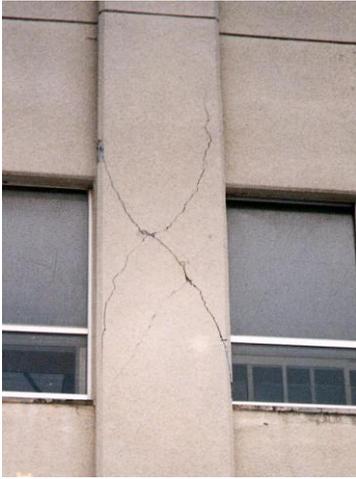
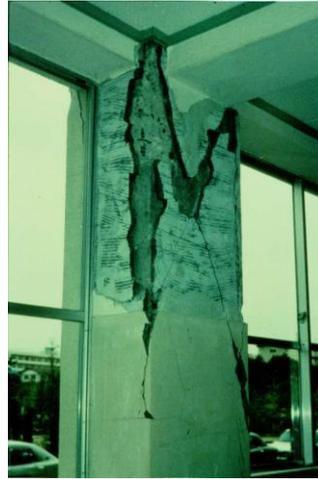
Damage class III: (left) Cracks with a width of about 2mm on structural concrete  
(right) Spalling concrete cover and slightly exposed rebars

Damage Class	Observed Damage on Structural Members
I	Some cracks are found. Crack width is smaller than 0.2 mm.
II	Cracks of 0.2 - 1 mm wide are found.
III	Heavy cracks of 1 - 2 mm wide are found. Some spalling of concrete is observed.
IV	Many heavy cracks are found. Crack width is larger than 2 mm. Reinforcing bars are exposed due to spalling of the covering concrete.
V	Buckling of reinforcement, crushing of concrete and vertical deformation of columns and/or shear walls are found. Side-sway, subsidence of upper floors, and/or fracture of reinforcing bars are observed in some cases.

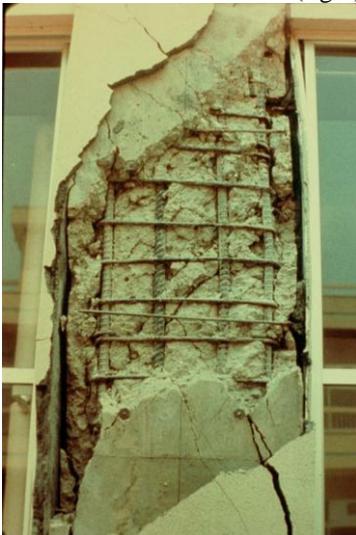
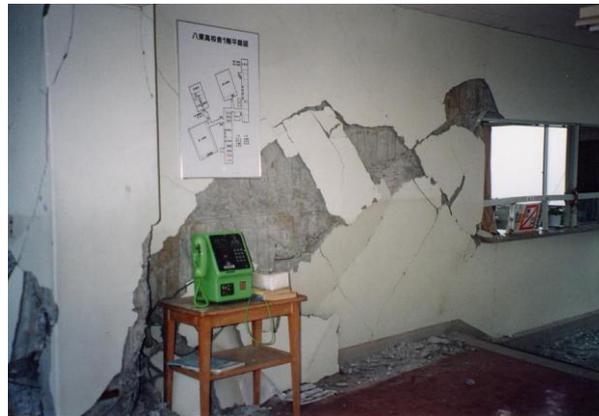
Damage class IV: Exposed rebars without buckling or fracture

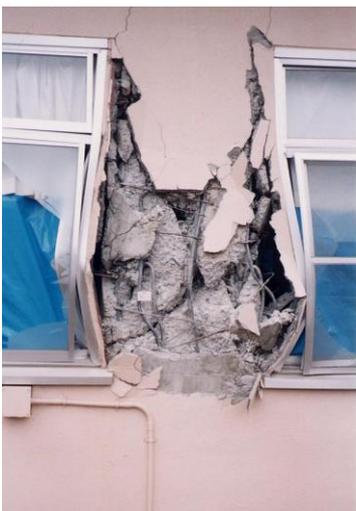
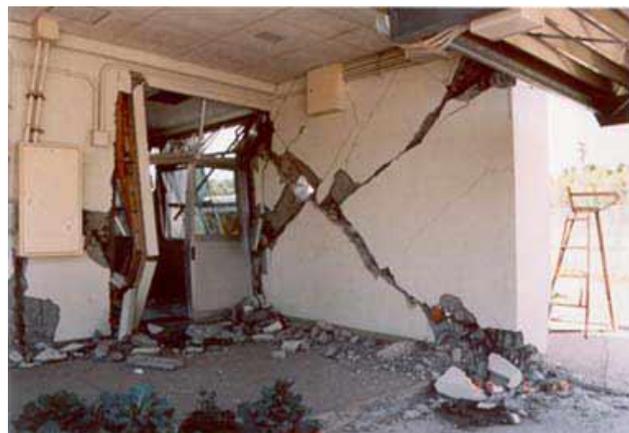
Damage class V:

Photo 1. Damage Class Examples

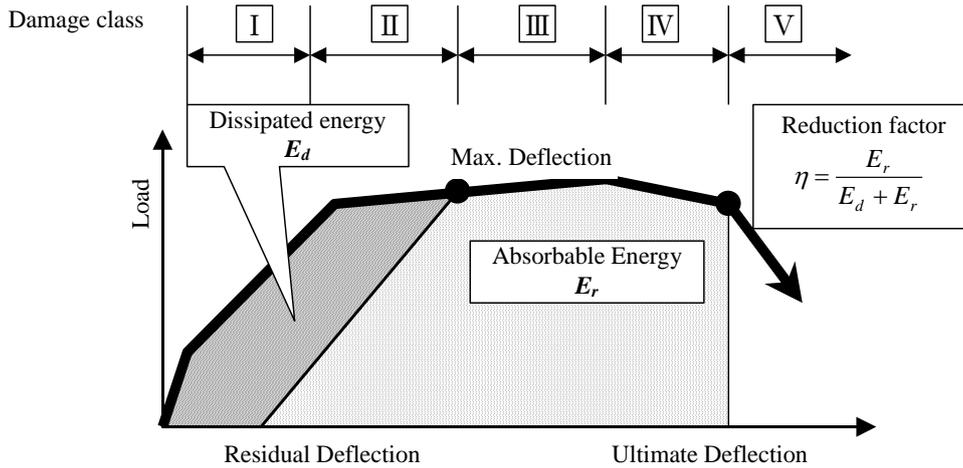
Figure 3. Seismic capacity reduction factor  $\eta$  (JBDPA 2001a)

In the Seismic Evaluation Standard (JBDPA 2001b), the most fundamental component for the  $I_s$  index is the  $E_0$  index, which is calculated from the product of the strength index ( $C$  index) and the ductility index ( $F$  index) (see Appendix). Accordingly, the  $E_0$  index corresponds to the energy dissipation capacity in a structural member. Fig. 3 shows a conceptual diagram illustrating the lateral force-displacement curve and a definition of the  $\eta$  factors. When the maximum response reaches point A during an earthquake and residual displacement (point B) occurs, the area of  $E_d$  and  $E_r$  is assumed to be the dissipated energy during the earthquake and the residual energy dissipation capacity after the earthquake, respectively. The  $\eta$  factor is defined as the ratio of residual energy dissipation capacity,  $E_r$ , to original energy dissipation capacity,  $E_t (= E_d + E_r)$ , and can be calculated by Eq. (2).

The seismic capacity reduction factors, *i.e.*,  $\eta$  factors for structural members corresponding to the damage classes, are listed in Table 2. The values for  $\eta$  factors are determined from the residual crack width and the overall damage state of RC columns observed in the first author's laboratory experiments (Maeda et al. 2004) and analytical studies (Maeda and Bun-no 2001, Maeda and Kang 2009). The post-earthquake seismic capacity,  $D/S$  index, of the overall building after earthquake damage can be calculated based on the  $E_0$  index reduced by the  $\eta$  factor corresponding to the observed damage class of each structural member.

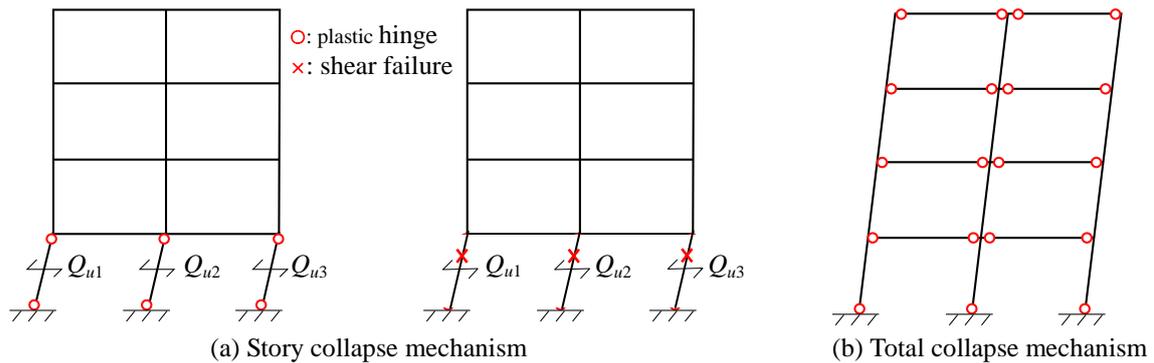
Fig. 4 shows typical collapse mechanism of frame structures. As was revealed in past damaging earthquakes in Japan, typical life-threatening damage is generally found in vertical members, and story collapse mechanism, as shown in Fig. 4(a), is formed. Therefore, the current Guideline is essentially designed to identify and classify damage in columns and walls rather than in beams, and residual seismic capacity,  $R$ -index, can be evaluated based on story shear by Eq.(3) assuming ductility index ( $F$  index) is uniform in all the vertical elements in the story. When damage is found in beams, the damage classification needs to be performed considering their deficiency in vertical load carrying capacity as well as lateral resisting of columns adjacent to damaged beams.

Figure 4. typical collapse mechanism of frame structures

Although story collapse is the most popular failure mechanism, other relatively ductile failure patterns were observed in reinforced concrete buildings damaged by recent earthquakes such as the 2011 East Japan Earthquake. Beam yielding total collapse mechanism (Fig.4(b)), which is recommended in the current seismic code and guidelines, was found in some relatively new middle or high rise buildings designed according to current seismic codes. Therefore, the evaluation method for total collapse mechanism, proposed by the first author et al. (Bao et al. 2010), is introduced into the Guideline and the scope of application was widened.  $R$ -index for total collapse mechanism is evaluated by Eq. (4). Eq. (4) gives a ratio of internal work at plastic hinges in virtual work method before and after an earthquake.

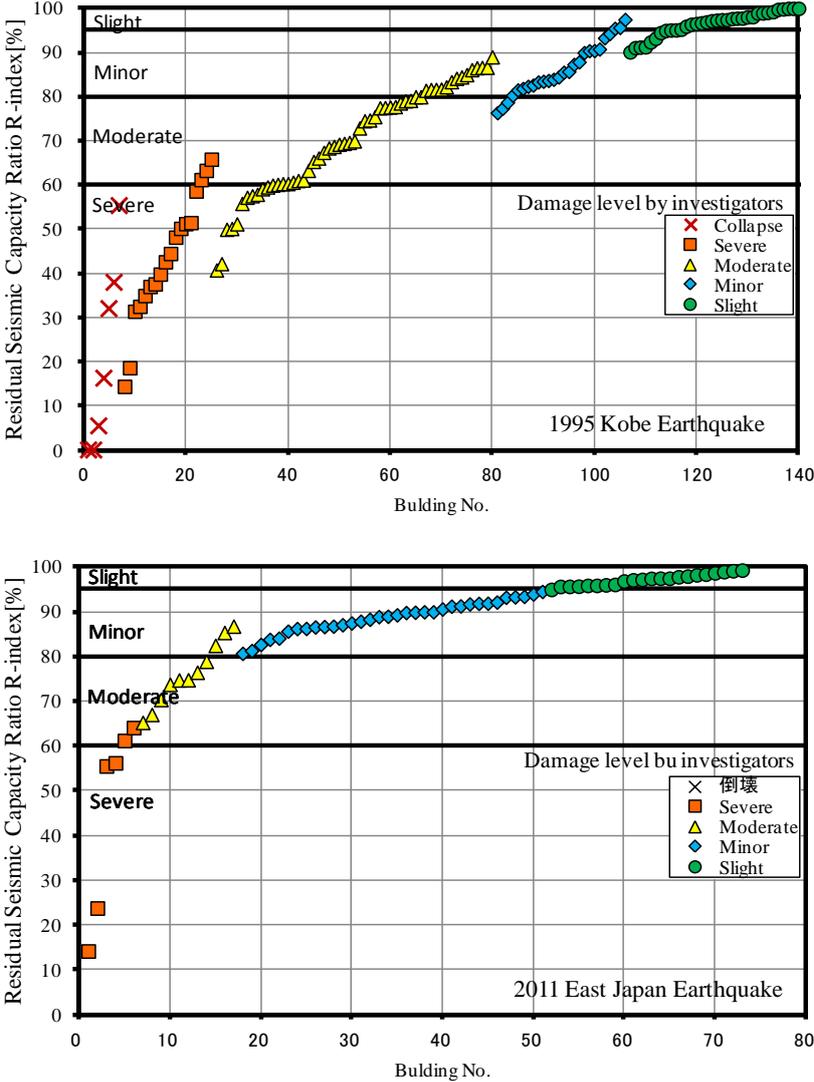
The residual seismic capacity ratio,  $R$  index, of about 140 reinforced concrete buildings damaged in the Kobe Earthquake and about 70 buildings in the East Japan Earthquake are shown in Fig. 4 together with the observed damage levels from field surveys by experts such as professors. The horizontal lines in Fig. 4 are the boundaries between damage levels employed in the Damage Evaluation Guideline in 2001.

Figure 4 Residual seismic capacity index  $R$  and observed damage levels due to Kobe Earthquake.

[slight damage]	$R \geq 95$ %
[minor damage]	$80 \leq R < 95$ %
[moderate damage]	$60 \leq R < 80$ %
[severe damage]	$R < 60$ %
[collapse]	$R \approx 0$

The boundary lines between damage levels were examined in the 2001 Guideline revision for the buildings in Fig. 4(a), of which failure mechanism is story collapse. The boundary line between slight and minor damage was set to  $R = 95\%$  to harmonize “slight damage” to the serviceability limit state in which repair is not required and buildings may be functional. Almost all severely damaged buildings and approximately 1/3 of moderately damaged buildings were demolished and rebuilt after the earthquake according to a report of the Hyogo Prefectural Government (1998). If the boundary between moderate and severe damage was set to  $R = 60\%$ , “moderate damage” may correspond to the repairability limit state. As shown in Fig. 4(b), the damage levels based on the  $R$  index generally agree with those classified by investigators for the buildings suffered from East Japan Earthquake, which include buildings with total collapse mechanism.
