DAMAGE AND RESIDUAL SEISMIC PERFORMANCE EVALUATION OF REINFORCED CONCRETE SHEAR WALLS

M. Maeda⁽¹⁾, T. Koike⁽²⁾, N. Hosoya⁽³⁾, Y. Suzuki⁽⁴⁾, K. Tsurugai⁽⁵⁾, A. Nimura⁽⁶⁾

Abstract

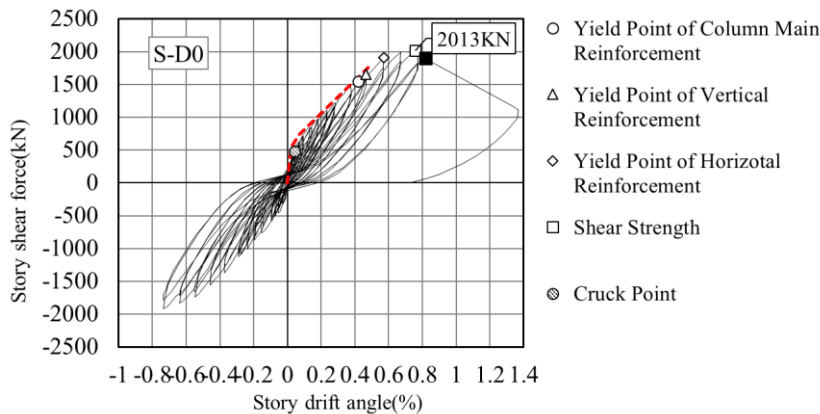
Shear force-story drift angle relationship of specimen S-D0 is shown for Fig.4 associated with a back bone curve calculated by JEAC design guideline [4]. Initial cracks were observed at the wall panel corner and cracks generated in entire wall panel at the loading cycle of 2/1000rad (see Fig.5). reinforcing bar yielded and fine spalling of concrete in wall panel was observed at the center of wall panel at cycle of 6/1000rad. At cycle of 8/1000rad, shear force reached to the maximum and, at the same time, crush of concrete and rapid drop in shear force occurred. Process of growth of cracks and crush in concrete is shown in Fig.6. Note that damage such as cracks and crush was recorded only left side part of a specimen (Fig.5), because symmetrical damage pattern can be predicted because of symmetrical stress distribution in a specimen.

Fig. 4– Shear force-story drift angle relationship of S-D0

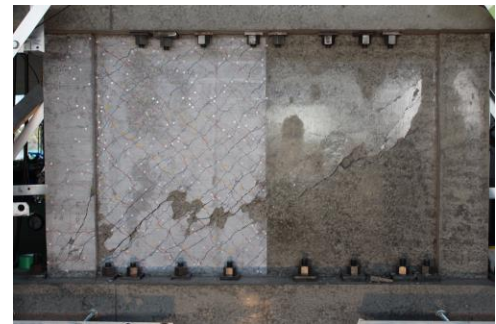
Fig.5–Damage at ultimate stage

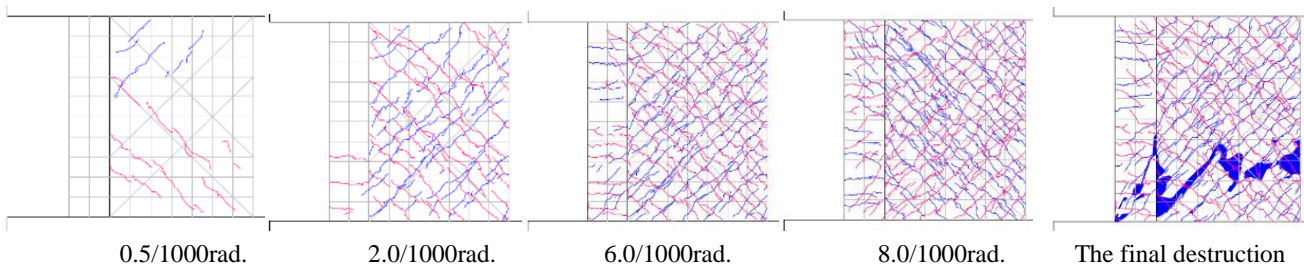
Fig. 6–Cracking maps of specimen S-D0

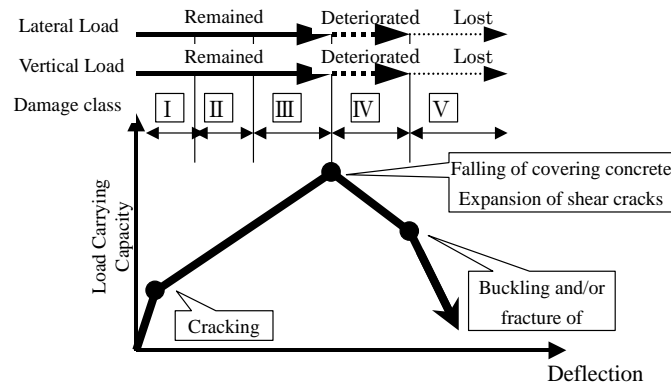
Fig. 7—Idealized lateral force-displacement relationships and damage class[2]

In Japan, damage level of reinforced concrete structural members is classified according to Japanese “Guideline for post-EQ Damage Evaluation” [1]. In the guideline, damage class is classified based on basic concept of shear force- deformation curve and Table 1. experimental data such as cracks, shear force-deformation relationship and stiffness degradation were examined and compared with judging criteria for damage classes, and judged the damage class. Cracks are related to strain of the reinforcement, the larger strain become, the more expand cracks as shown in Fig.8,

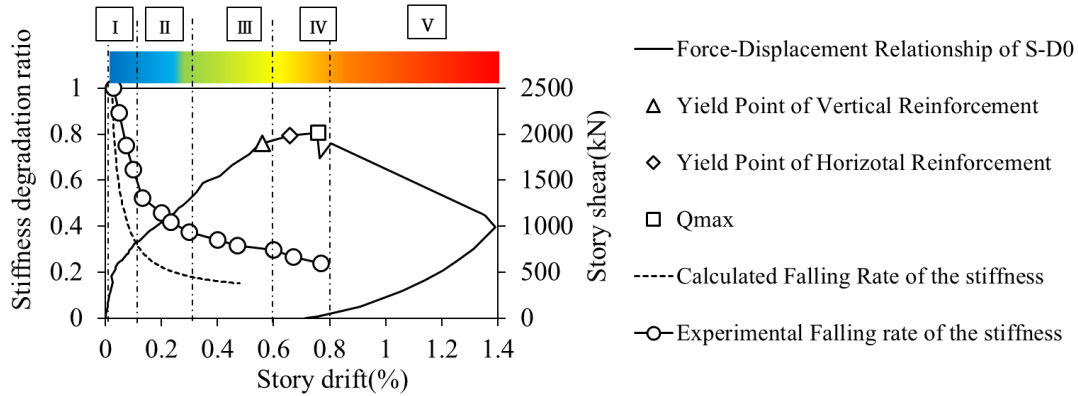
Based on the above understanding, damage class, stiffness degrading ratio and crack width/length are integrated in Fig.9. From this result, story drifts required by each the damage level were determined. Specifically, damage class I is a cracking drift $\sim 1/1000\text{rad}$, Damage class II is $1/1000\text{rad} \sim 3/1000\text{rad}$, Damage class III is $3/1000\text{rad} \sim 6/1000\text{rad}$, and Damage class IV is $6/1000\text{rad} \sim$ ultimate shear strength. Thus, pre-loading for specimen S-DI~IV was carried out as shown in Table 4.

Fig. 9(a)–Damage class and stiffness degrading ratio

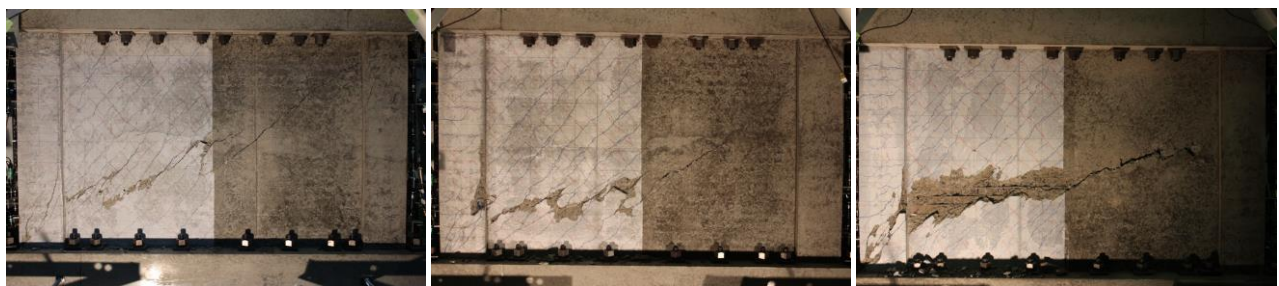
(a)S-D I

(b)S-D III

(c)S-D IV

Fig.11– Damage at ultimate stage

Fig.10 shows shear force-story drift angle relationship of positive loading parts for damaged specimens S-DI-IV. All of the specimen indicate similar trend with un-damaged specimen S-D0, cracks generated from the wall corners, reinforcing bars yielded at the cycle of 6/1000rad. The specimens reached the maximum shear force at the drift angle of 8/1000rad. After that the peak, specimens suddenly lost shear resistance with shear failure of wall panels. Further, it can be seen from the damage at ultimate stage of each test body shown in Fig.11, the spalling area increased when the damage level of specimen was higher.

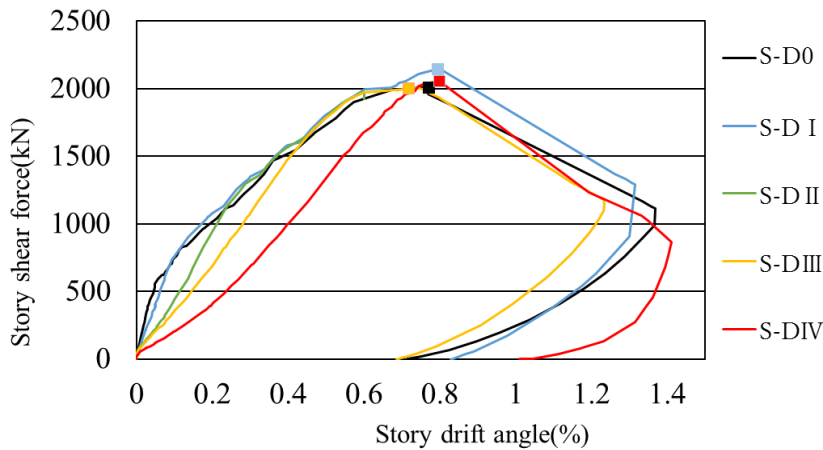
Envelope of shear force-deformation relationships for all the specimens is shown in Fig.13. In a region within the maximum deformation in pre-loading, shear force of damaged specimens decreases due to the degradation of equivalent stiffness as shown in Fig. 12. However, recovery of shear resistance can be seen from the figures when deformation exceeds the maximum in the pre-loading and no significant effect of damage on ultimate shear strength and deformation capacity was found in the shear wall investigated in this paper.

Fig.13(a) – Envelopes of shear-force – story drift curves with different levels of damage

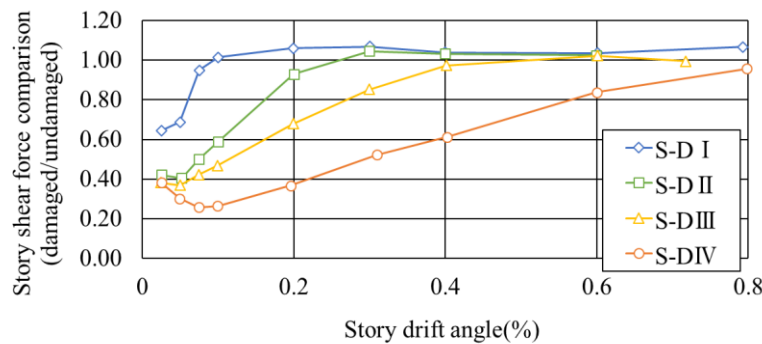
Fig.13(b)– Comparison of story shear force in each cycle

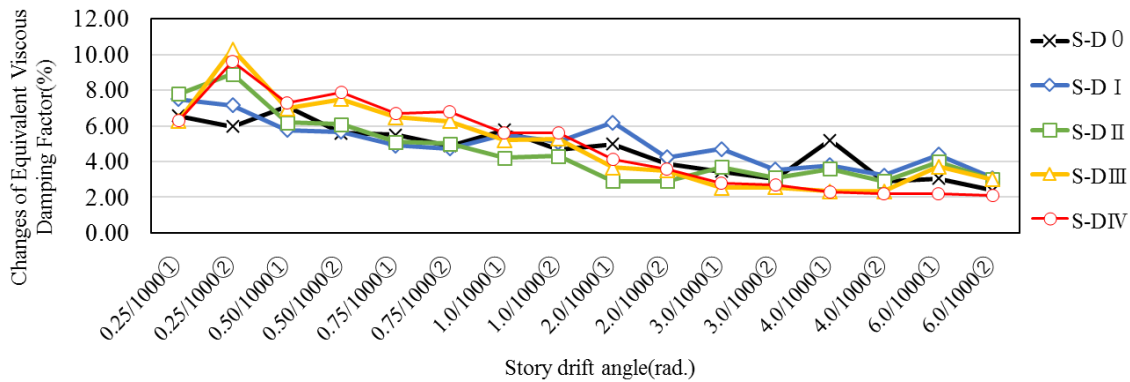
As shown in Fig.14, equivalent viscous damping factor h_{eq} of heavily damaged specimens, S-DIII and S-DIV, are larger than the other specimens in small deformation. However, when the deformation becomes larger, there is no big difference among the specimens with different levels of damage, although heavily damaged specimen tend to have smaller damping factor. Significant effect of damage on damping factors was not observed as was found in shear strength and deformation capacity in 4.3.

Fig.14– Equivalent viscous damping factor

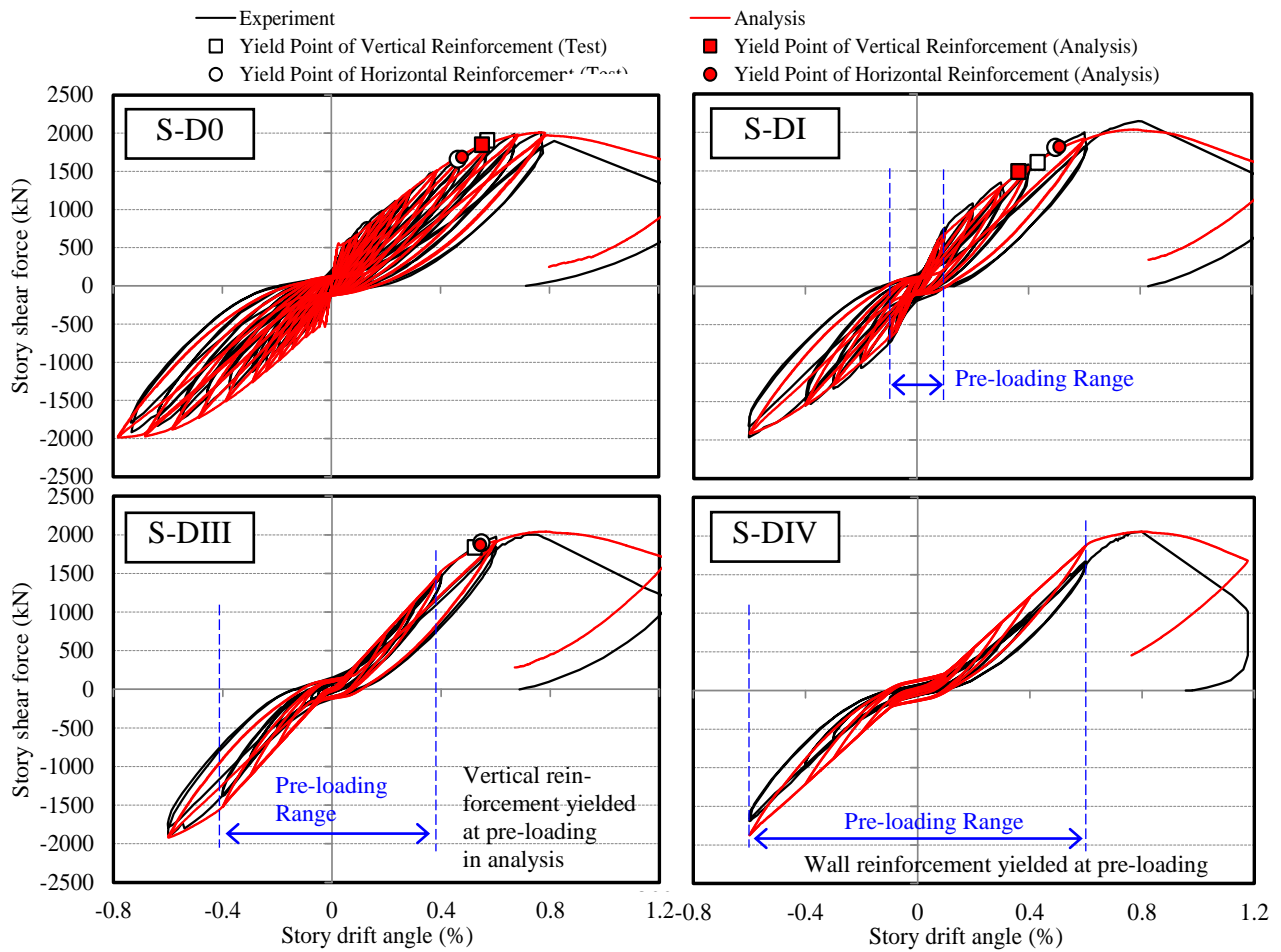
Fig.16 shows the comparison of experiments and analysis of the shear force-story drift angle relationships and the points where the wall reinforcements start yielding for the non-damaged specimen S-D0 and damaged specimens S-DI · III · IV. And, Table 6 shows the comparison of maximum strength of each cases. The shear force-story drift angle relationships show only main loading, and the range of deformation by pre-loading is indicated in Fig.16.

Analysis result of non-damaged specimen S-D0 corresponded to experiments well both in maximum strength and cyclic characteristics. Analysis is also consistent with the experiment for the point where the wall reinforcements start yielding.

For the damaged specimens S-DI and S-DIII, the analysis simulates well both the deformation level where damage occurred from preloading and the deformation level without damage, and the maximum strength is also evaluated well. On the other hand, the stiffness of analysis during pre-loading range in SD-IV, that has experienced large deformation such as 6/1000rad, was higher than that of experiment. However, maximum strength that occurred in no-damage deformation level was evaluated well in the analysis.

Fig.16 – Comparison of analysis and tests
