Tenth U.S. National Conference on Earthquake Engineering
Frontiers of Earthquake Engineering
July 21-25, 2014
Anchorage, Alaska

REVISION OF GUIDELINE FOR POST-EARTHQUAKE DAMAGE EVALUATION OF RC BUILDINGS IN JAPAN

M. Maeda¹, K. Matsukawa² and Y. Ito³

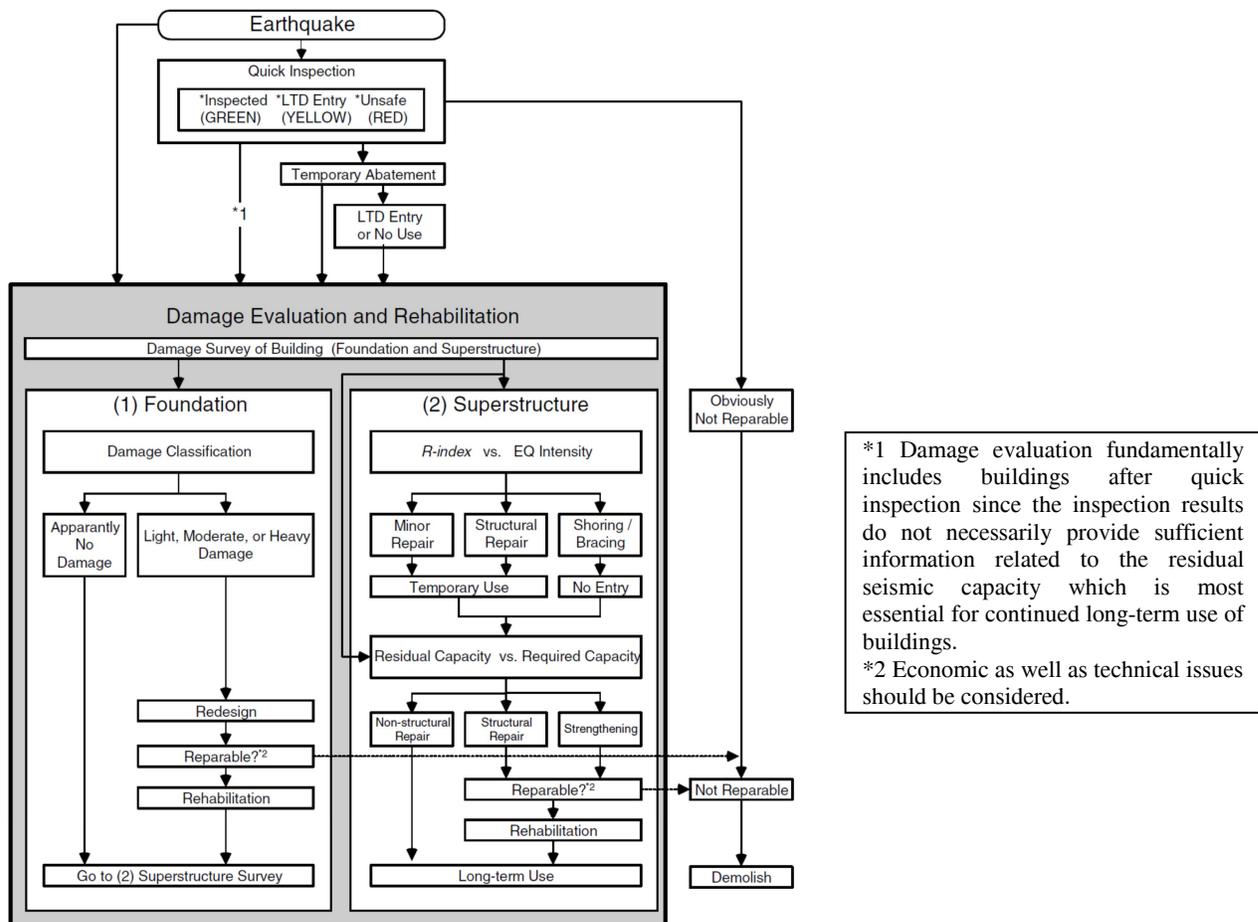
Figure 1. General Flow of Damage Evaluation and Rehabilitation in the Guideline [3]

Damage evaluation of a building is performed on the foundation system and superstructure system, respectively, and the damage rating of each building is made in a combination form for each system such as “no damage in foundation and moderate damage in superstructure”. Rehabilitation actions necessary for the building are then determined considering identified damage. **Fig. 1** shows the general flow of damage evaluation and subsequent rehabilitation.

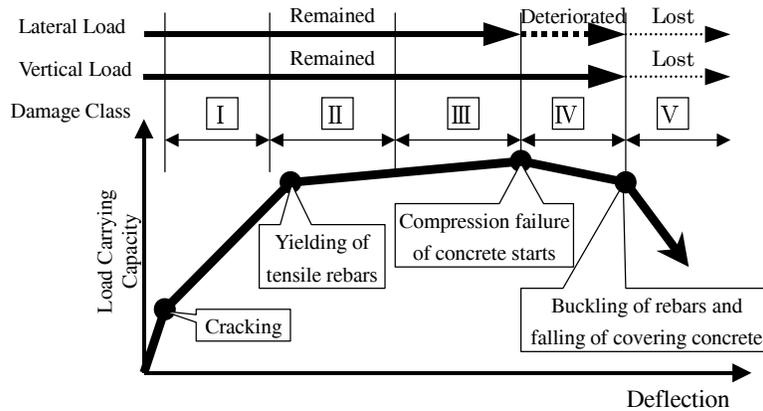
(a) Ductile member

In **Fig. 2(a)**, a ductile member deforms up to a maximum lateral strength level after yielding. Furthermore, after reaching the maximum strength, the reduction of strength is relatively small. If the maximum deformation during an earthquake does not reach deformation at yielding point, extensive damage would not occur. This state corresponds to damage class I, between the cracking and yield points. If the maximum deformation does not exceed the maximum strength, damage to cover concrete is limited and most of the lateral and vertical strengths remains in the

Figure 2. Idealized lateral force-displacement relationships and damage class[2]

In the Damage Evaluation Guideline [1], the state of damage of each structural member is first classified into one of the five classes listed in **Table 1**. The relationship between each damage class given in **Table 1** and the lateral force-displacement curve is approximated as shown in **Fig. 2**. Examples of damage class for columns and walls are shown in **Photo 1**.

flexural member. This state corresponds to damage class II and damage class III. If the maximum response exceeds the maximum lateral strength point, deterioration in lateral strengths with spalling of cover concrete would be observed. The vertical strength may remain if the buckling and/or fracture of reinforcing bars and crush of core concrete, etc., do not occur. This state corresponds to damage class IV. If buckling and/or fracture of reinforcing bars and crush of core concrete occur, both the lateral and vertical load carrying capacities will be lost (damage class V).

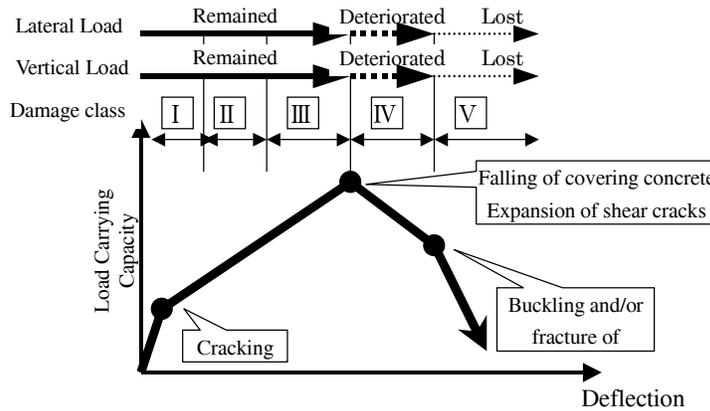
(b) Brittle member

The degree of damage in a brittle member, as shown in **Fig. 2(b)**, is similar to that of a ductile member up to the maximum strength, although diagonal or X-shape cracks may also be visible (damage classes I, II and III). After the maximum strength is reached, a significant reduction in both lateral and vertical strength may occur (damage class IV). Finally, X-shape shear cracks widen and both lateral and vertical load carrying capacity will be lost suddenly (damage class V). In the Seismic Evaluation Standard [2], the most fundamental component for the I_s index is the E_0 index, which is calculated from the product of the strength index (C index) and the ductility index (F index) (see Appendix). Accordingly, the E_0 index corresponds to the energy dissipation capacity in a structural member. **Fig. 3** shows a conceptual diagram illustrating the lateral force-displacement curve and a definition of the η factors. When the maximum response reaches point A during an earthquake and residual displacement (point B) occurs, the area of E_d and E_r is assumed to be the dissipated energy during the earthquake and the residual energy dissipation capacity after the earthquake, respectively. The η factor is defined as the ratio of residual energy dissipation capacity, E_r , to original energy dissipation capacity, $E_t (= E_d + E_r)$, and can be calculated by Eq. (2).

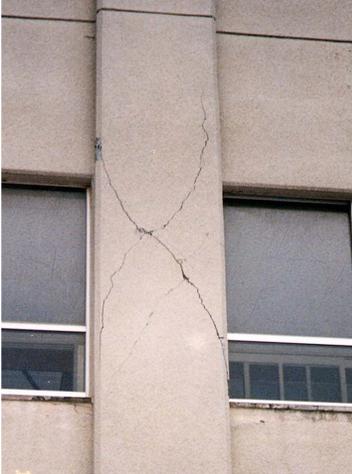
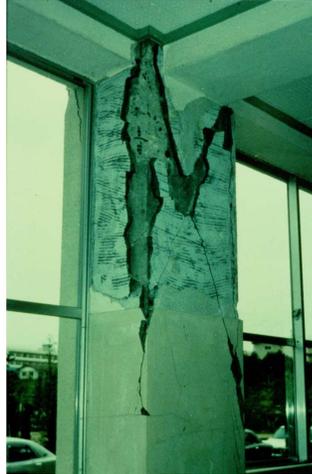
Damage class III: (left) Cracks with a width of about 2mm on structural concrete
(right) Spalling concrete cover and slightly exposed rebars

Photo 1. Damage Class Examples

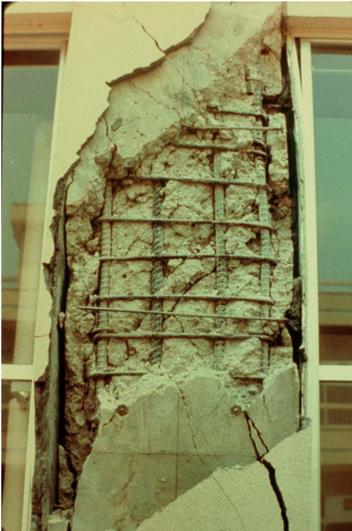
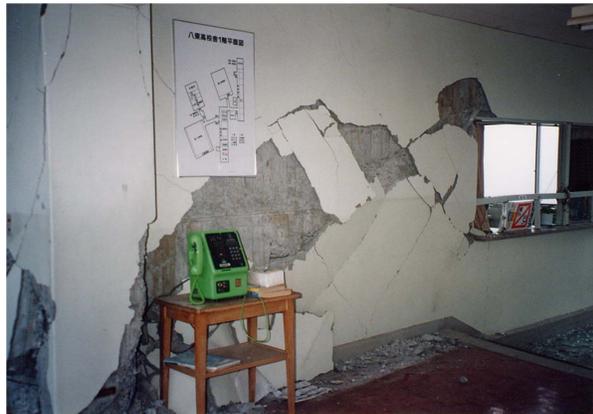
Damage class IV: Exposed rebars without buckling or fracture

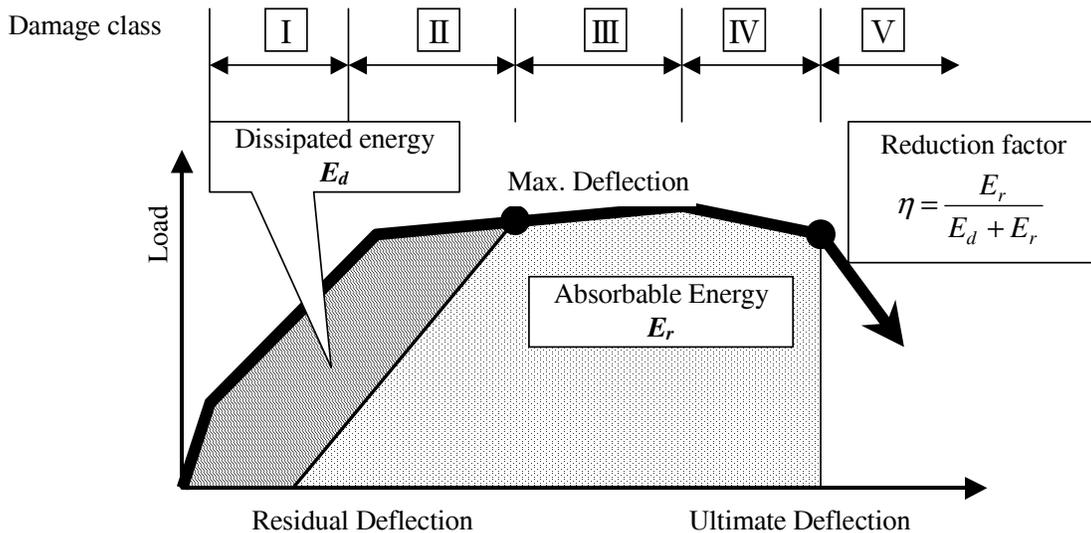
Figure 3. Seismic capacity reduction factor η

$$\eta = \frac{E_r}{E_t} \quad (2)$$

where, E_d : dissipated energy, E_r : residual energy dissipation capacity, E_t : original energy dissipation capacity ($E_t = E_d + E_r$).

The seismic capacity reduction factors, *i.e.*, η factors for structural members corresponding to the damage classes, are listed in **Table 2**. The values for η factors are determined from the residual crack width and the overall damage state of RC columns observed in the first author's laboratory experiments [4] and analytical studies [5], [6]. The post-earthquake seismic capacity, DIs index, of the overall building after earthquake damage can be calculated based on the E_0 index reduced by the η factor corresponding to the observed damage class of each structural member.

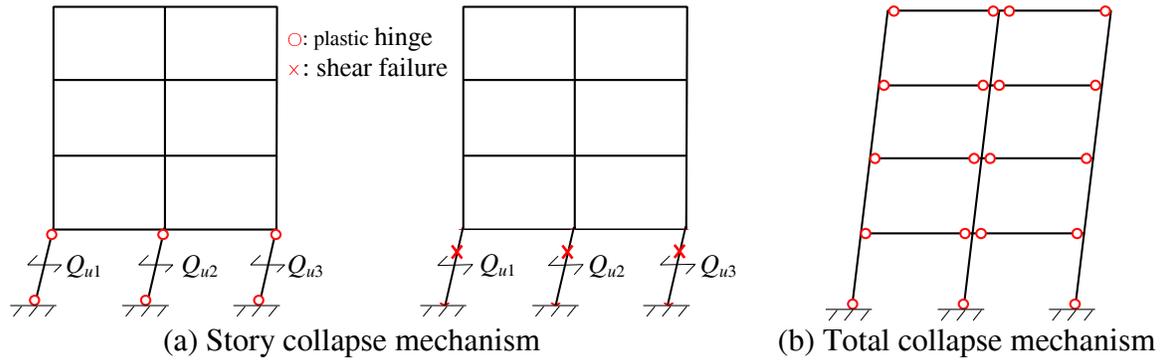
Figure 4. typical collapse mechanism of frame structures

Fig. 4 shows typical collapse mechanism of frame structures. As was revealed in past damaging earthquakes in Japan, typical life-threatening damage is generally found in vertical members, and story collapse mechanism, as shown in **Fig. 4(a)**, is formed. Therefore, the current Guideline is essentially designed to identify and classify damage in columns and walls rather than in beams, and residual seismic capacity, R -index, can be evaluated based on story shear by Eq.(3) assuming ductility index (F index) is uniform in all the vertical elements in the story. When damage is found in beams, the damage classification needs to be performed considering their deficiency in vertical load carrying capacity as well as lateral resisting of columns adjacent to damaged beams.

Although story collapse is the most popular failure mechanism, other relatively ductile failure patterns were observed in reinforced concrete buildings damage by recent earthquakes such as the 2011 East Japan Earthquake. Beam yielding total collapse mechanism (**Fig.4(b)**), which is recommended in the current seismic code and guidelines, was found in some relatively new middle or high rise buildings designed according to current seismic codes. Therefore, the evaluation method for total collapse mechanism, proposed by the first author et al. [7], is introduced into the Guideline and the scope of application was widened. R -index for total

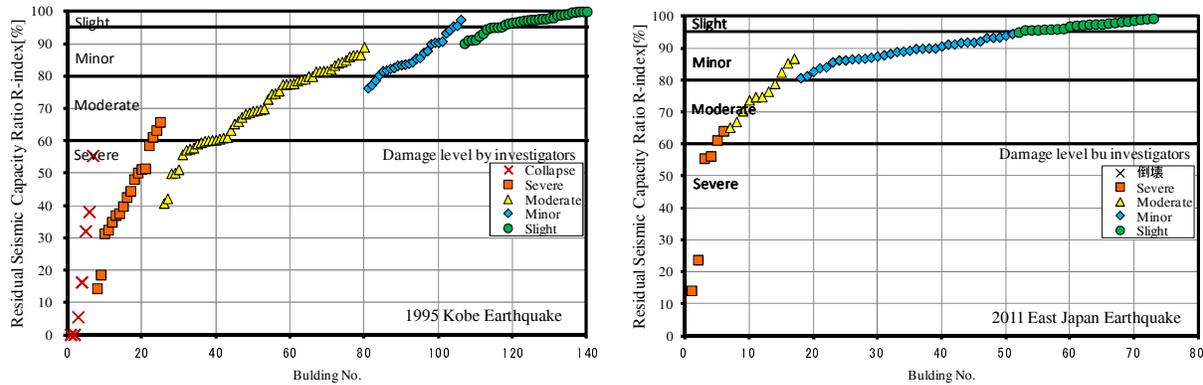
Figure 4 Residual seismic capacity index R and observed damage levels due to Kobe Earthquake.

The residual seismic capacity ratio, R index, of about 140 reinforced concrete buildings damaged in the Kobe Earthquake and about 70 buildings in the East Japan Earthquake are shown in **Fig. 4** together with the observed damage levels from field surveys by experts such as professors. The horizontal lines in **Fig. 4** are the boundaries between damage levels employed in the Damage Evaluation Guideline in 2001.

[slight damage]	$R \geq 95 \%$
[minor damage]	$80 \leq R < 95 \%$
[moderate damage]	$60 \leq R < 80 \%$
[severe damage]	$R < 60 \%$
[collapse]	$R \approx 0$

The boundary lines between damage levels were examined in the 2001 Guideline revision for the buildings in **Fig. 4(a)**, of which failure mechanism is story collapse. The boundary line between

slight and minor damage was set to $R = 95\%$ to harmonize “slight damage” to the serviceability limit state in which repair is not required and buildings may be functional. Almost all severely damaged buildings and approximately 1/3 of moderately damaged buildings were demolished and rebuilt after the earthquake according to a report of the Hyogo Prefectural Government (1998). If the boundary between moderate and severe damage was set to $R = 60\%$, “moderate damage” may correspond to the reparability limit state. As shown in Fig. 4(b), the damage levels based on the R index generally agree with those classified by investigators for the buildings suffered from East Japan Earthquake, which include buildings with total collapse mechanism.

In this paper, the basic concept of the Guideline for Post-Earthquake Damage Evaluation of RC buildings in Japan was presented. The concept and supporting data of the residual seismic capacity ratio, R index, which is assumed to represent post-earthquake damage of a building structure, were discussed. Good agreement between the residual seismic capacity ratio, R index, and the observed damage levels of RC buildings in recent severe earthquakes was found.
