## GUIDELINE FOR POST-EARTHQUAKE DAMAGE EVALUATION AND REHABILITATION OF RC BUILDINGS IN JAPAN

### SUMMARY

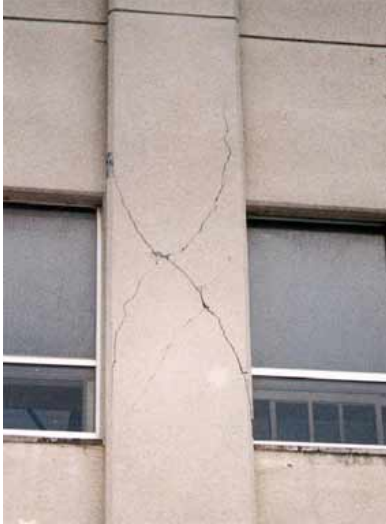
Damage class III:  
(left) Cracks with a width of about 2mm on structural concrete  
(right) Spalling concrete cover and slightly exposed rebar

Damage classification of columns and shear walls is performed based on the damage definition shown in **Table 2** and **Photo 1**. As was revealed in the past damaging earthquakes in Japan, typical life-threatening damage is generally found in vertical members, and the Guideline is essentially designed to identify and classify damage in columns and walls rather than in beams. When damage is found in beams, the damage classification needs to be performed considering their deficiency in vertical load carrying capacity as well as lateral resisting of columns adjacent to damaged beams. As defined in **Table 2**, columns and walls are classified in one of five categories I through V. **Figure 2** schematically illustrates the load carrying capacity, load-deflection curve, and member damage class.

**Photo 1: Damage Class Examples**

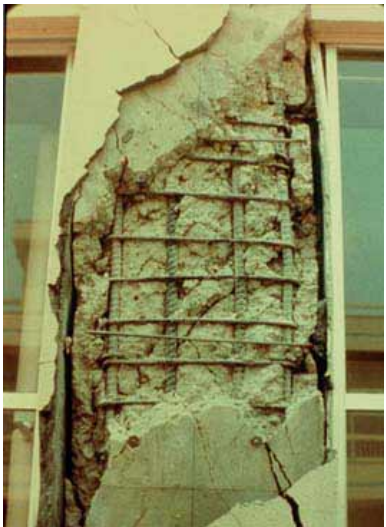
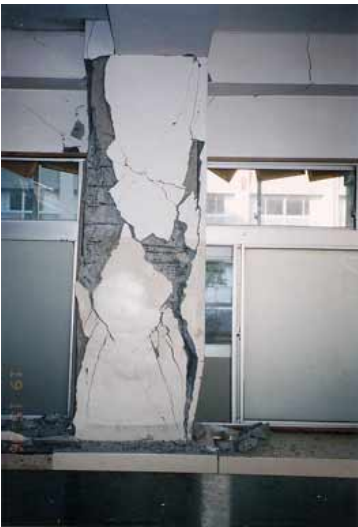
Damage class IV:  
Exposed rebar without buckling or fracture

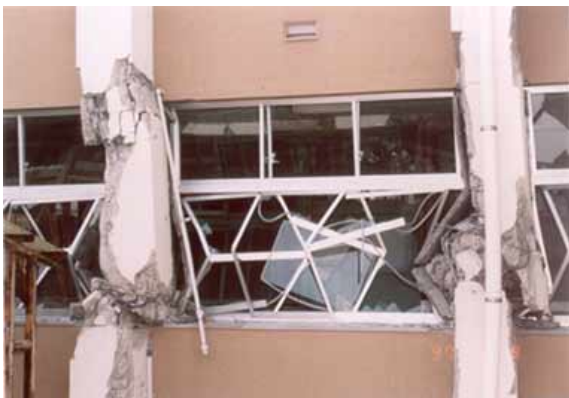
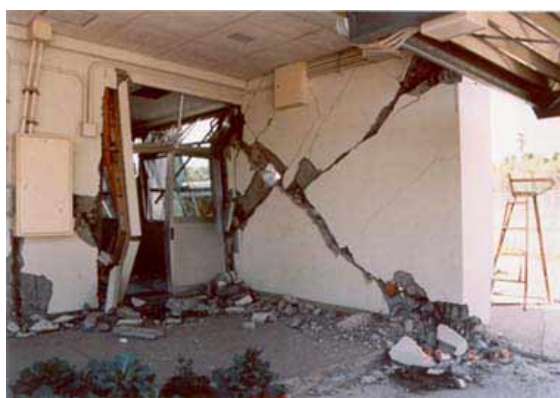
Damage class V

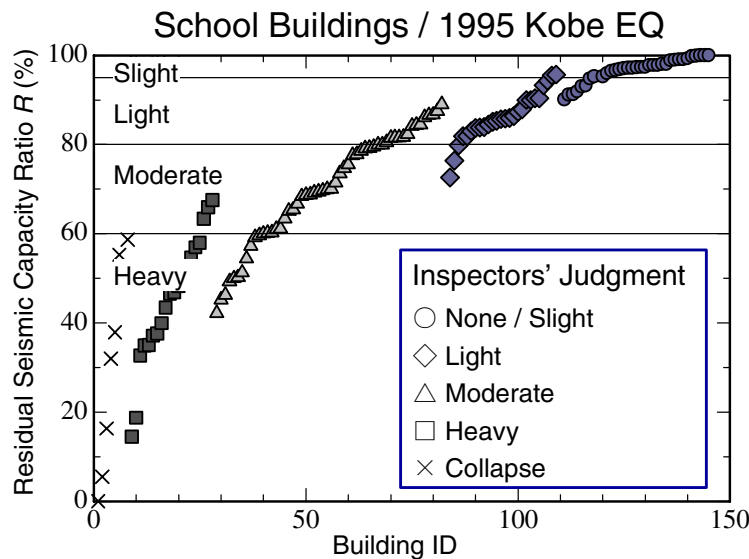
**Figure 5: Residual Seismic Capacity Ratio  $R$  vs. Observed Damage**

The residual seismic capacity ratio index  $R$  defined in (2) can be considered to represent damage sustained by a building. For example, it may represent no damage when  $R = 100\%$  (100% capacity is preserved), more serious damage with decrease in  $R$ , and total collapse when  $R = 0\%$  (no residual capacity). To identify the criteria for damage rating,  $R$  values, calculated from the simplified procedure shown in Eq.(3), of 145 school buildings that experienced the 1995 Kobe earthquake are compared with observed damage and judgment by experts as shown in Figure 5. Based on the results shown in the figure, the Guideline then defines the damage rating criteria shown below.

It should be noted, however, that the border line between two adjacent damage rating such as [heavy damage] and [moderate damage] is not necessarily explicit, and overlapping or gray zones may be found in the figure. Those close to the damage rating criteria should be categorized after careful damage examination rather than a simple numerical judgment.
